# Property and Timber Pest Report

Inspection Date: 20 Nov 2025

Property Address: 57-73 Glaneuse Road Point Lonsdale 3225

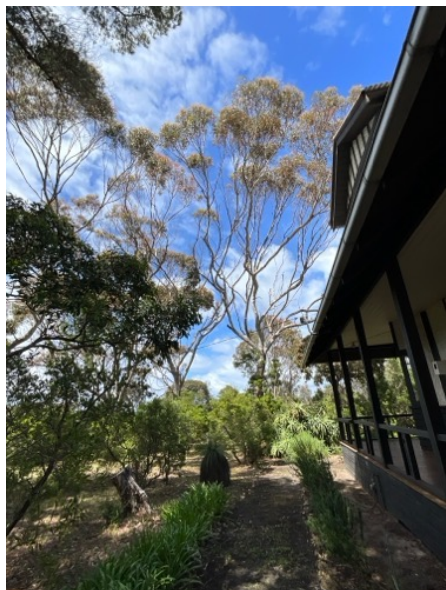
**Finding:** Trees - Falling vegetation

It was observed at the time of inspection that there is evidence where deteriorated tree branches / vegetation exist throughout the property. The vegetation will require trimming / removal. A specialist arborist should be engaged as soon as possible to rectify this issue.

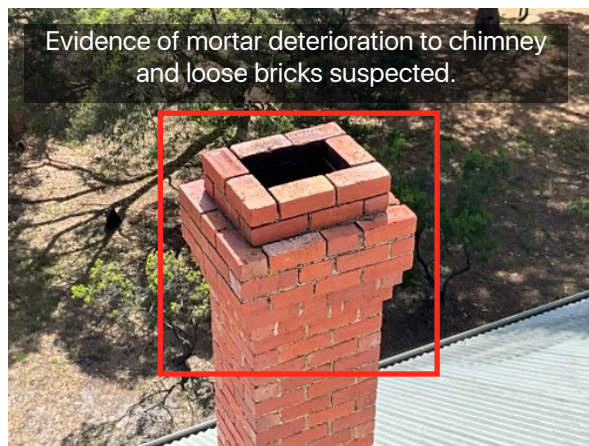
**Location:** The site  
**Finding:** Brickwork - Deteriorated mortar

Mortar or bedding, is the material which fills joints and intersections between bricks in masonry walls and structures. Sections of the mortar in the brickwork were identified as having deteriorated, which is generally expected for a property of this age.

Mortar may deteriorate as a result of age of the building materials, minor movement in bricks or frequent exposure to weathering. Mortar should be replaced to ensure the bricks remain in their intended location and to prevent gaps, which would allow water or moisture ingress and secondary damage as a result.

Mortar deterioration can be addressed by a brick layer where areas of deterioration are localised and easily accessible. Alternatively appointment of a registered builder is advised to repoint large areas of decayed mortar. Where secondary structural defects have become evident consultation with a structural engineer may be required.

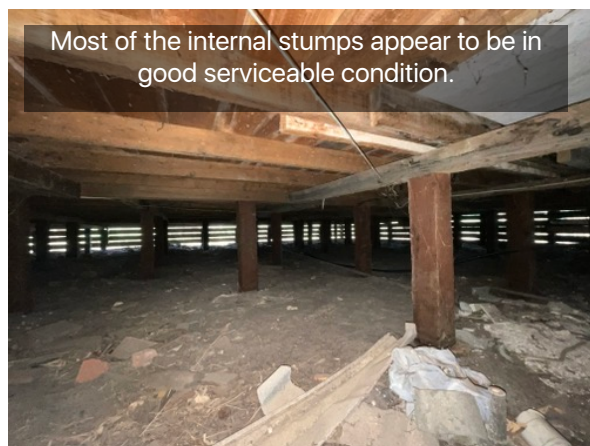
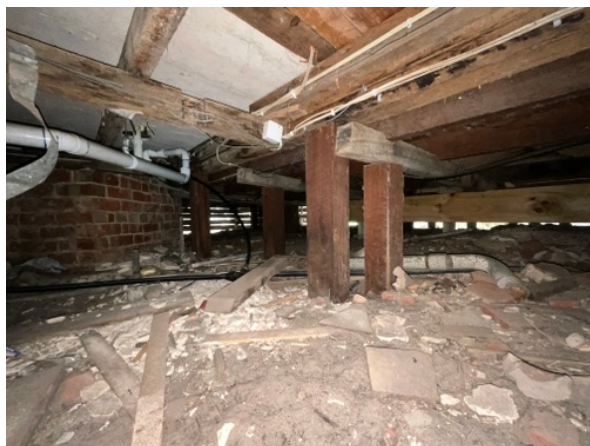
**Location:** Subfloor  
**Finding:** Timber stumps - Suspected deterioration

It was noted that the property has timber stumps. Inspection of the condition of the timber stumps - below the surface of the ground - is excluded from the scope of this report. Where timber stumps are failing replacement of stumps may be required in the short- to medium-term future. Timber stumps are no longer used in current building practices due to their susceptibility to wood rot and deterioration over time. The client should be prepared that in purchasing a property with timber stumps, that the need to either partially or fully restump the property in the short- to medium-term future is likely.

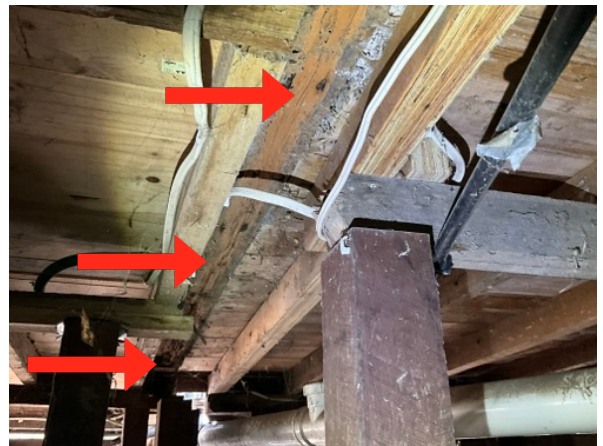
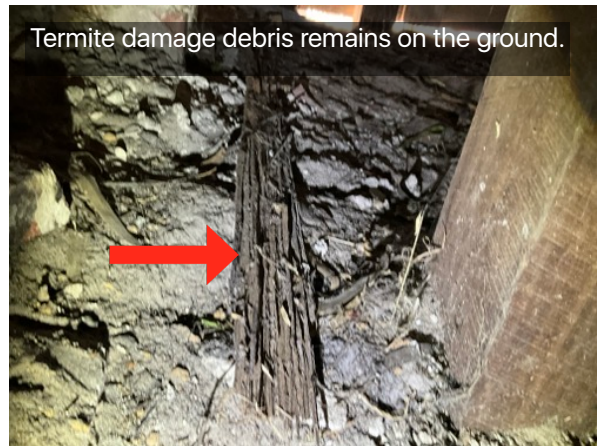
**Location:** Subfloor  
**Finding:** Termite Damage/workings ( Structural )

Despite no live termite or timber pest activity been identified, previous termite damage was found in this area. This damage is considered to be inactive but structural in nature. It was however noted that damaged sections of the structure have been either replaced or reinforced with new timbers.

Due to the nature of Termites it is highly likely that further damage may be present to areas that are not readily accessible. It is advised that the area be visually inspected frequently to ensure that the condition of the affected building materials does not worsen and that there is no further termite activity.

It is highly recommended that advise from the home owner be given with regard to the reparative works that have been completed and any permits or certificates that may have been issued by the builder to complete such works.

The homeowner should comply with instructions and recommendations as per the warranty provided by the pest control company and continue to monitor area's which have conditions conducive to termite activity.

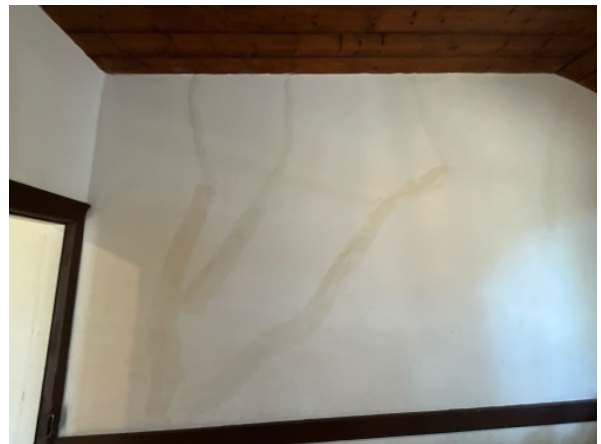
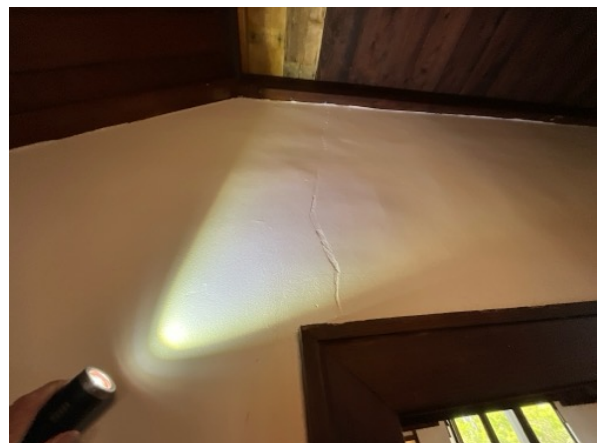
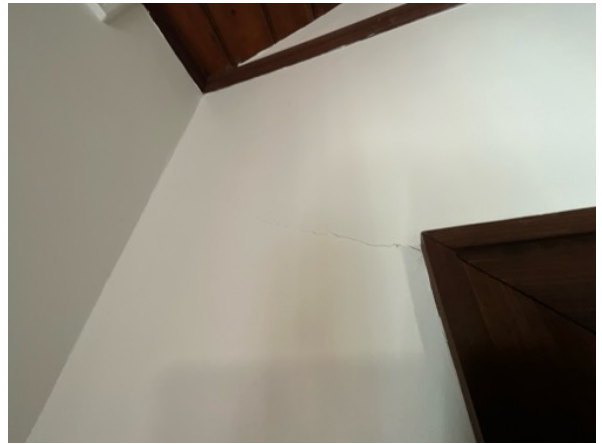
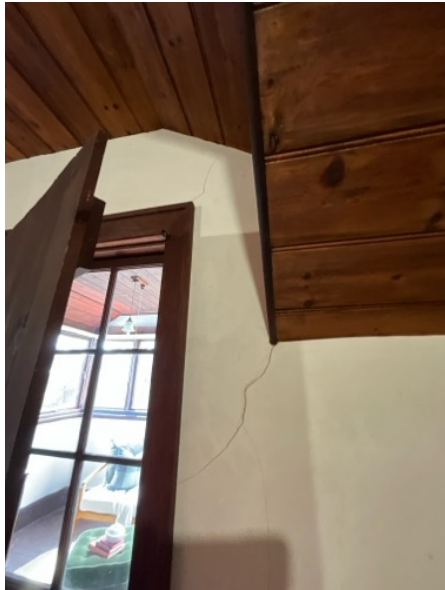
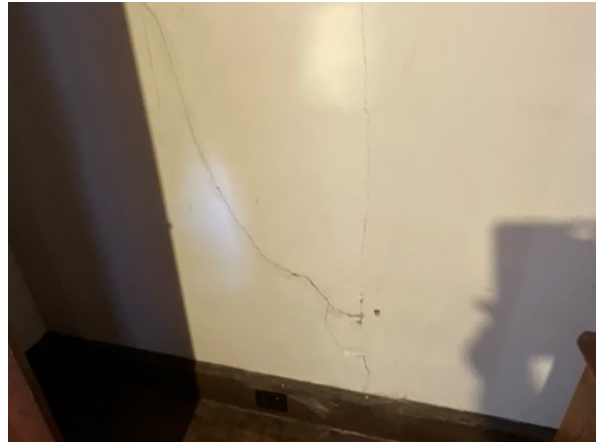
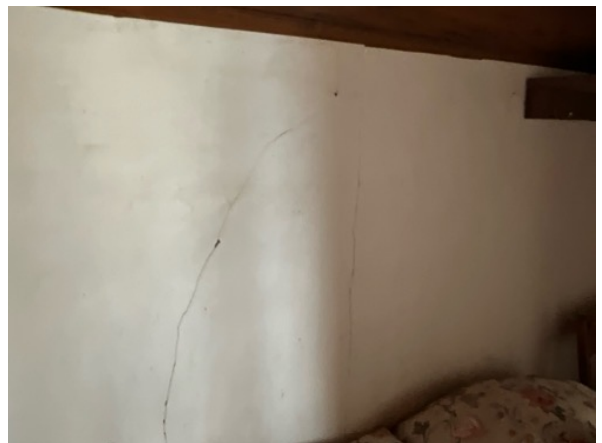
**Finding:** Cracking - Damage Category 2 - Noticeable ( up to 5mm )

Noticeable cracks are a common occurrence as a result of many primary defects . Such courses may include age, general wear and tear, expected building movement, general expansion contraction of building materials in different weather conditions, and/or minor failings in the installation or application of building materials.

Noticeable cracks may result in minor sticking or jamming of associated doors and windows which require easement. However noticeable cracks are easily filled and repaired. Plasterer can be consulted to install an expansion joint at this point to allow for this movement during different weather conditions

Monitoring of all cracking should be conducted frequently. Always can contact the building inspector should cracks widen lengthen or become more near but numerous. Additionally your building inspector should be contacted if associated building elements such as doors and windows become more difficult to operate overtime.

Other trades people such as carpenters, painters and plasterers should be appointed to perform remedial works as necessary !

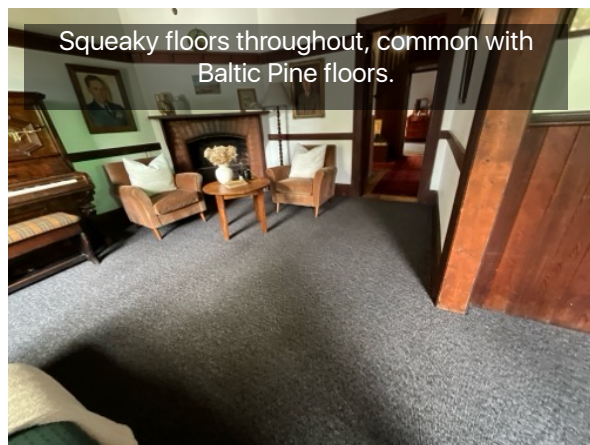
**Location:** The site  
**Finding:** Flooring - Squeaking

It was noted at the time of inspection that some of the internal floors as well the stairs are squeaky when walked across. This is quite common in older homes where there has been minor building movement as well settlement and shrinking of the timber frame and subfloor structure. Works to reduce the noise can be completed by a registered builder, at client discretion.

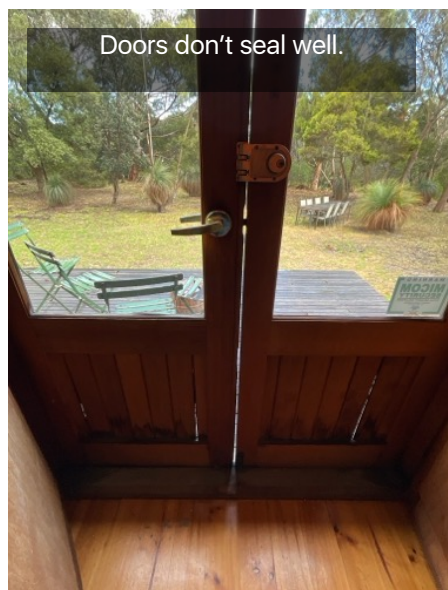
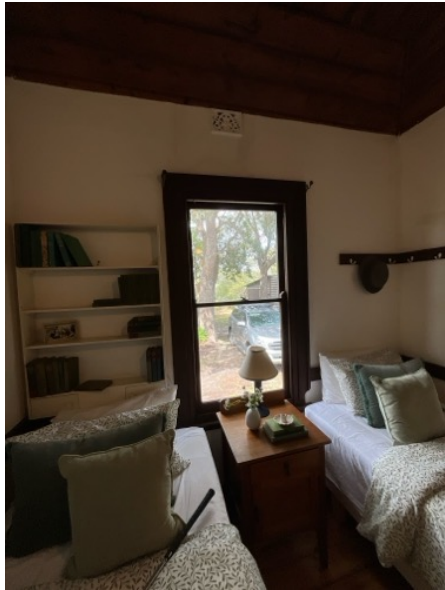
**Finding:** Door and windows – difficult to operate

A number of Doors and Windows to the dwelling were difficult to operate during standard operation. This defect inhibits the functionality of the affected building element as well as creating potential for secondary defects to associated building elements. A door that binds may have several causes, ranging from poor installation of the door or deteriorated hinges. Where door binding/jamming appears to indicate major structural issues, a registered structural engineer should be appointed to provide scope of rectification works at client discretion.

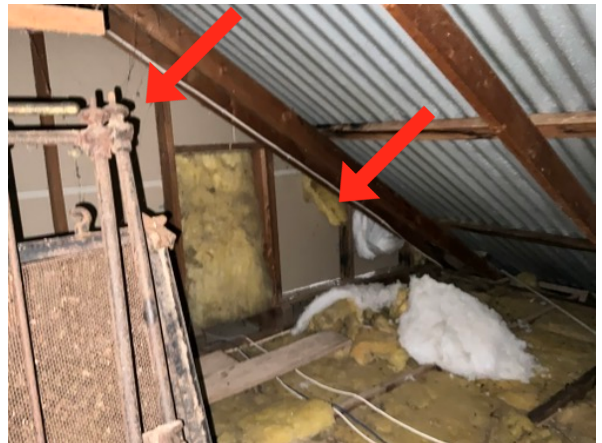
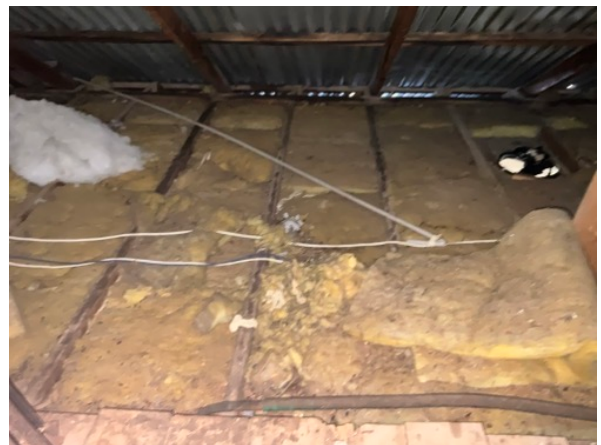
**Finding:** Insulation - Inadequate

Upon inspection of the roof void it was noted that there is a lack of adequate insulation. Insufficient insulation will result in a comparatively higher energy efficiency costs. The level of insulation in the property does not meet current Australian Standards. Installation of adequate insulation is required and should be conducted a professional contractor. Caution should be exercised when accessing the roof void, do not attempt to stand on the framework to the underside of the trusses and be aware there is a potential for electric shock if contact is made with exposed or faulty electrical wiring.

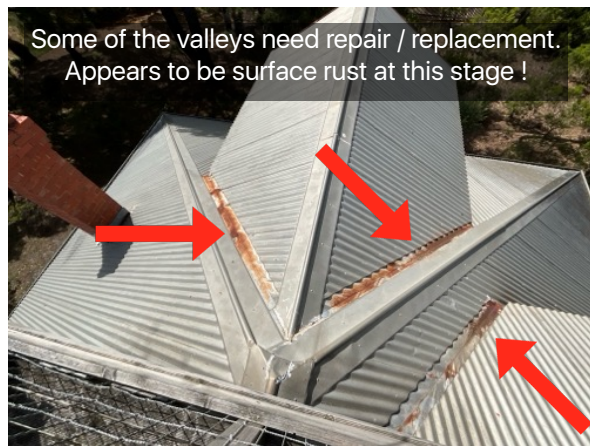
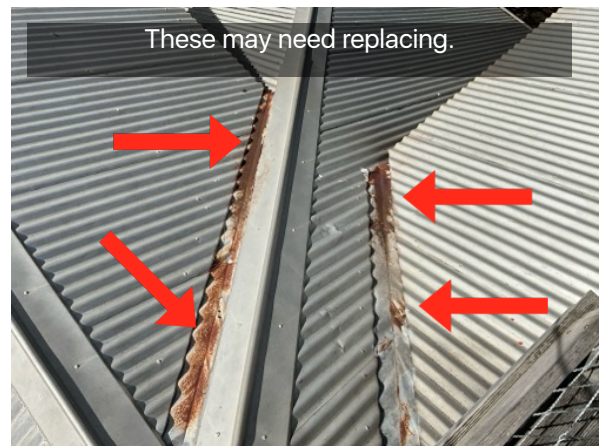
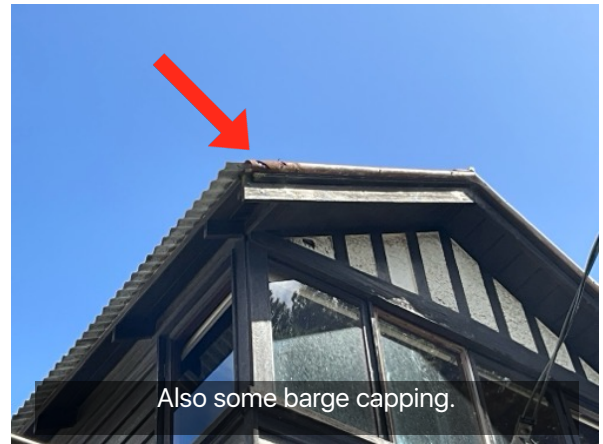
Roof plumbing - Rusted or corroded

The roof plumbing has areas of rust and corrosion. It is suspected that this has been caused by blockages, resulting in pooling or standing water, that have prematurely rusted elements of the roof plumbing. Rusty roof plumbing will generally develop holes and leaks that can affect other building elements with poor drainage of storm water. A licensed plumber or specialist roof restoration company should be appointed to undertake these works. It is advised that such works be completed as soon as possible to prevent any further damage and deterioration.

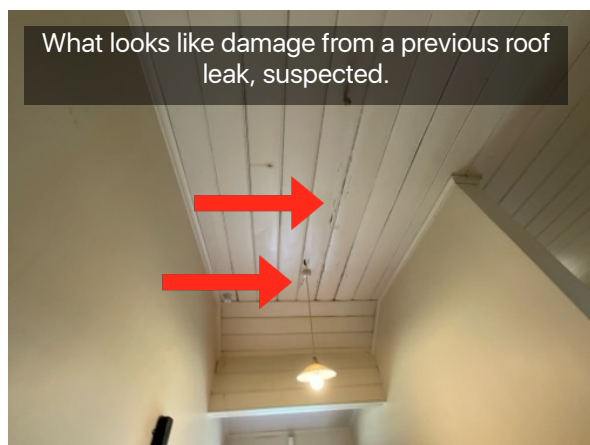
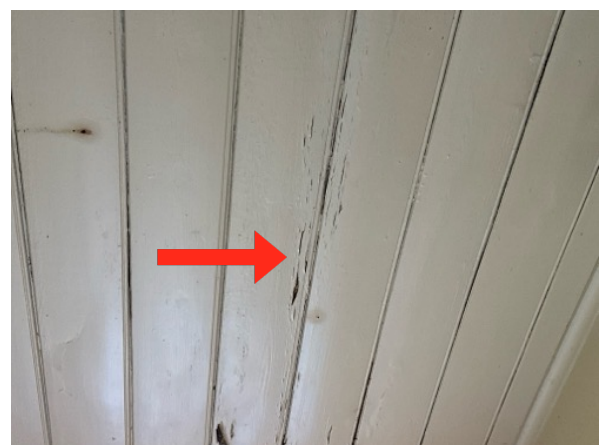
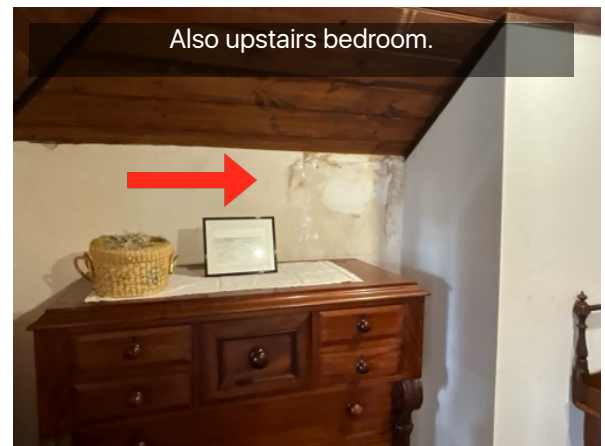
**Location:** The site  
**Finding:** Water leak - Inactive

While the damage in this area appears to be from an old inactive water leak, the area should be monitored frequently for the recurrence of any dampness. Replacement of previously affected building elements is at client discretion.  
 Alternatively where the property has been left vacant for a prolonged period of time we recommend a further more invasive inspection. Eg, leak testing by a Licensed Plumber and/or removal of obstructions or wall linings around the damaged area may reveal further damage which has been concealed.  
 A more significant or major defect may be identified at this time.

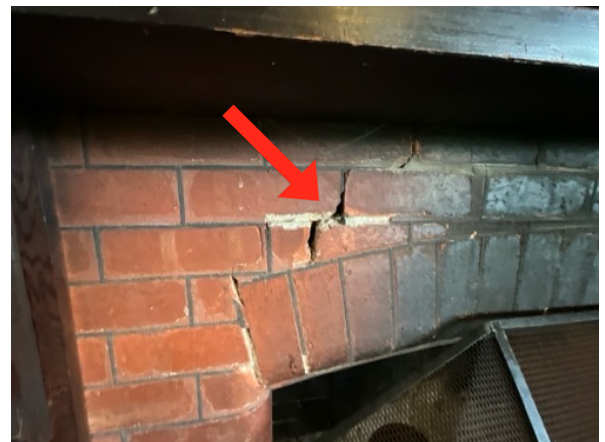
**Location:** Some Areas  
**Finding:** Damage to Masonry Walls ( Cracks )- Category 2

It has been observed that damage to masonry walls caused by movement of slabs footings or other causes has occurred. The degree of damage falls within category 2, described as noticeable cracks which are easily filled. Such cracking make holes doors and all windows to stick slightly and I generally up to 5 mm in width.

Damage of this category is required to be monitored for a period of 12 months, after which time a crack rated a category 3 or above is a defect requiring rectification such as minor repairs and repointing. Always contact your building inspector should cracks widen, lengthen or grow more numerous.

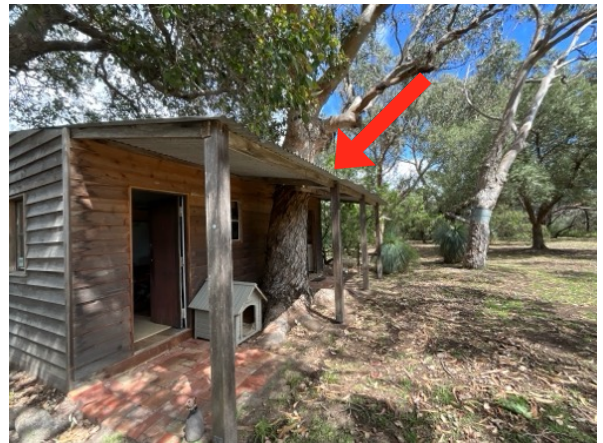
**Finding:** Stormwater drain - Not connected

The roof plumbing is not adequately connected to stormwater drainage in this area. This disconnection negatively impacts the functional capacity of the roof plumbing. Where roof plumbing doesn't drain adequately, the area at the base perimeter can become excessively damp. It is highly recommended that a plumber be appointed to further inspect the area and to install adequate drainage equipment where necessary.

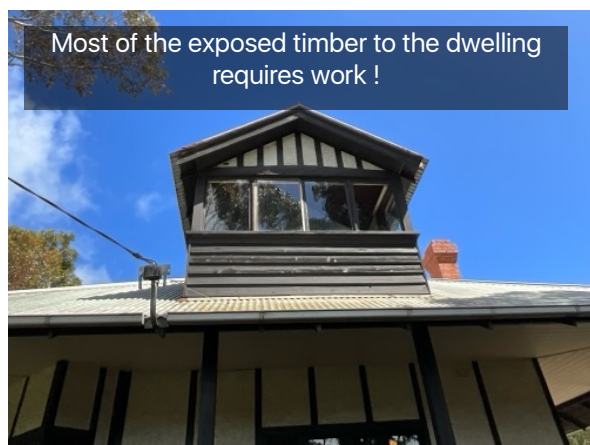
**Finding:** Timber - exposed to weather

External timbers that are frequently exposed to harsh weather conditions require adequate protection in order to maintain their condition. Where timbers have not been painted or treated adequately, general deterioration is likely to occur at an accelerated rate. If left unattended, replacement of these timbers is likely to be necessary in the short-term future. Adequate treatment of these timbers is required as soon as possible by a painting contractor or general handyman.

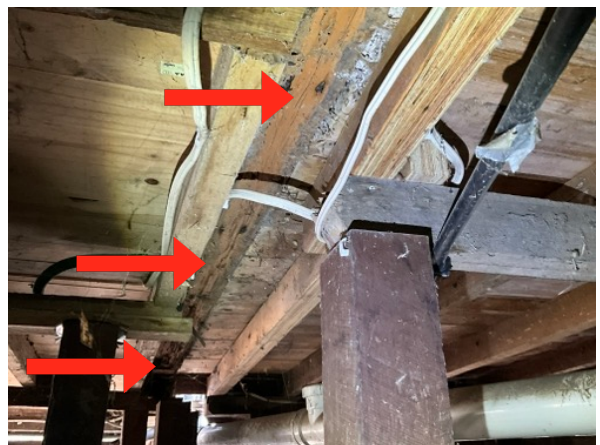
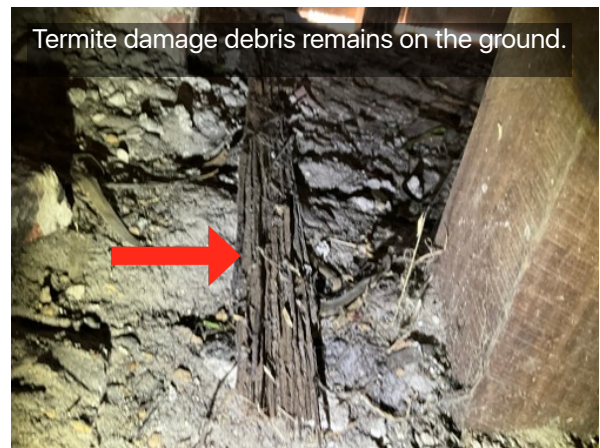
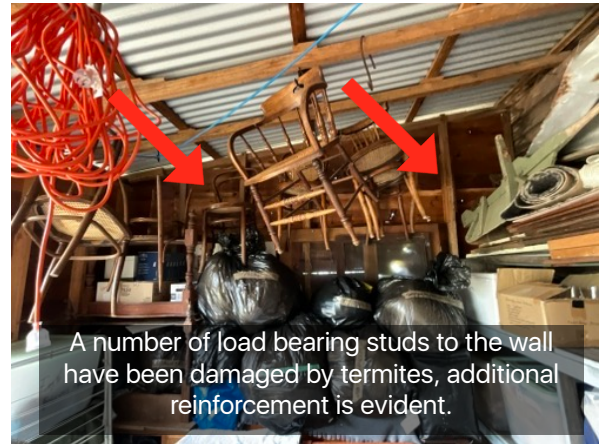
**Location:** Subfloor  
**Finding:** Termite Damage/workings ( Structural )

Due to the nature of Termites it is highly likely that further damage may be present to areas that are not readily accessible. It is advised that the area be visually inspected frequently to ensure that the condition of the affected building materials does not worsen and that there is no further termite activity.

The homeowner should comply with instructions and recommendations as per the warranty provided by the pest control company and continue to monitor area's which have conditions conducive to termite activity.

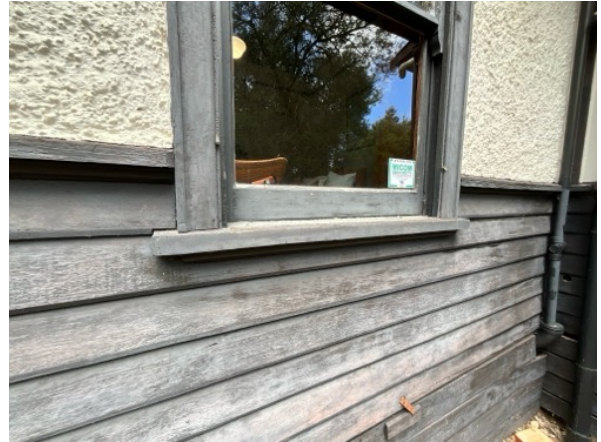
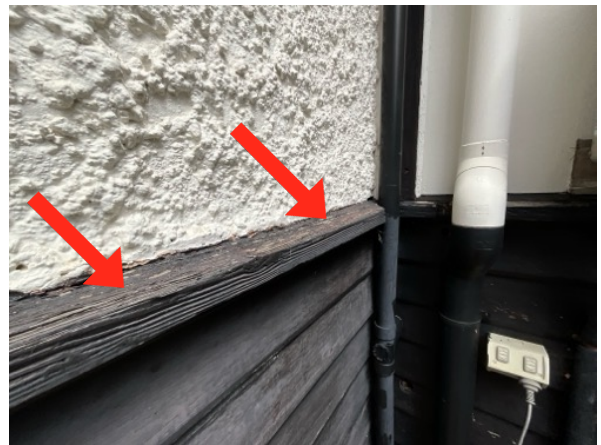
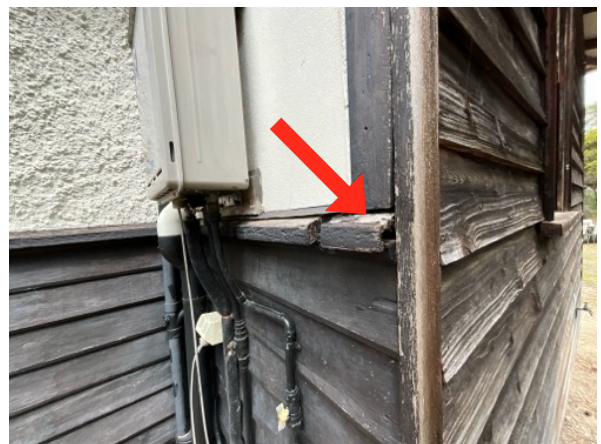
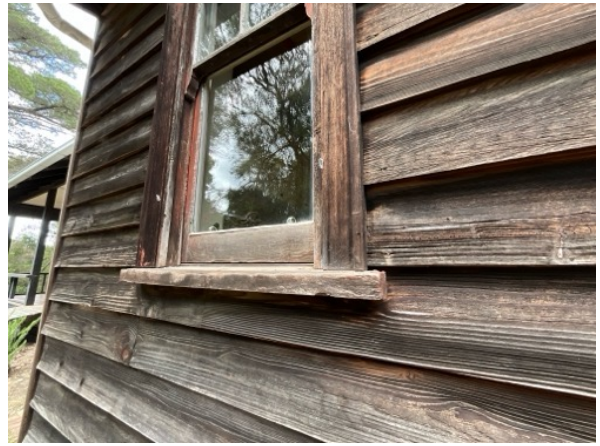
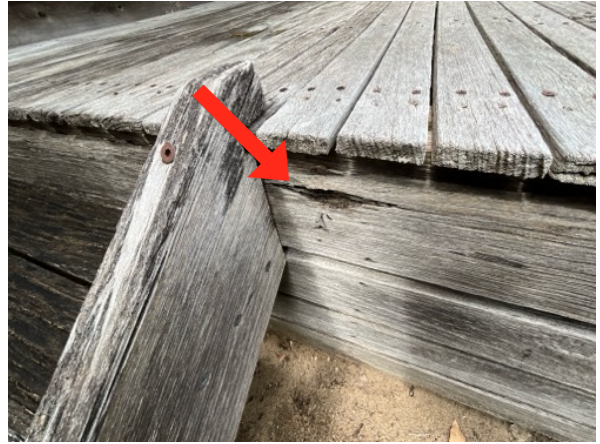
**Finding:** Wood rot

Wood rot which also known as Fungal Decay, occurs when timbers and other cellulose type building materials are exposed to damp conditions on a continual basis. Replacement of affected timbers may then be a necessary step in protecting surrounding building elements from such deterioration. Where wood rot is present to any structural timber, the replacement of the affected timber is required immediately. A qualified carpenter or registered builder may also be required to replace affected building materials. Consultation with a structural engineer is highly advised as soon as possible.

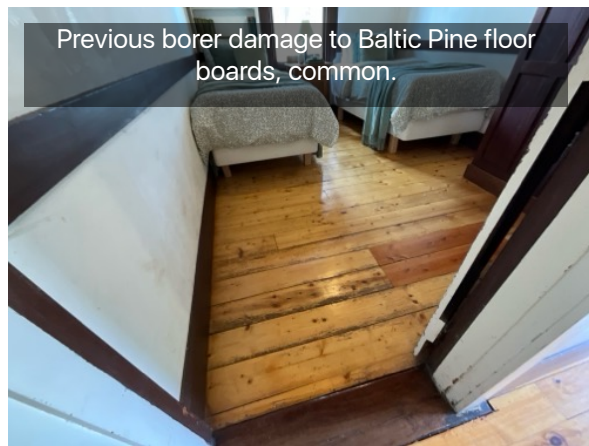
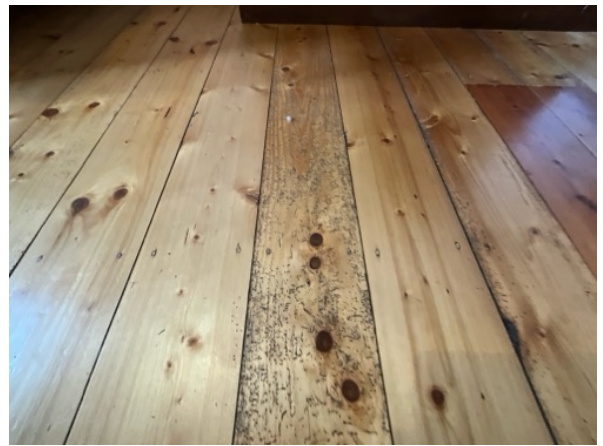
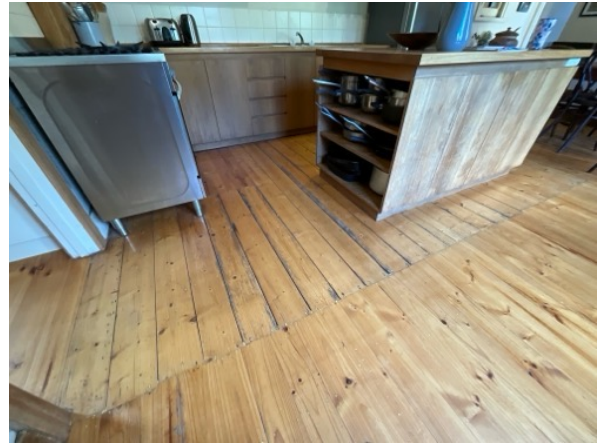
The other commonly known borer, the Anobium borer is more likely to attack floor boards and may cause severe structural damage to flooring areas.

As no live wood Borer activity was identified treatment is not required at this time. Replacement of affected timbers maybe considered by the client for superficial reasons.

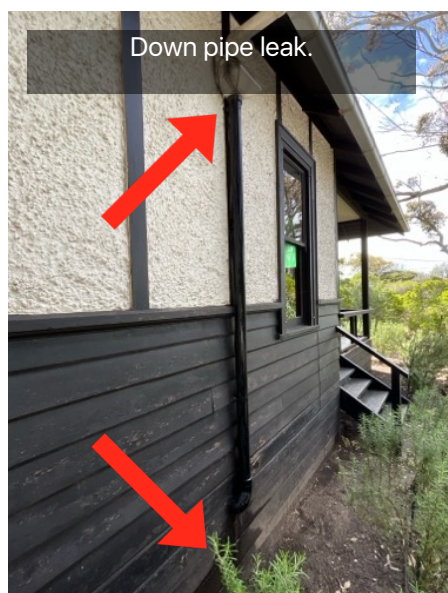
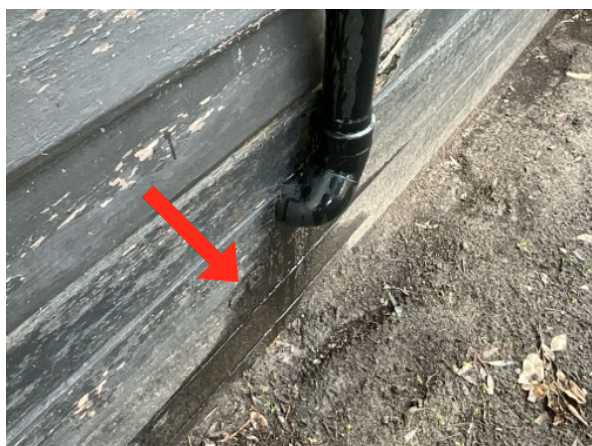
If left unmanaged damp or wet conditions may have many consequences including the development of fungal decay and/or wood rot as well as providing an environment that may be conducive to termite and timber pest attack.

A qualified plumber should be appointed to identify the cause of the excessive moisture in order to prevent further damage. The water leak should be resolved prior to any repairs of the damaged area which may require localised replacement of building materials and re-finishing.

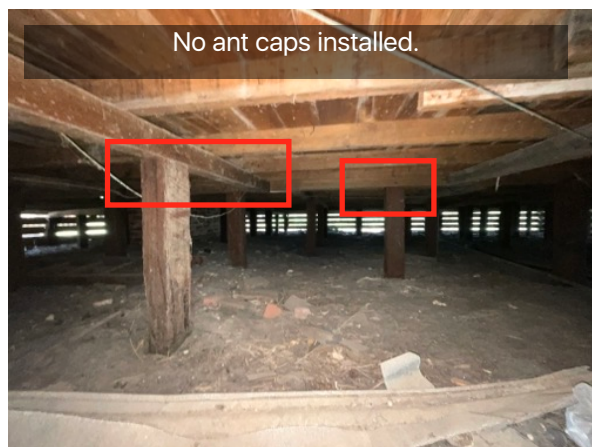
Installed during the construction process, Ant caps are designed to easily identify termite or pest ingress from stumps to the adjoining bearers.

Where Ant caps have not been installed, frequent monitoring of these areas should be carried out in order to identify signs of termite or timber pest workings.

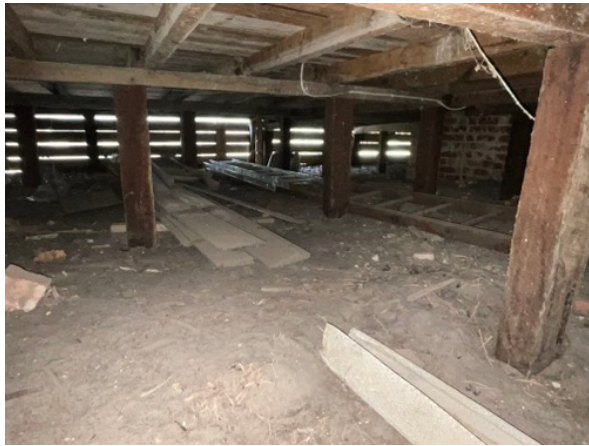
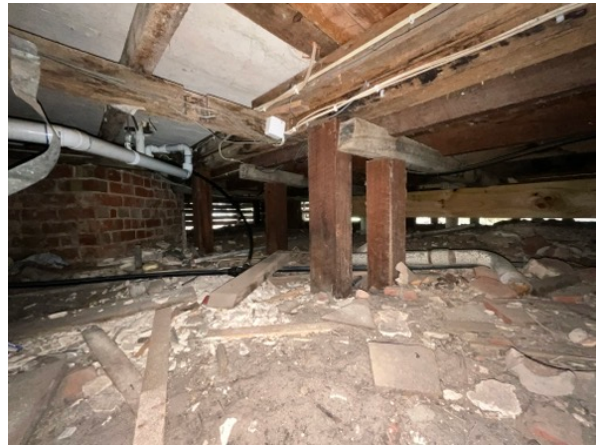
A clear and empty subfloor will be better ventilated and easier to maintain in a dry condition. The removal of any timber debris is vital in minimising the risk of termite or Wood Borer activity.

Debris in the subfloor should be removed as soon as possible. Depending on the location and amount of debris and stored items the homeowner may elect to undertake this task. Alternatively there are a large number of rubbish removal subcontractors that could undertake these works.
