# Property and Timber Pest Report

Inspection Date: 20 Nov 2025

Property Address: 57-73 Glaneuse Road Point Lonsdale 3225

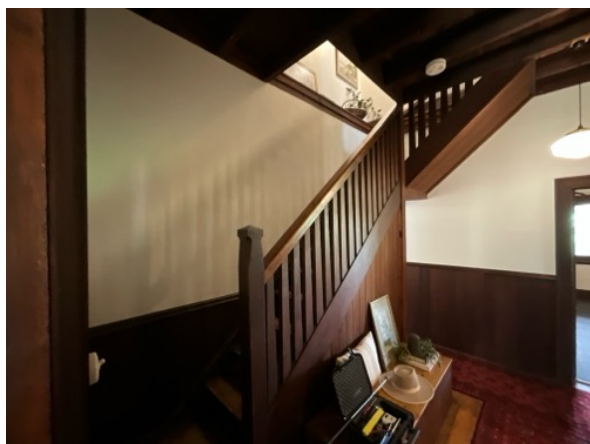
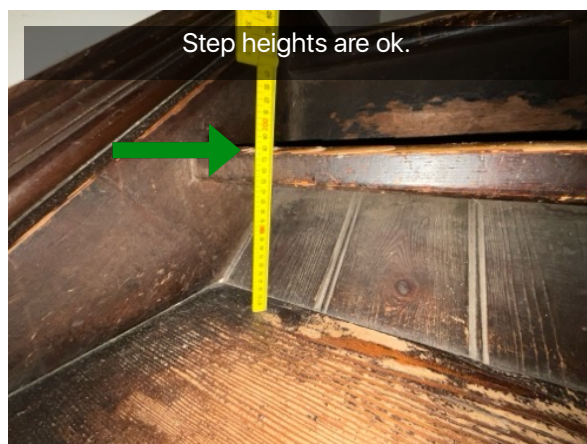
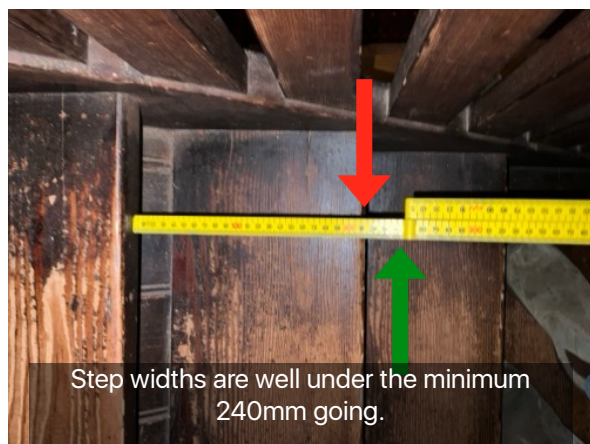
It was noted at the time of inspection that the stairs that have been installed to the dwelling have been poorly constructed, creating a potential trip hazard for users of the staircase. According to normal building practices all stairs should be measured and levelled to exact heights so to prevent tripping as well have a minimum tread/step width of 240mm and a maximum rise/height of 190mm.

Although retrospective works may not be relevant or cost efficient, replacement of the stairs advised. Consultation with a qualified carpenter as to the cost of potential solutions is recommended as soon as possible.

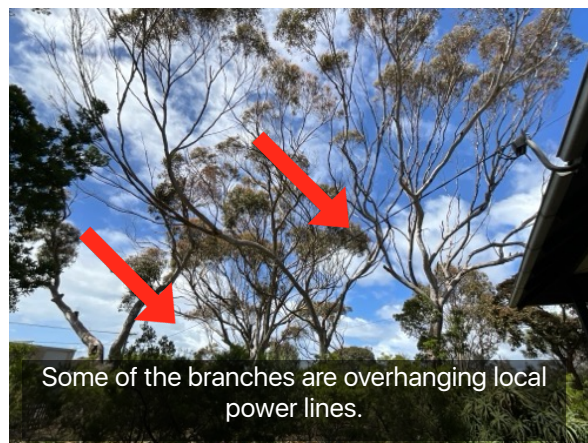
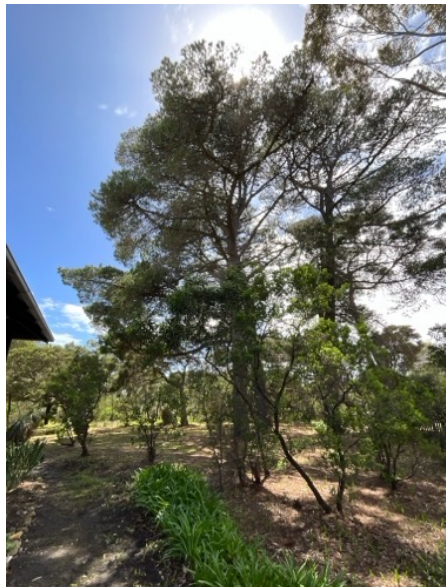
## Serious Safety Hazard 1.02

**Finding:** Trees - Falling vegetation

It was observed at the time of inspection that there is evidence where deteriorated tree branches / vegetation exist throughout the property. The vegetation will require trimming / removal. A specialist arborist should be engaged as soon as possible to rectify this issue.

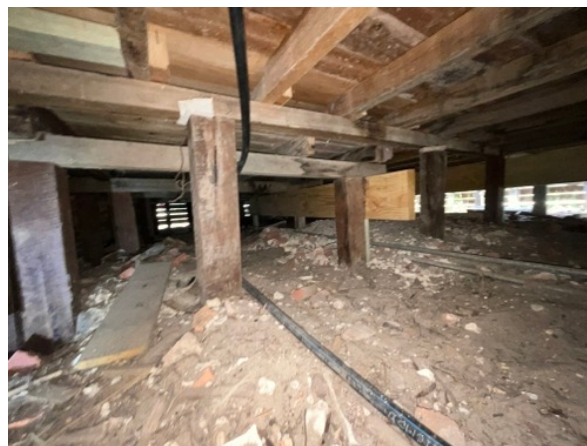
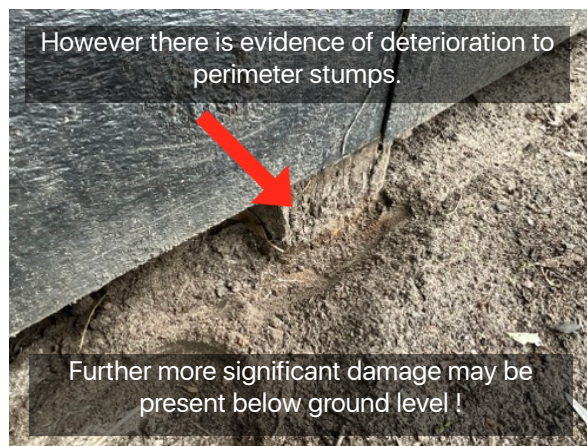
### Major Defect 2.01

**Location:** Subfloor  
**Finding:** Timber stumps - Suspected deterioration

It was noted that the property has timber stumps. Inspection of the condition of the timber stumps - below the surface of the ground - is excluded from the scope of this report. Where timber stumps are failing replacement of stumps may be required in the short- to medium-term future. Timber stumps are no longer used in current building practices due to their susceptibility to wood rot and deterioration over time. The client should be prepared that in purchasing a property with timber stumps, that the need to either partially or fully restump the property in the short- to medium-term future is likely.

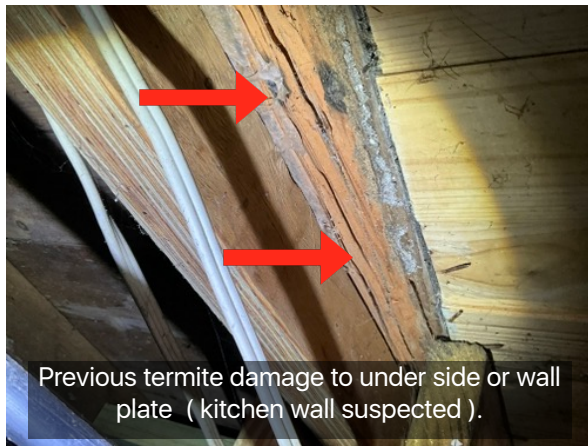
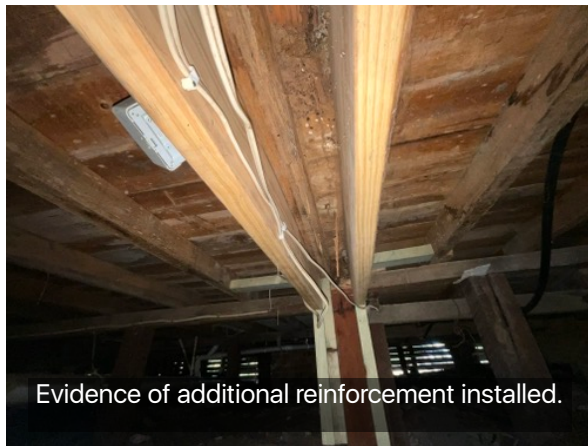
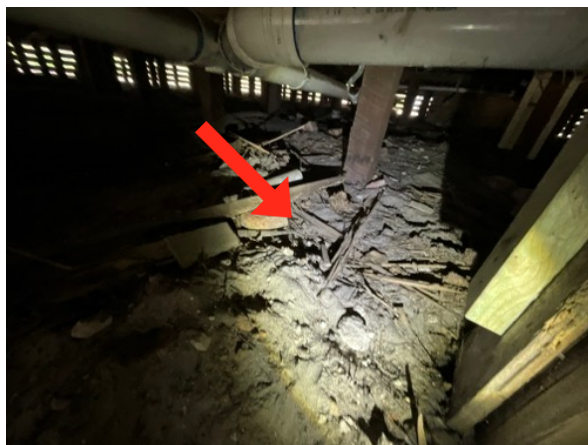
## Major Defect 2.02

**Location:** Subfloor  
**Finding:** Termite Damage/workings ( Structural )

Despite no live termite or timber pest activity been identified, previous termite damage was found in this area. This damage is considered to be inactive but structural in nature. It was however noted that damaged sections of the structure have been either replaced or reinforced with new timbers.

Due to the nature of Termites it is highly likely that further damage may be present to areas that are not readily accessible. It is advised that the area be visually inspected frequently to ensure that the condition of the affected building materials does not worsen and that there is no further termite activity.

It is highly recommended that advise from the home owner be given with regard to the reparative works that have been completed and any permits or certificates that may have been issued by the builder to complete such works.

The homeowner should comply with instructions and recommendations as per the warranty provided by the pest control company and continue to monitor area's which have conditions conducive to termite activity.

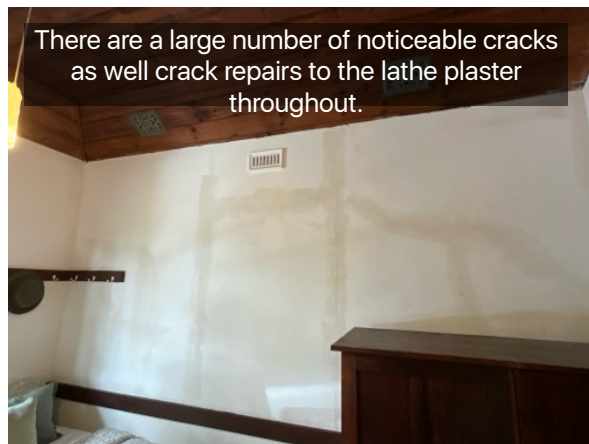
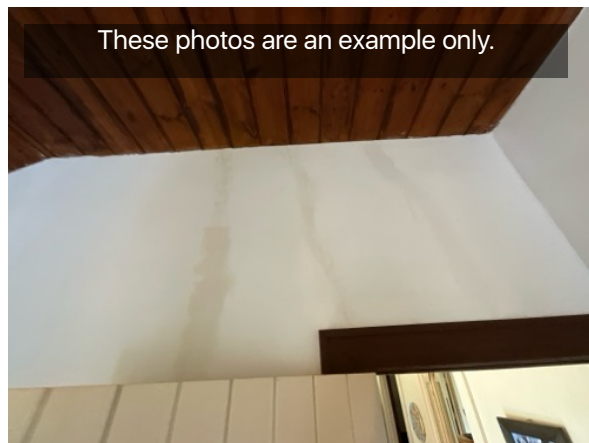
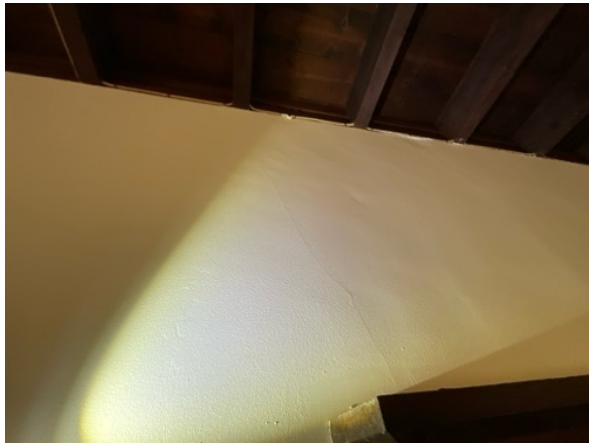
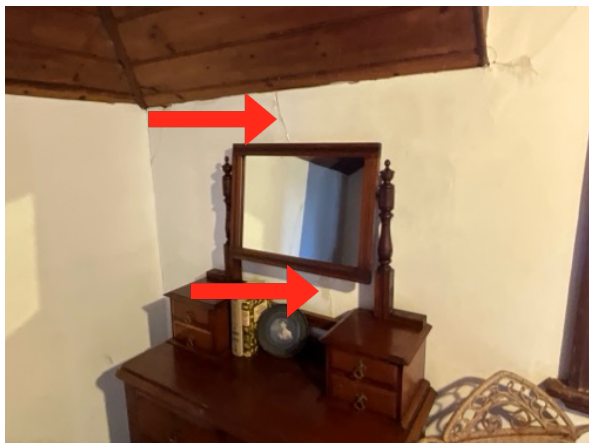
## Minor Defect 3.01

**Finding:** Cracking - Damage Category 2 - Noticeable ( up to 5mm )

Noticeable cracks are a common occurrence as a result of many primary defects . Such courses may include age, general wear and tear, expected building movement, general expansion contraction of building materials in different weather conditions, and/or minor failings in the installation or application of building materials.

Noticeable cracks may result in minor sticking or jamming of associated doors and windows which require easement. However noticeable cracks are easily filled and repaired. Plasterer can be consulted to install an expansion joint at this point to allow for this movement during different weather conditions

Monitoring of all cracking should be conducted frequently. Always can contact the building inspector should cracks widen lengthen or become more near but numerous. Additionally your building inspector should be contacted if associated building elements such as doors and windows become more difficult to operate overtime.

Other trades people such as carpenters, painters and plasterers should be appointed to perform remedial works as necessary !

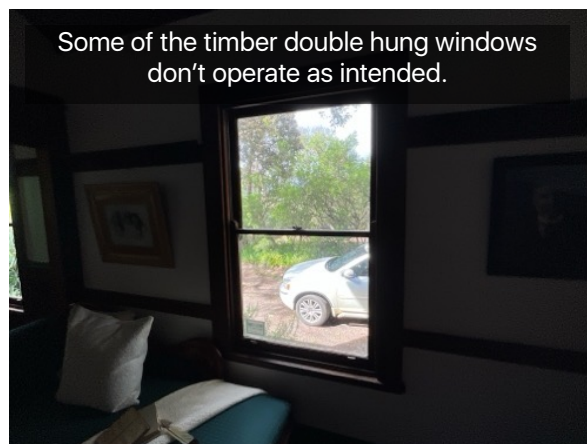
## Minor Defect 3.03

**Finding:** Door and windows – difficult to operate

A number of Doors and Windows to the dwelling were difficult to operate during standard operation. This defect inhibits the functionality of the affected building element as well as creating potential for secondary defects to associated building elements. A door that binds may have several causes, ranging from poor installation of the door or deteriorated hinges. Where door binding/jamming appears to indicate major structural issues, a registered structural engineer should be appointed to provide scope of rectification works at client discretion.

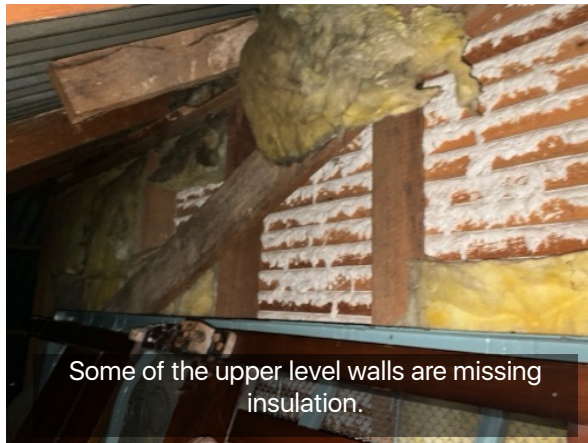
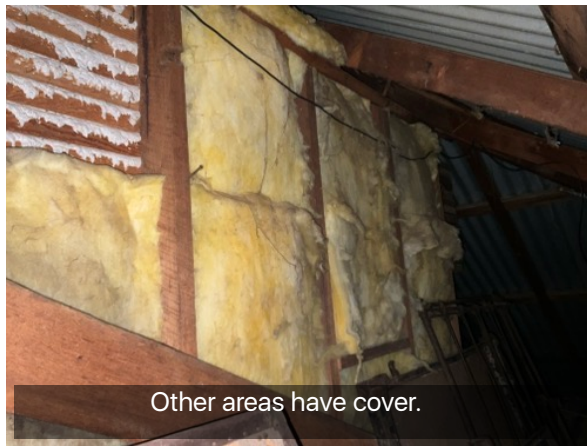
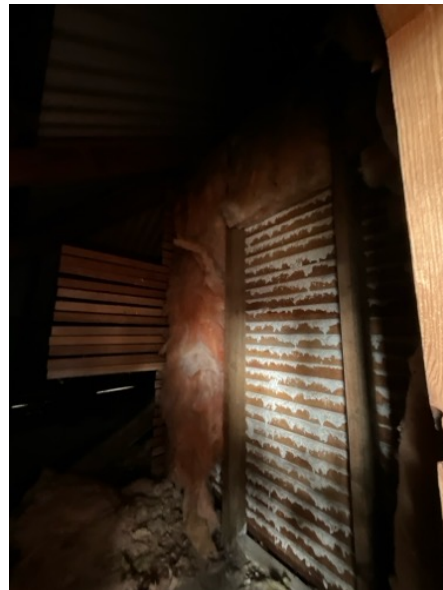
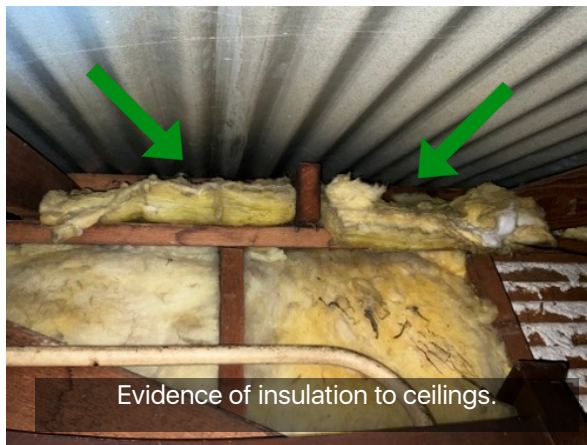
## Minor Defect 3.04

**Finding:** Insulation - Inadequate

Upon inspection of the roof void it was noted that there is a lack of adequate insulation. Insufficient insulation will result in a comparatively higher energy efficiency costs. The level of insulation in the property does not meet current Australian Standards. Installation of adequate insulation is required and should be conducted a professional contractor. Caution should be exercised when accessing the roof void, do not attempt to stand on the framework to the underside of the trusses and be aware there is a potential for electric shock if contact is made with exposed or faulty electrical wiring.

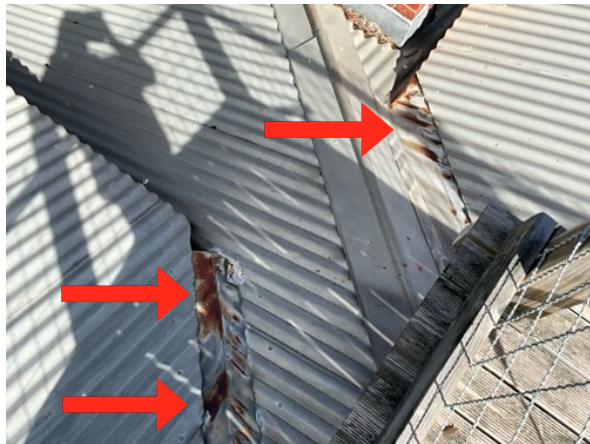
## Minor Defect 3.05

Roof plumbing - Rusted or corroded

The roof plumbing has areas of rust and corrosion. It is suspected that this has been caused by blockages, resulting in pooling or standing water, that have prematurely rusted elements of the roof plumbing. Rusty roof plumbing will generally develop holes and leaks that can affect other building elements with poor drainage of storm water. A licensed plumber or specialist roof restoration company should be appointed to undertake these works. It is advised that such works be completed as soon as possible to prevent any further damage and deterioration.

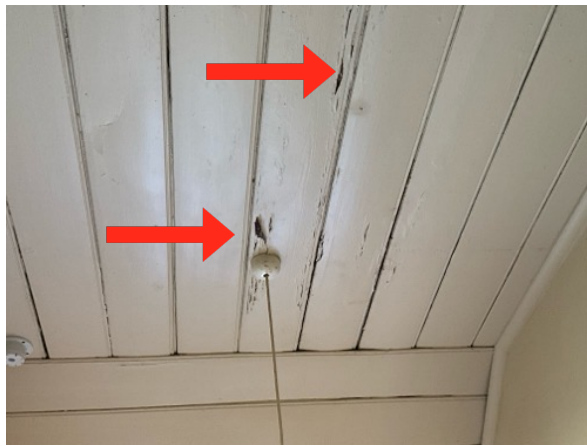
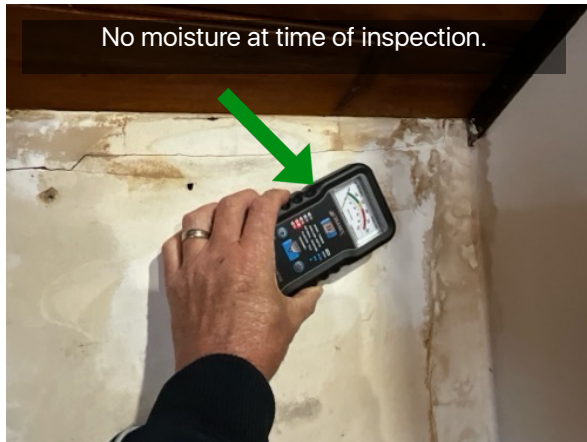
## Minor Defect 3.06

**Location:** The site  
**Finding:** Water leak - Inactive

While the damage in this area appears to be from an old inactive water leak, the area should be monitored frequently for the recurrence of any dampness. Replacement of previously affected building elements is at client discretion.  
 Alternatively where the property has been left vacant for a prolonged period of time we recommend a further more invasive inspection. Eg, leak testing by a Licensed Plumber and/or removal of obstructions or wall linings around the damaged area may reveal further damage which has been concealed.  
 A more significant or major defect may be identified at this time.

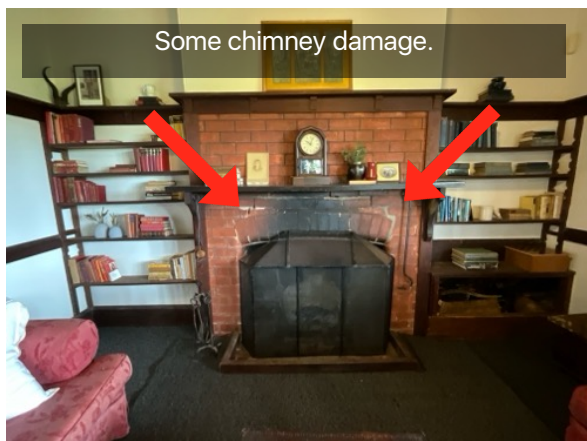
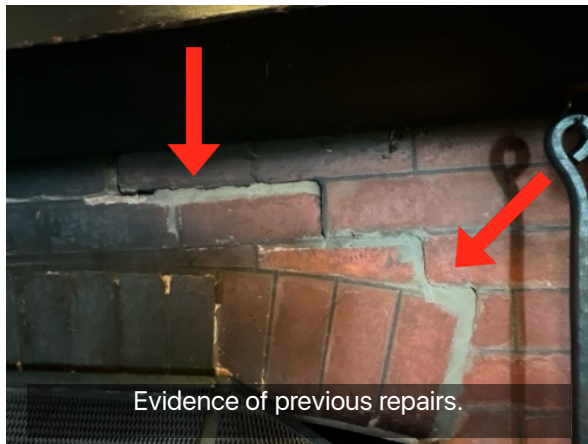
## Minor Defect 3.07

**Location:** Some Areas  
**Finding:** Damage to Masonry Walls ( Cracks )- Category 2

It has been observed that damage to masonry walls caused by movement of slabs footings or other causes has occurred. The degree of damage falls within category 2, described as noticeable cracks which are easily filled. Such cracking make holes doors and all windows to stick slightly and I generally up to 5 mm in width.

Damage of this category is required to be monitored for a period of 12 months, after which time a crack rated a category 3 or above is a defect requiring rectification such as minor repairs and repointing. Always contact your building inspector should cracks widen, lengthen or grow more numerous.

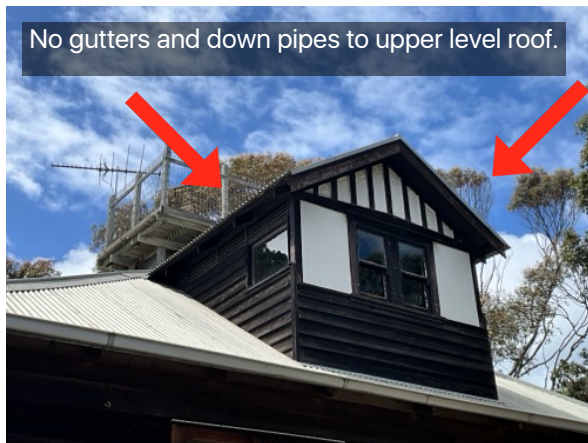
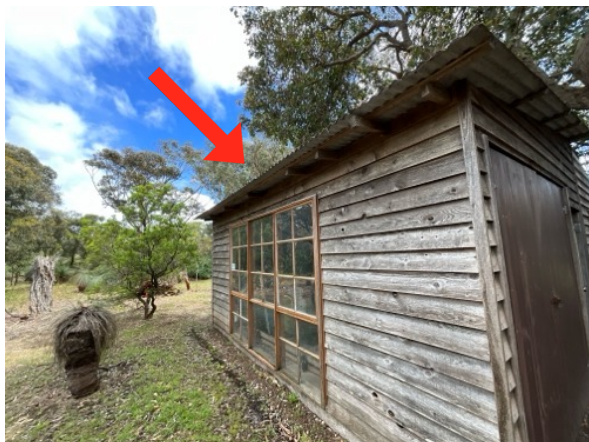
## Minor Defect 3.08

**Finding:** Stormwater drain - Not connected

The roof plumbing is not adequately connected to stormwater drainage in this area. This disconnection negatively impacts the functional capacity of the roof plumbing. Where roof plumbing doesn't drain adequately, the area at the base perimeter can become excessively damp. It is highly recommended that a plumber be appointed to further inspect the area and to install adequate drainage equipment where necessary.

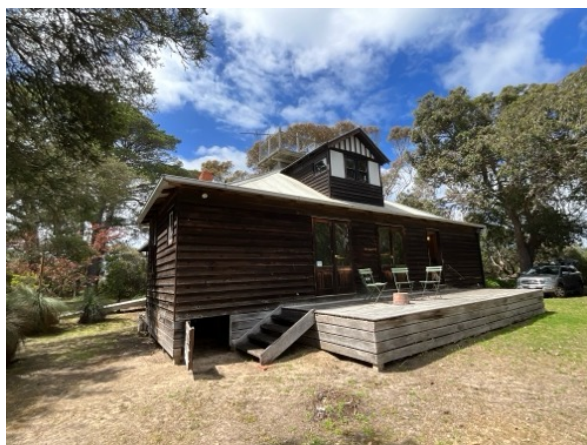
## Minor Defect 3.09

**Finding:** Timber - exposed to weather

External timbers that are frequently exposed to harsh weather conditions require adequate protection in order to maintain their condition. Where timbers have not been painted or treated adequately, general deterioration is likely to occur at an accelerated rate. If left unattended, replacement of these timbers is likely to be necessary in the short-term future. Adequate treatment of these timbers is required as soon as possible by a painting contractor or general handyman.

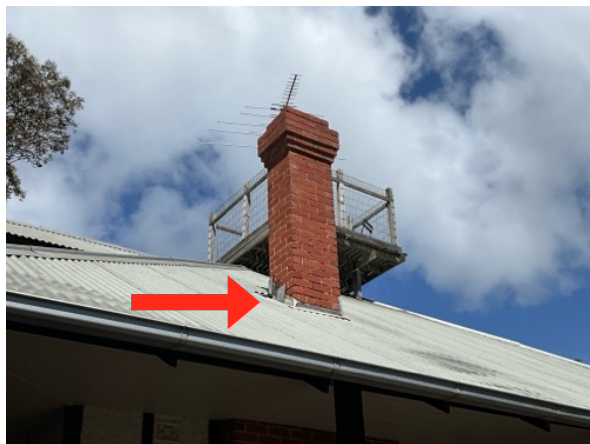
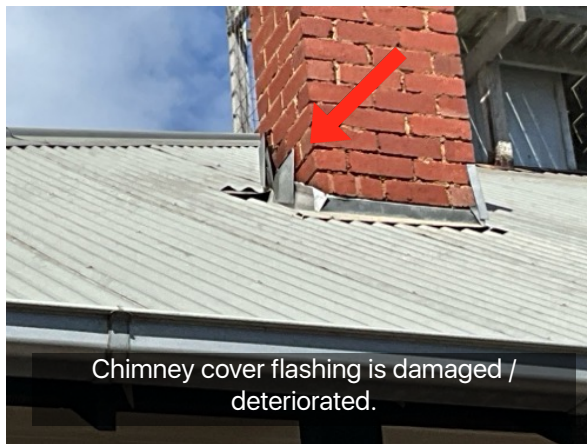
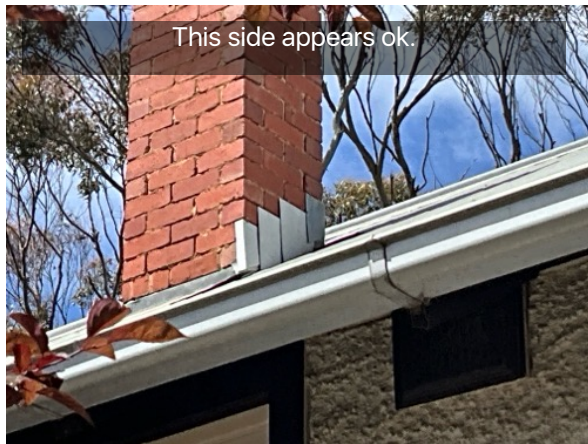
## Minor Defect 3.10

**Finding:** Roof plumbing - Flashing inadequate

Some sections of the roof are missing or have inadequate roof flashings. Flashings are metal and other materials which are applied to seals and intersections between roof coverings and building elements. They are designed to aid in the weatherproofing of roof joins. Flashings that are not installed adequately or missing are likely to result in water penetration to the interior of the property.

The roofing plumber should be appointed as soon as possible to install relevant roof plumbing materials, ensuring that no further damage is sustained.

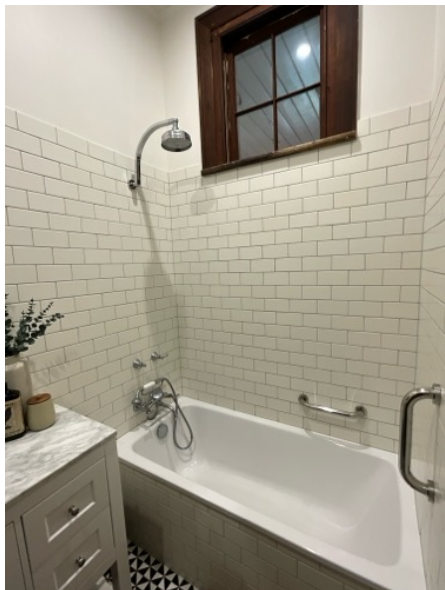
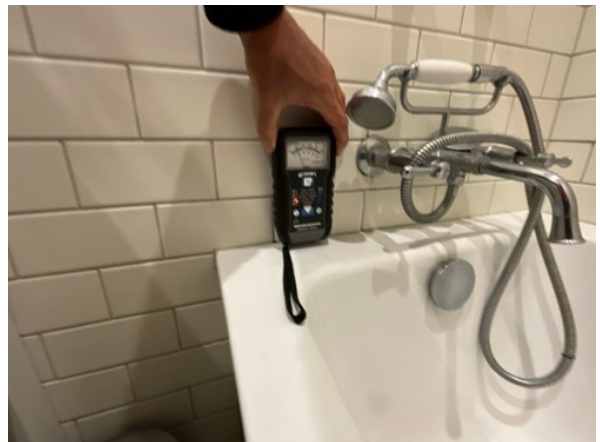
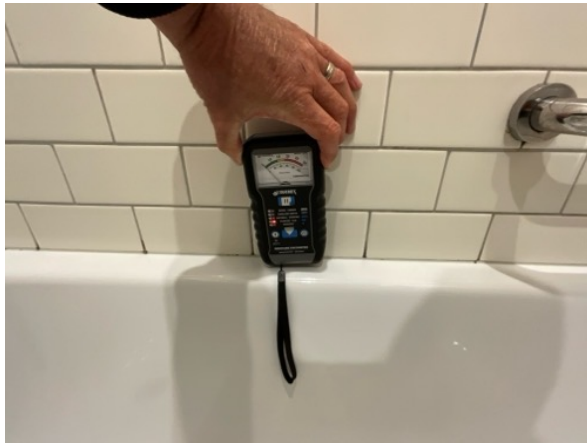
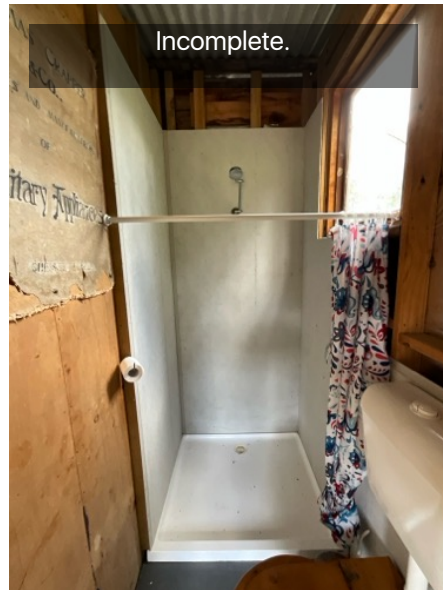
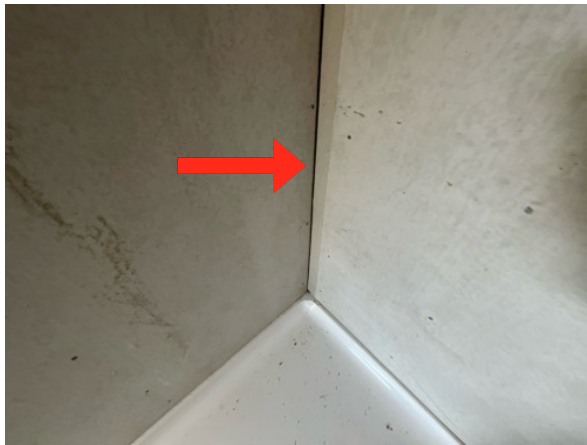
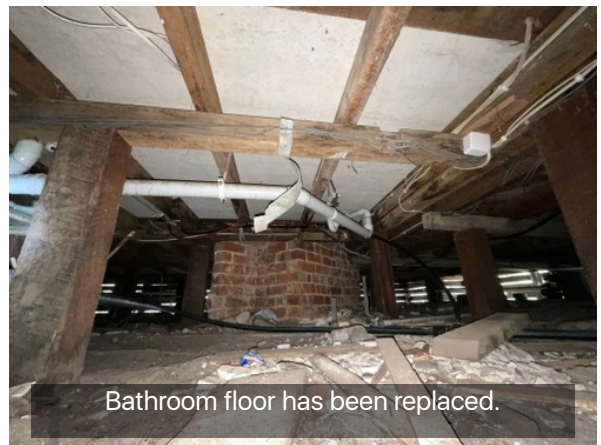
**Location:** Wet Areas  
**Finding:** Bathroom - Shower condition

At the time of inspection it was noted that the tiles grout and sealant to the shower recess are in good condition with no evidence of excessive moisture or water damage identified. Always ensure that tiles, grout and sealant are well maintained and kept in good condition at all times to prevent future moisture issues.

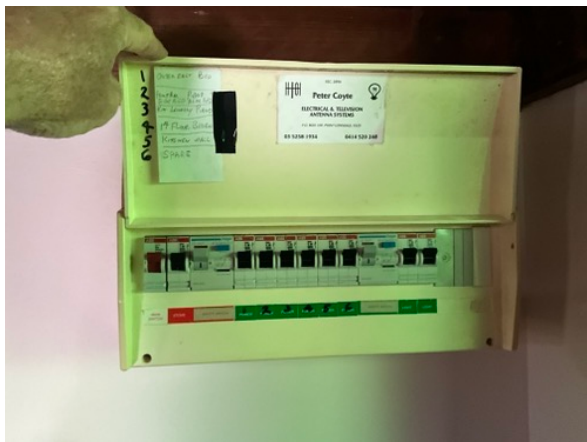
## For your information 4.02

**Finding:** Electrical switchboard - Safety switch or RCD installed

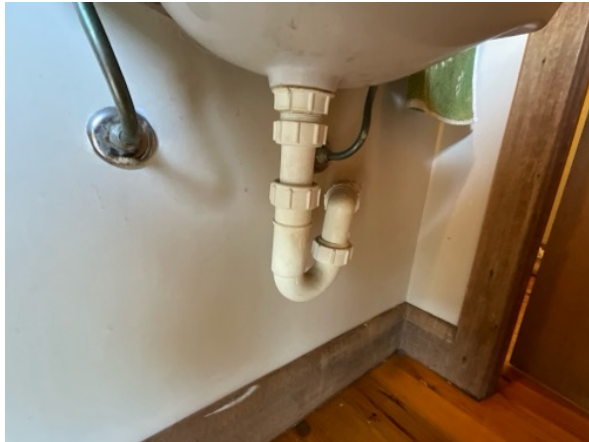
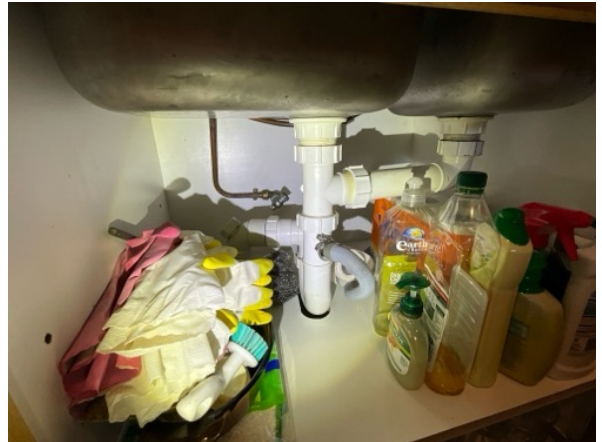
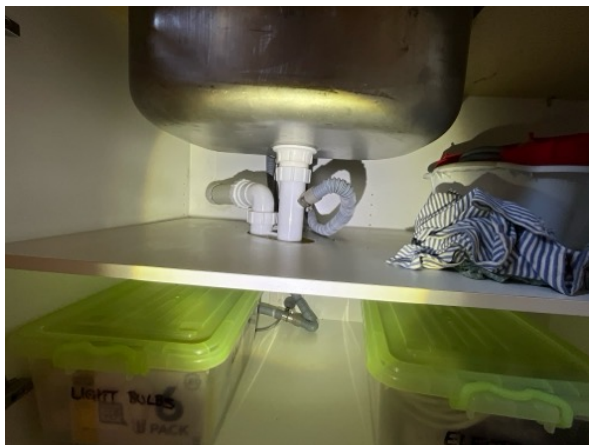
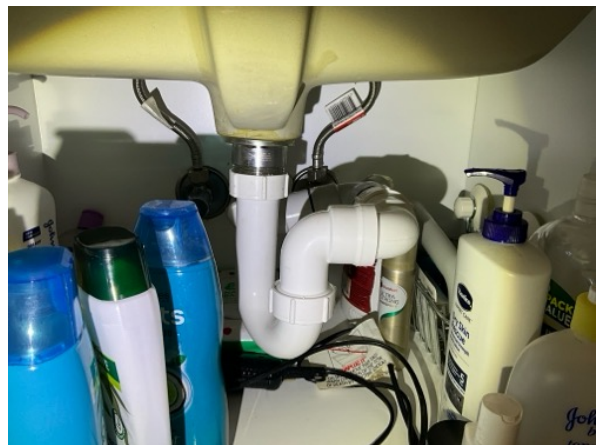
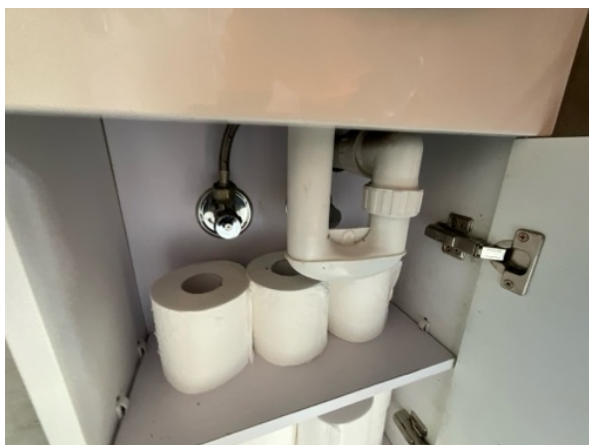
**Finding:** Inspection of plumbing wastes

It must be noted inspection of all plumbing waste to the dwelling showed no evidence of leaks or damp identified to all areas.

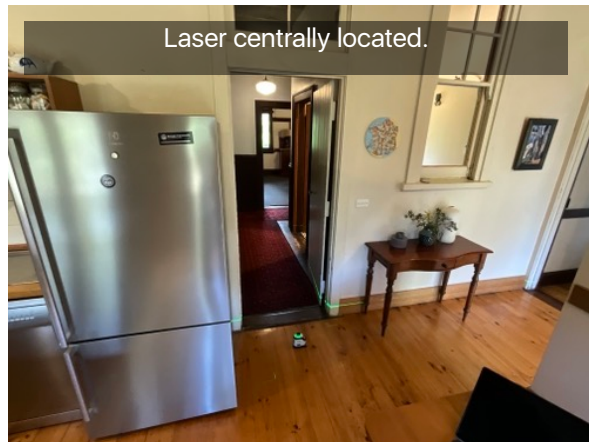
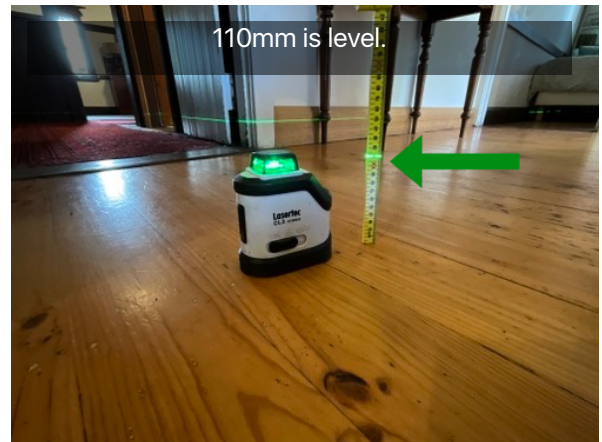
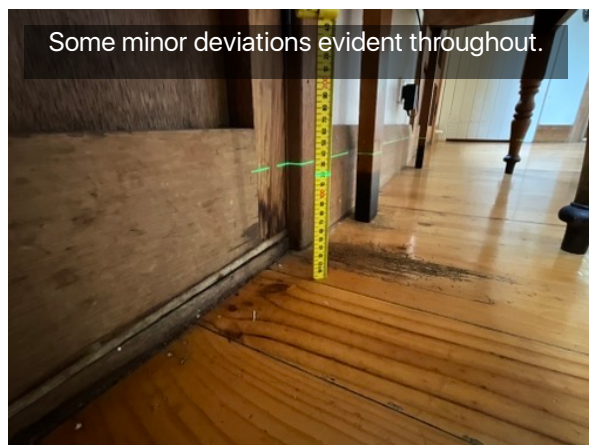
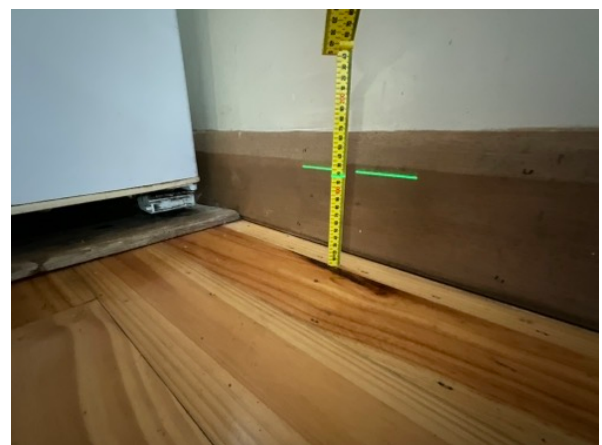
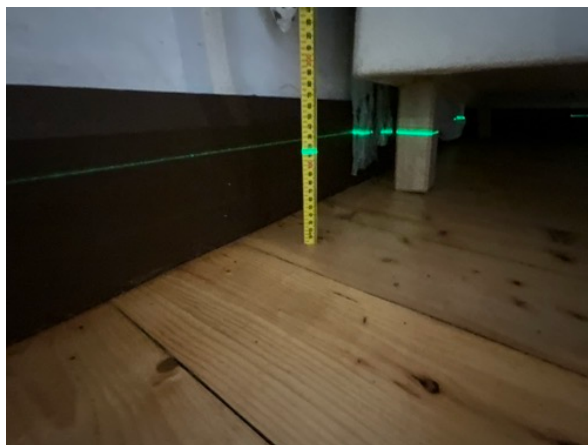
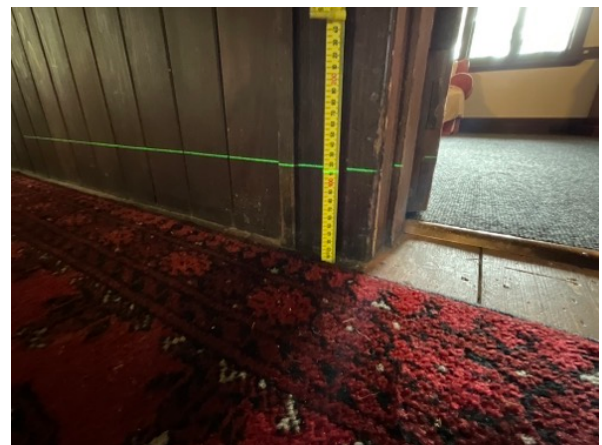
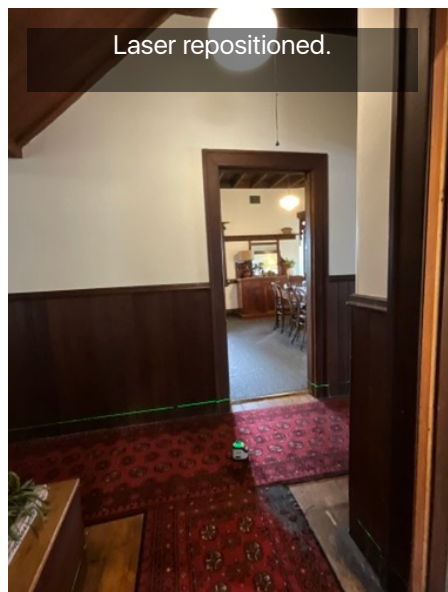
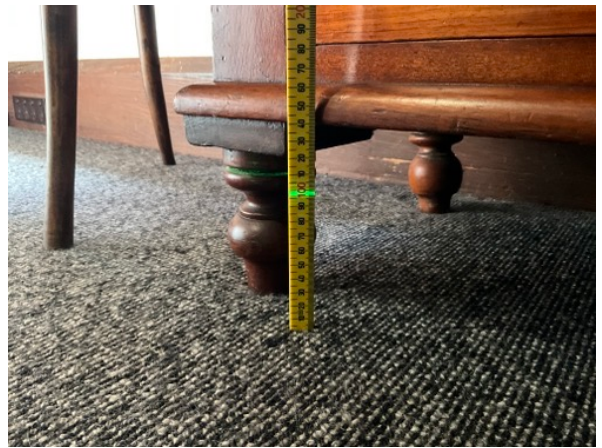
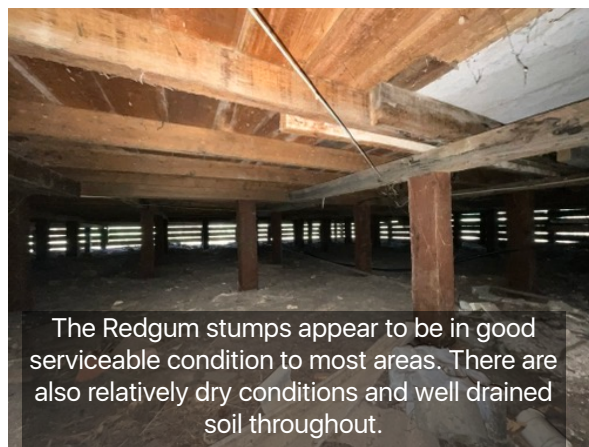
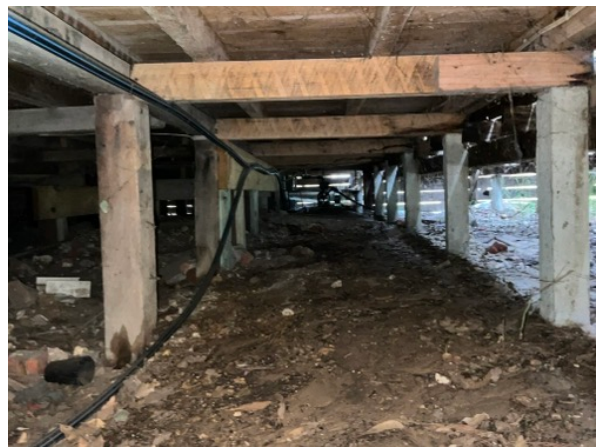
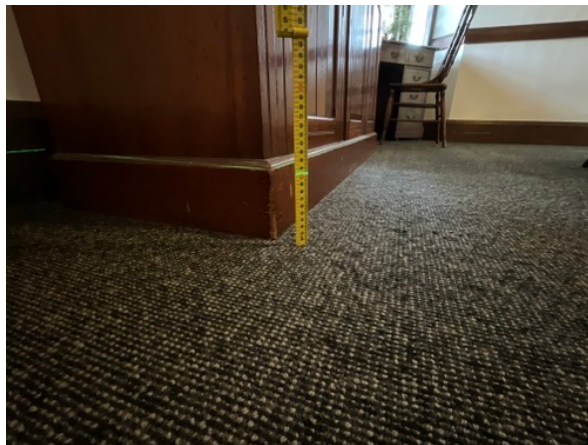
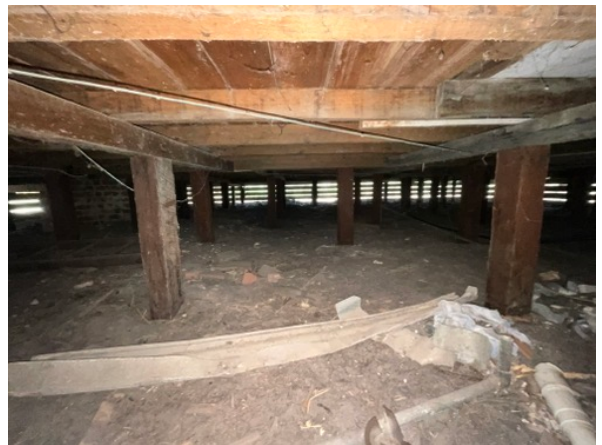
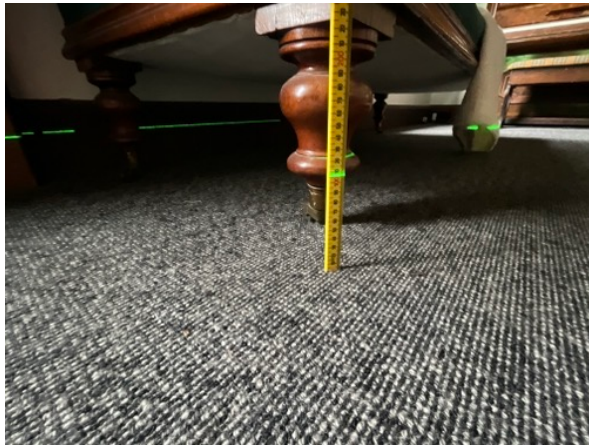
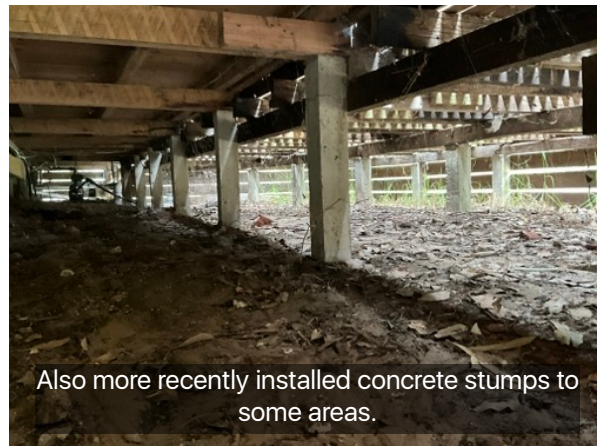
## For your information 4.04

**Location:** All Internal Areas

**Finding:** Floor Levels - Timber & Concrete Stumps.

At the time of inspection a series of levels were taken throughout the dwelling with all areas being either level or within an acceptable deviation.  
Please note a Lasertec instrument is used to assess floor levels ( at the time of inspection ) and is limited to line of sight. Eg, the laser doesn't bend around corners.  
It gives a broad assessment of the footing levels of the dwelling only !

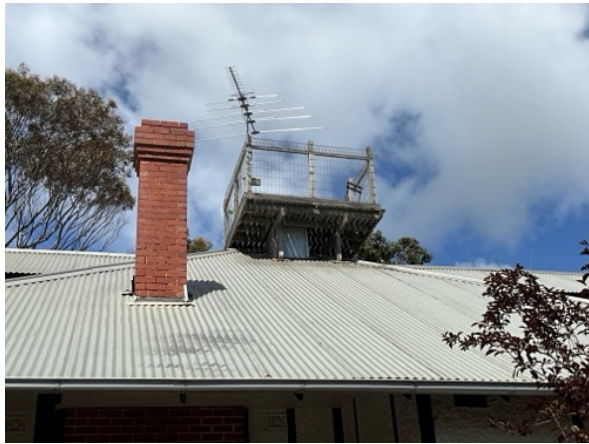
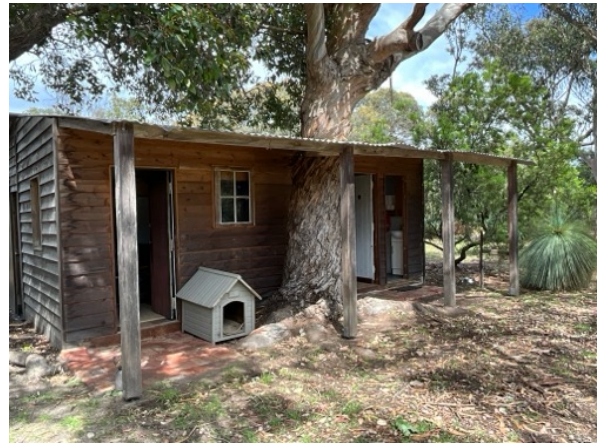
## For your information 4.07

**Location:** Outbuildings  
**Finding:** Elevated Structure Inspection

You should always arranged annual inspections of the structure by an engineer or a suitably qualified person to ensure any maintenance, that maybe necessary, is identified.

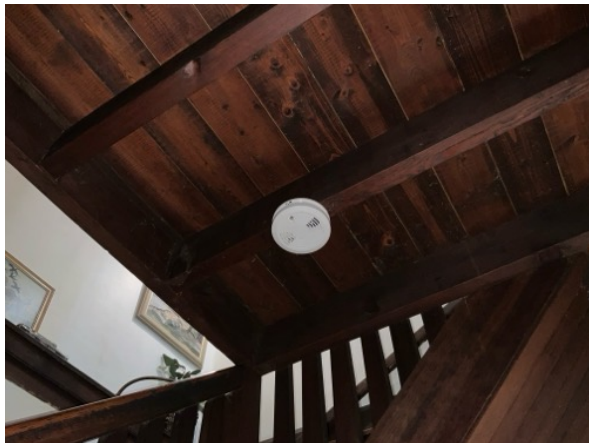
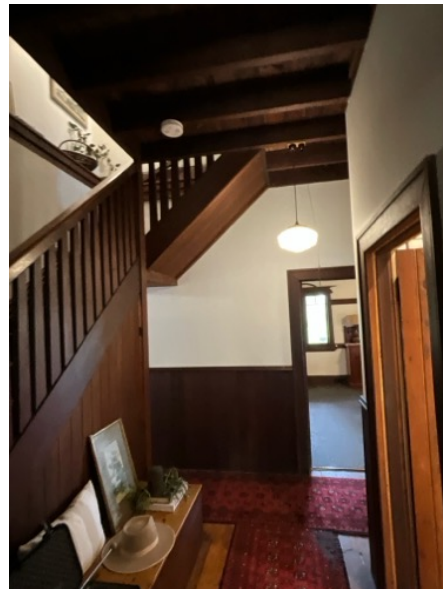
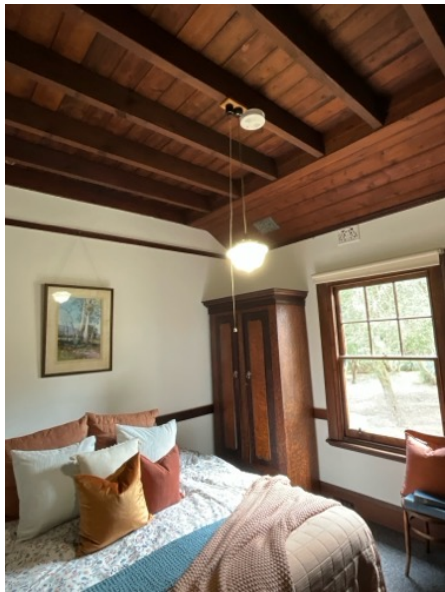
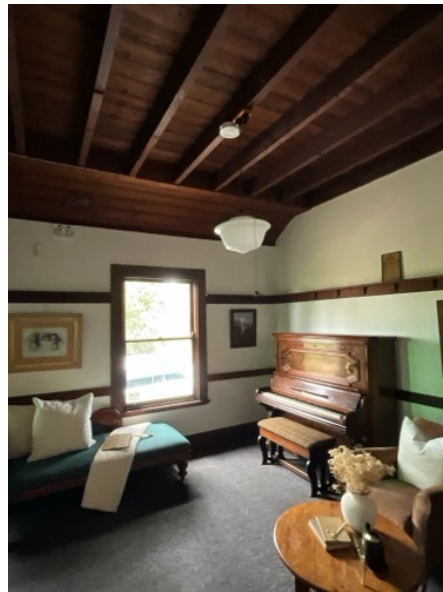
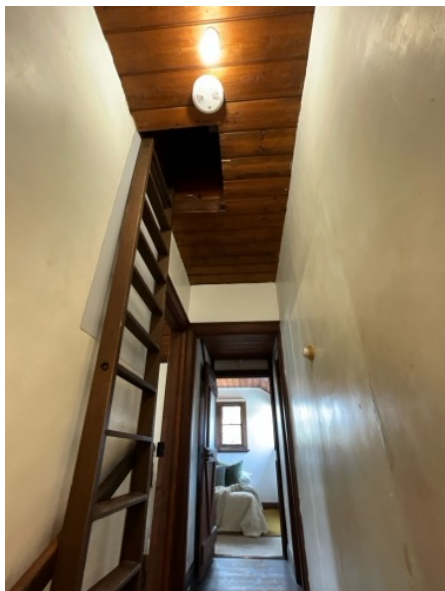
## For your information 4.08

**Location:** Outside Bedrooms  
**Finding:** Smoke Detectors and Alarms

Reporting on Smoke Detectors or Alarms, including hard wired smoke detection systems and their legislative requirements, is outside the Scope of this Report. Please note that this defect is highlighted as a caution only. Always ensure sufficient working and suitable smoke detectors are installed prior to occupying any building. Additionally, it is advised that all smoke detectors be tested by the homeowner. Please refer to AS3786 and state based legislation, which may also apply.

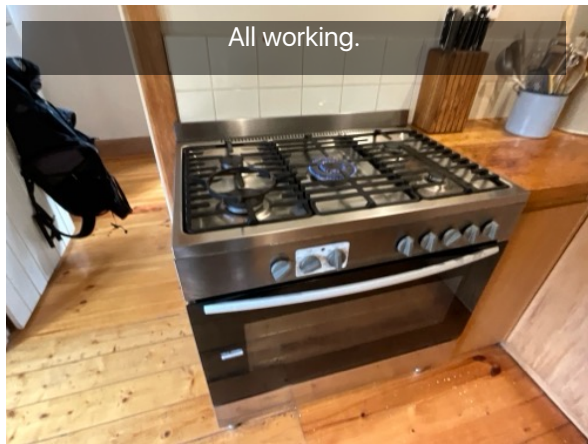
All working.

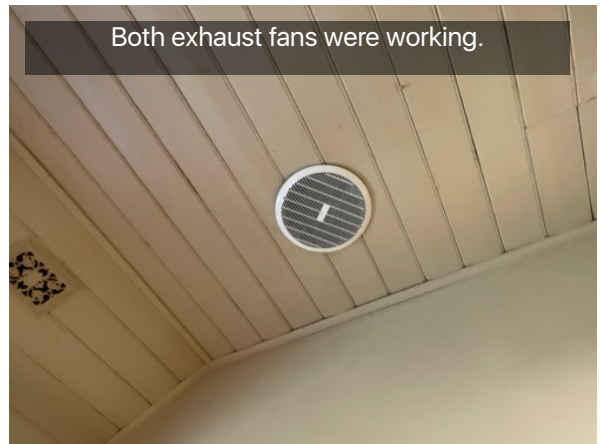
Both exhaust fans were working.

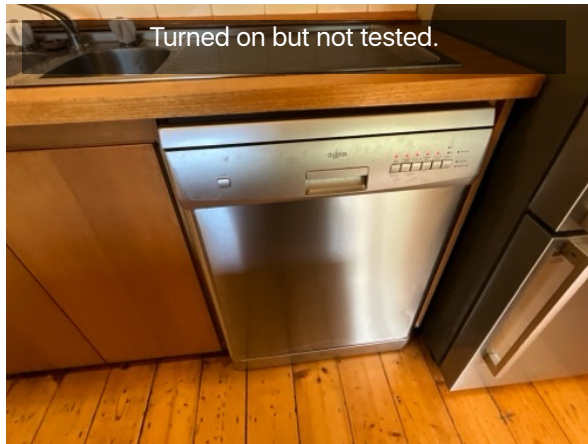
Turned on but not tested.

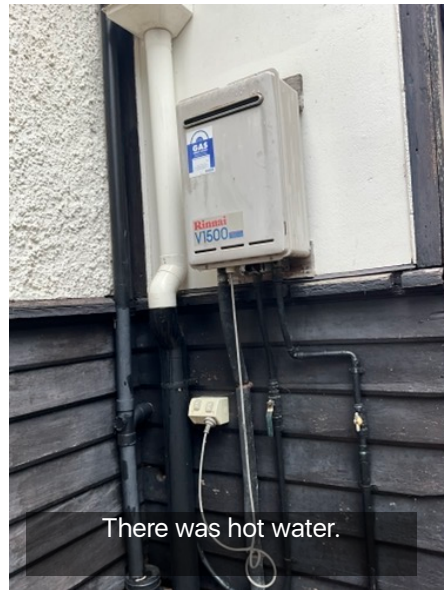
There was hot water.
