# Property and Timber Pest Report

Inspection Date: 20 Nov 2025

Property Address: 57-73 Glaneuse Road Point Lonsdale 3225

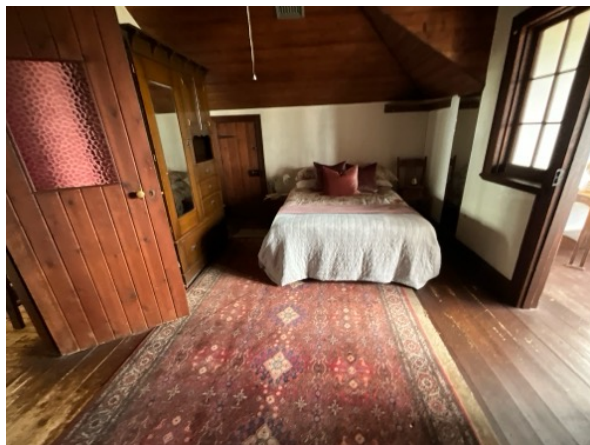
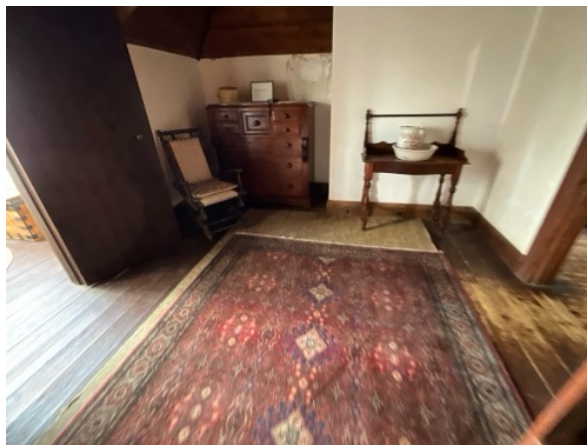
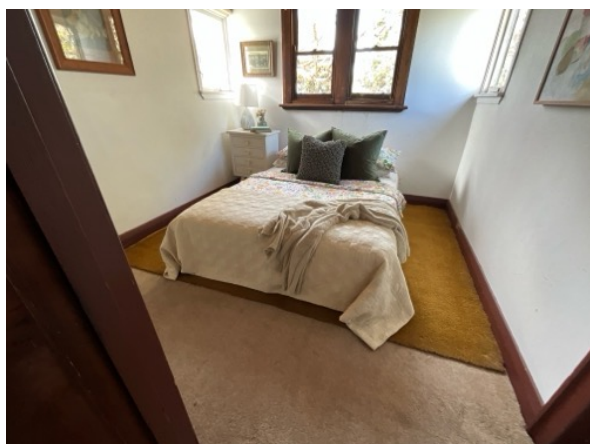
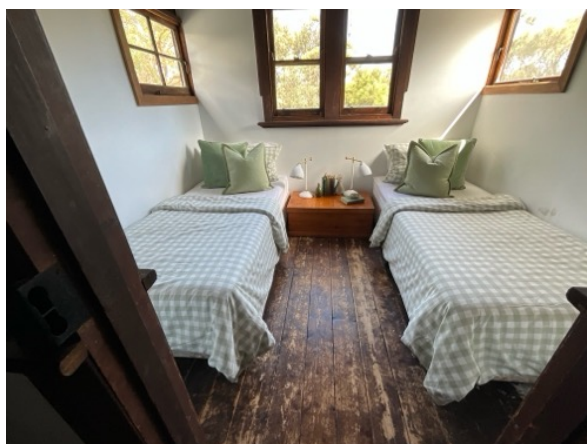
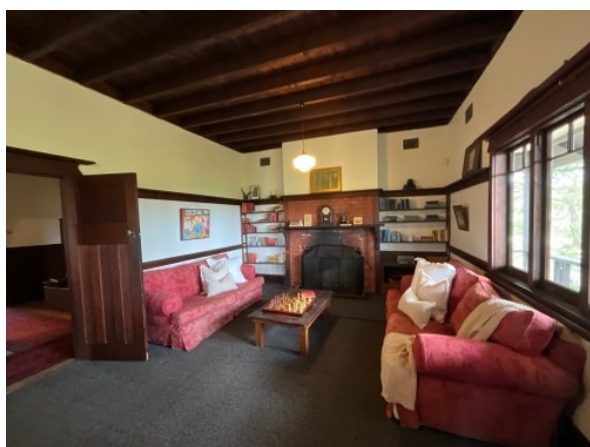
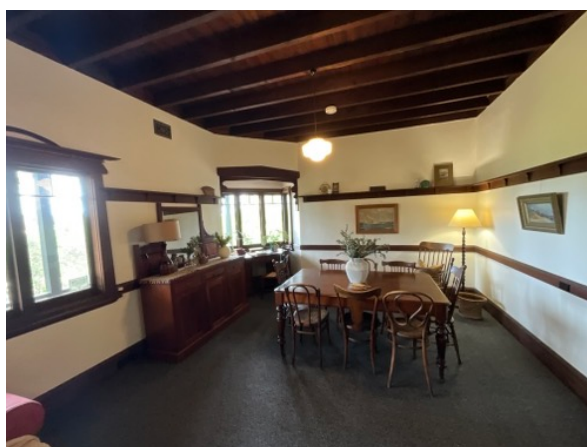
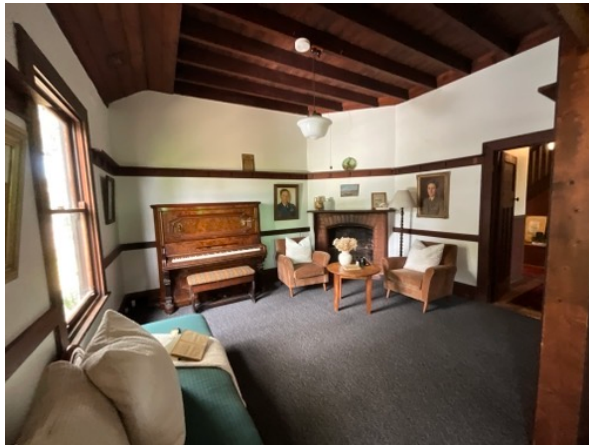
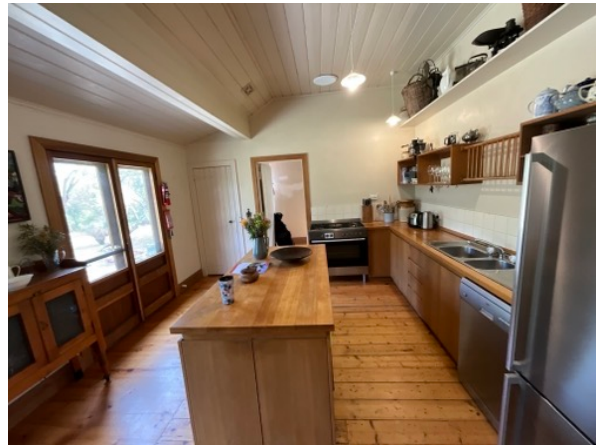
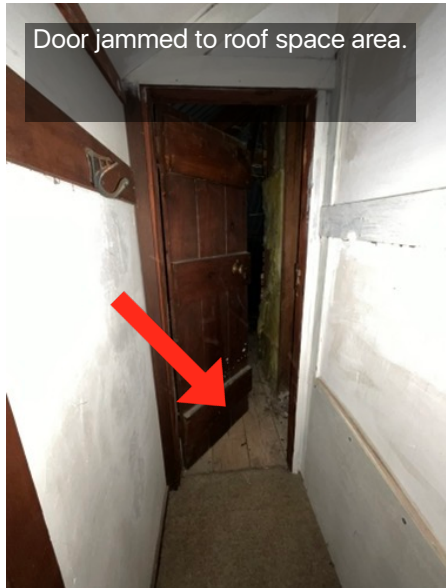
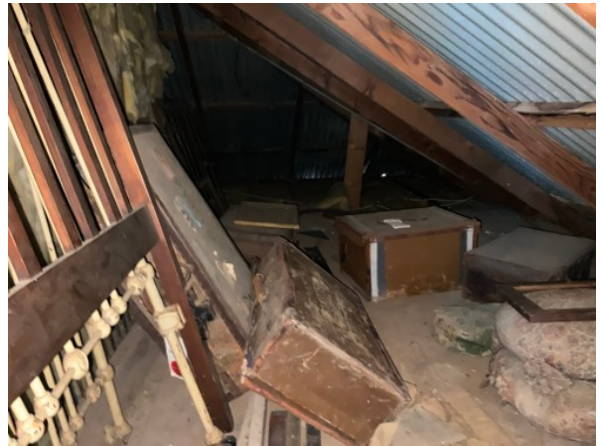
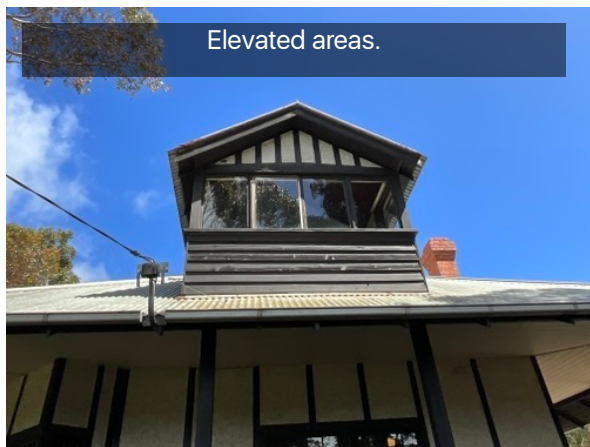
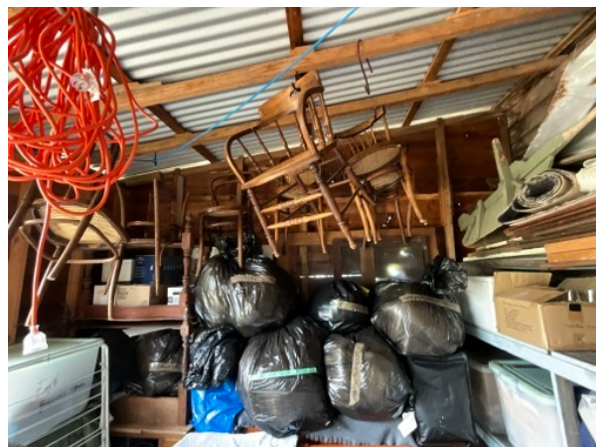
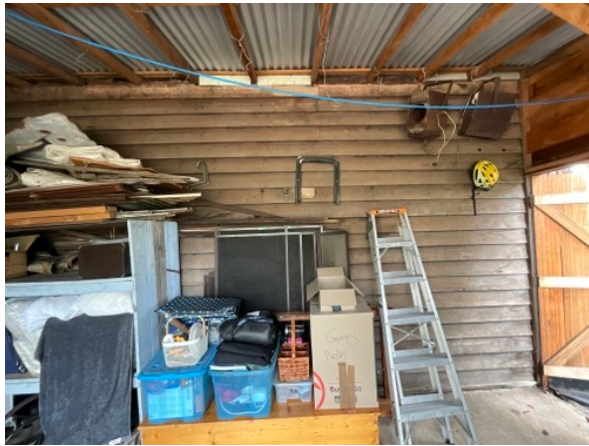
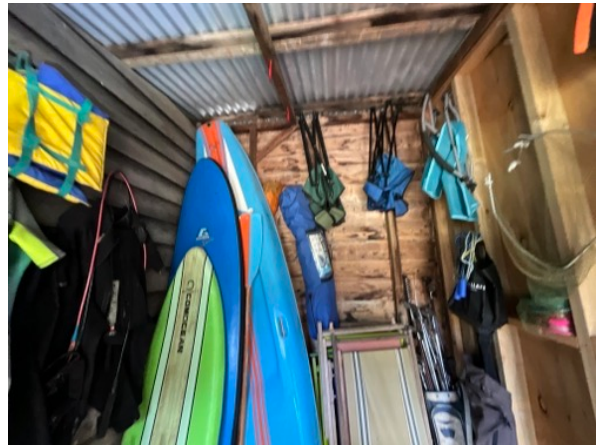
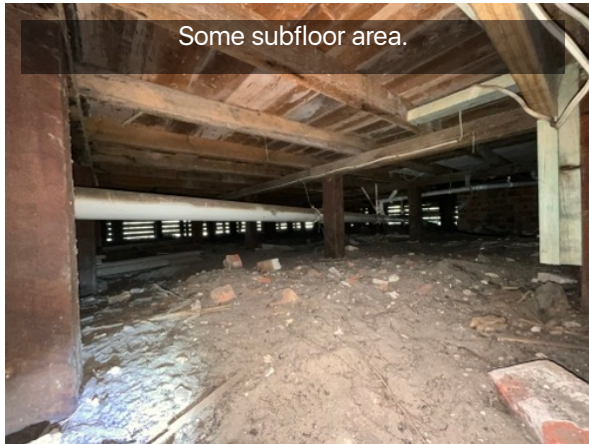
**Location:** The site

These photos are an indication of the obstructions and limitations which impeded full inspection of the property at the time of inspection. These obstructions can hide an array of defects and should be removed where possible to allow for further inspection to be carried out.

A reinspection is highly recommended once the areas are made accessible.

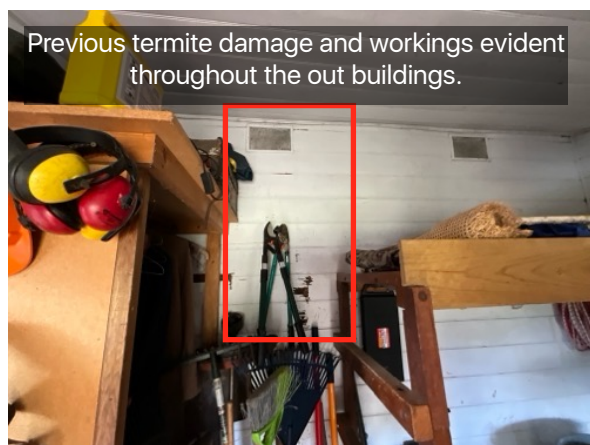
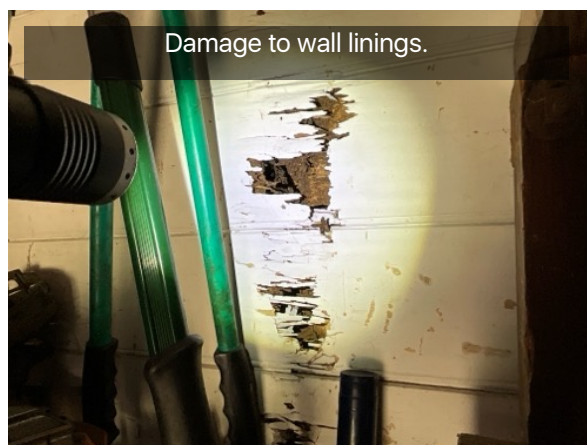
**Finding:** Evidence of termite damage - minor ( non structural )

Despite no live termite or timber pest activity being indicated, previous termite damage was found to have affected this area. This damage is considered to be inactive and is minor in nature. However where previous termite activity has been detected it is highly likely that there could be more significant damage to areas that are otherwise not accessible during a routine ( visual ) inspection, Eg wall and ceiling cavity's, inaccessible roof space and subfloor areas !

It is also advised that the area be visually inspected frequently to ensure that the condition of the affected building materials does not worsen. At the time of inspection the damage is not structural and is only considered to be superficial.

A building contractor may be appointed to provide a further more invasive inspection at client discretion.

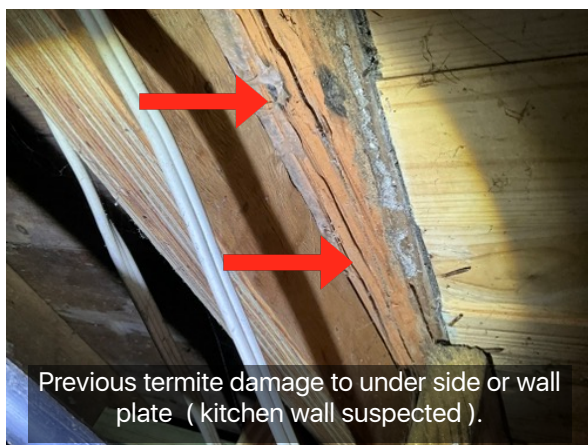
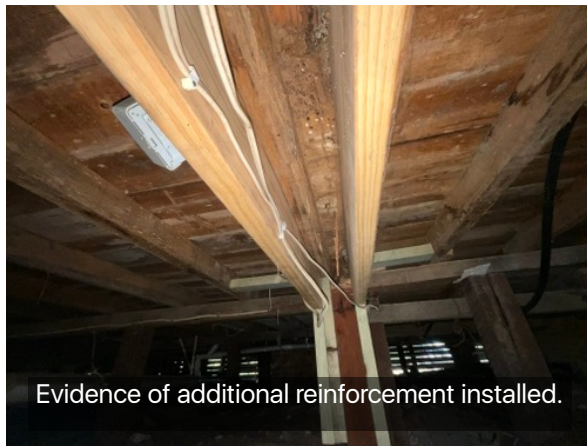
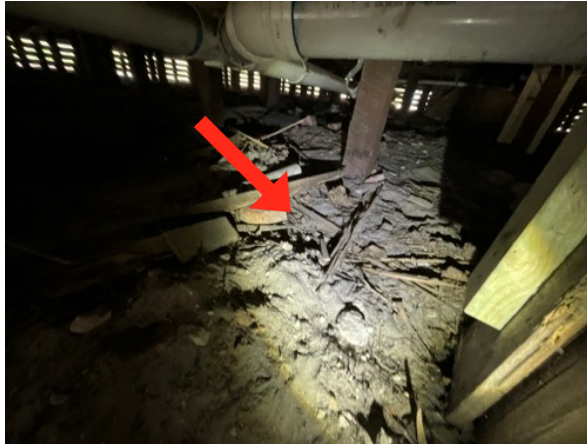
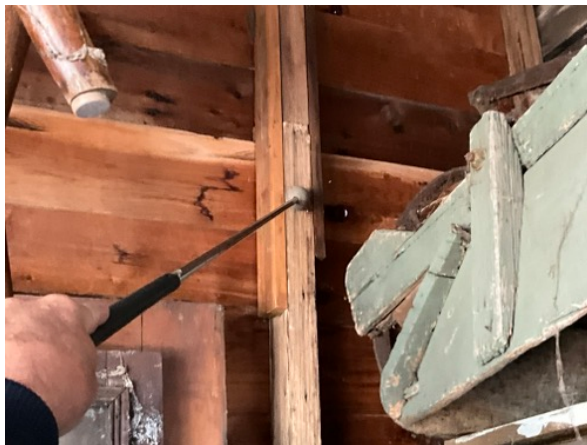
## Timber pest attack 5.02

**Location:** Subfloor  
**Finding:** Termite Damage/workings ( Structural )

Despite no live termite or timber pest activity been identified, previous termite damage was found in this area. This damage is considered to be inactive but structural in nature. It was however noted that damaged sections of the structure have been either replaced or reinforced with new timbers.

Due to the nature of Termites it is highly likely that further damage may be present to areas that are not readily accessible. It is advised that the area be visually inspected frequently to ensure that the condition of the affected building materials does not worsen and that there is no further termite activity.

It is highly recommended that advise from the home owner be given with regard to the reparative works that have been completed and any permits or certificates that may have been issued by the builder to complete such works.

The homeowner should comply with instructions and recommendations as per the warranty provided by the pest control company and continue to monitor area's which have conditions conducive to termite activity.

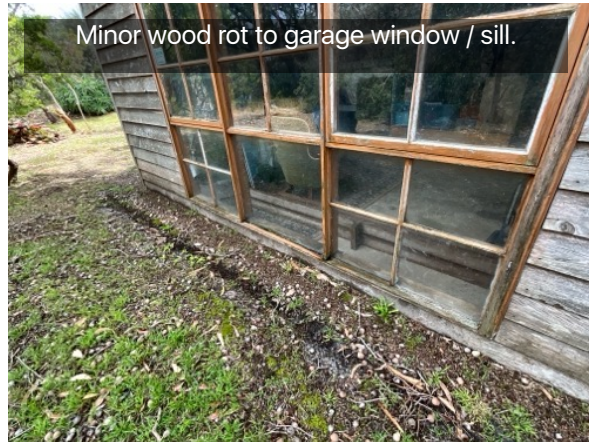
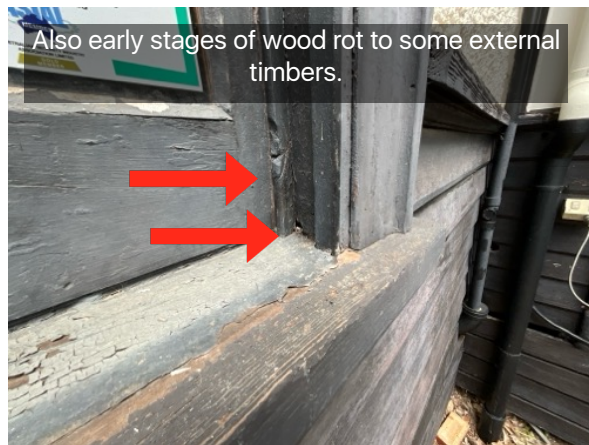
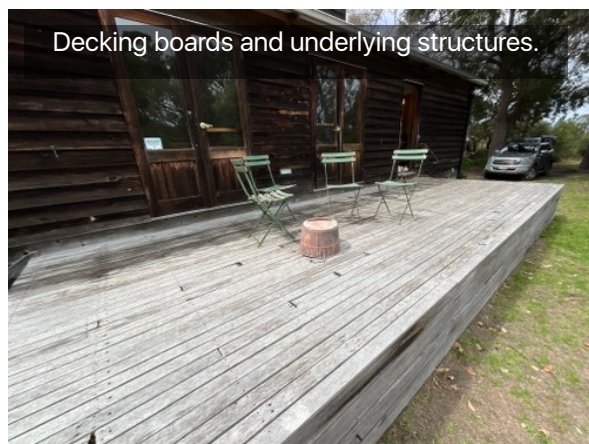
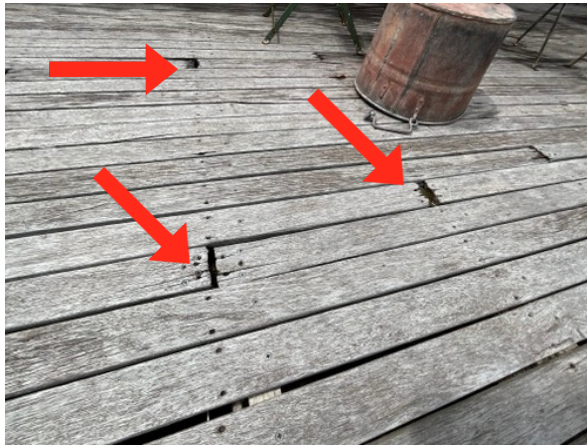
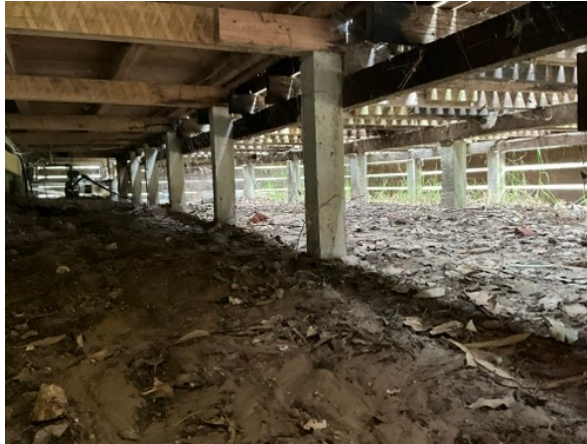
**Finding:** Wood rot

Wood rot which also known as Fungal Decay, occurs when timbers and other cellulose type building materials are exposed to damp conditions on a continual basis. Replacement of affected timbers may then be a necessary step in protecting surrounding building elements from such deterioration. Where wood rot is present to any structural timber, the replacement of the affected timber is required immediately. A qualified carpenter or registered builder may also be required to replace affected building materials. Consultation with a structural engineer is highly advised as soon as possible.

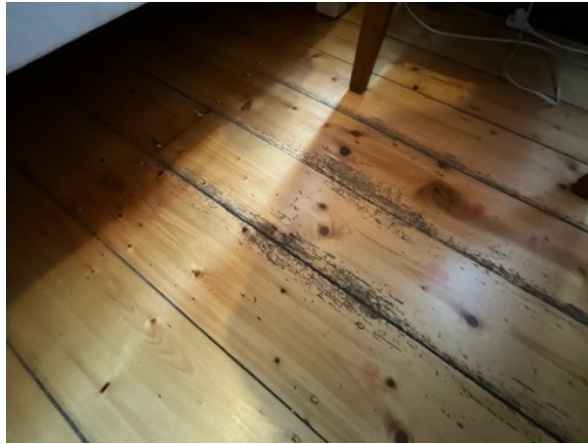
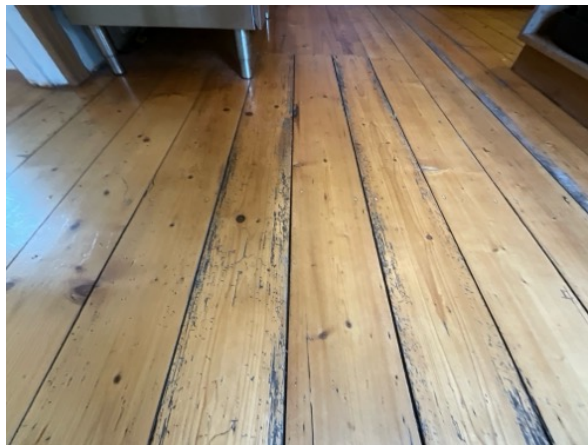
### Timber pest attack 5.04

**Location:** The site  
**Finding:** Evidence of wood Borer damage identified

Wood borer, small Beetles that colonise an exposed timber elements are a common timber pest that are regularly mistaken for termites. Although wood borer activity is generally not detrimental to the affected timber they may lead to serious damage and necessitate replacement of certain building elements if left unattended.

The other commonly known borer, the Anobium borer is more likely to attack floor boards and may cause severe structural damage to flooring areas.

As no live wood Borer activity was identified treatment is not required at this time. Replacement of affected timbers maybe considered by the client for superficial reasons.

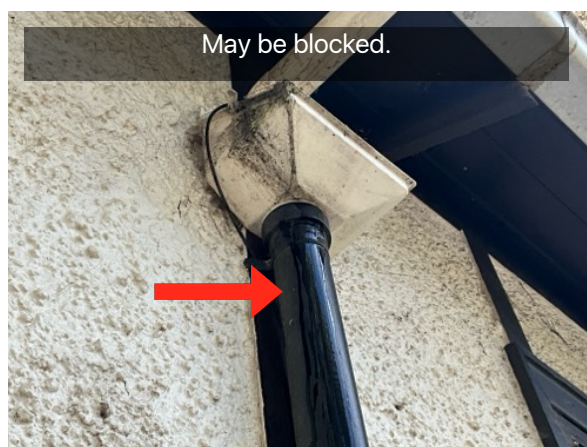
## Conditions conducive to timber pest attack 5.05

**Finding:** Damp or wet-leak

Damp or wet conditions are generally a direct result of poor drainage, an active leak, or poor ventilation (or a combination of the three). Dry conditions should be maintained to prevent secondary building defects from developing.

If left unmanaged damp or wet conditions may have many consequences including the development of fungal decay and/or wood rot as well as providing an environment that may be conducive to termite and timber pest attack.

A qualified plumber should be appointed to identify the cause of the excessive moisture in order to prevent further damage. The water leak should be resolved prior to any repairs of the damaged area which may require localised replacement of building materials and re-finishing.

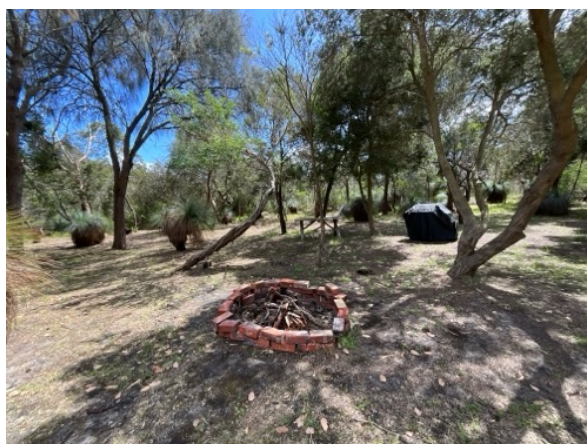
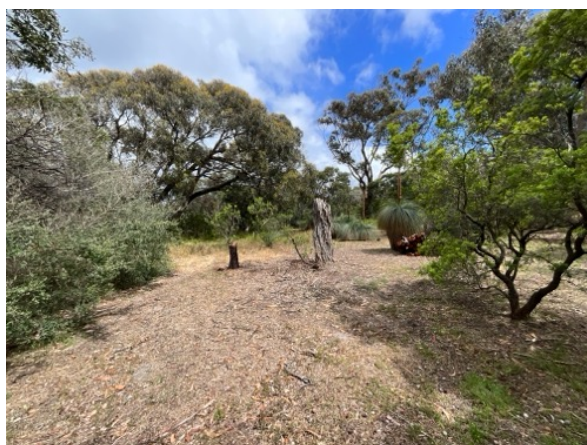
### Conditions conducive to timber pest attack 5.06

Garden Beds and especially mulched areas and non durable timbers in direct contact with the ground provide opportunities for concealed Termite activity and/or entry and are likely to be subject to premature rot and decay as the soil retains moisture or damp conditions against the timbers.

Remove all untreated timber that is in direct contact with external grounds. Consider replacement with more durable materials i.e. treated timber or non-timber elements.

Frequent pest inspections are advised to readily identify any termite activity in these areas.

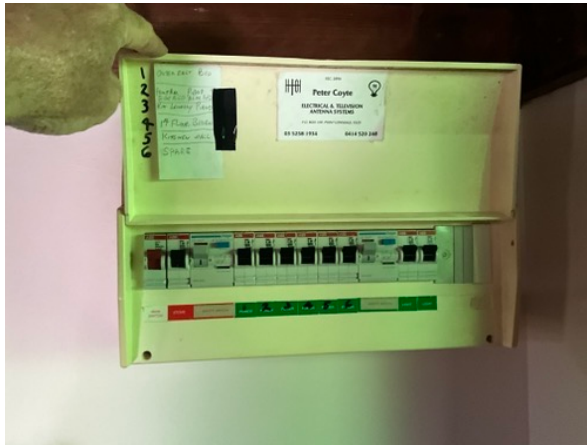
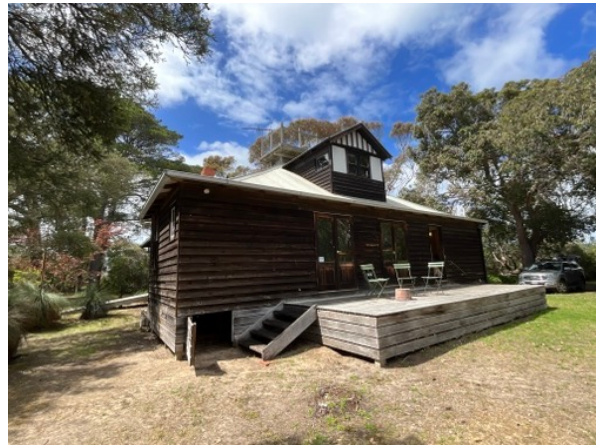
Preventative measures may include a post-Construction installation of a chemical termite barrier or the prevention of excess moisture in high-risk areas. Generally where there is a Chemical Termite Barrier installed to the property a durable sticker will be located inside the meter box. There was no sticker present !

Such a proposal is recommended to all properties that have a condition that may be conducive to termite or timber pest activity. The prevention of such infestations is far easier to manage than the management of live termite activity on the property.
