# CONTRACT OF SALE

**Property:** "Ballara" 57-73 Glaneuse Road, Point Lonsdale 3225

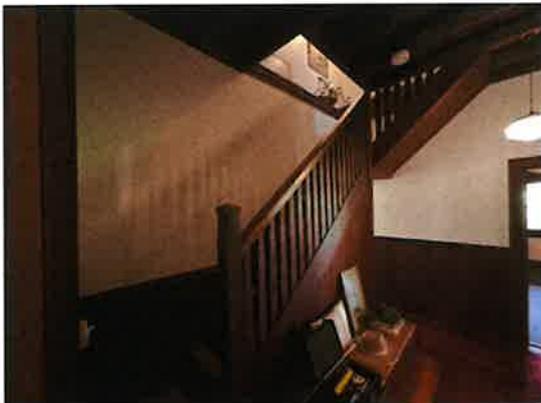
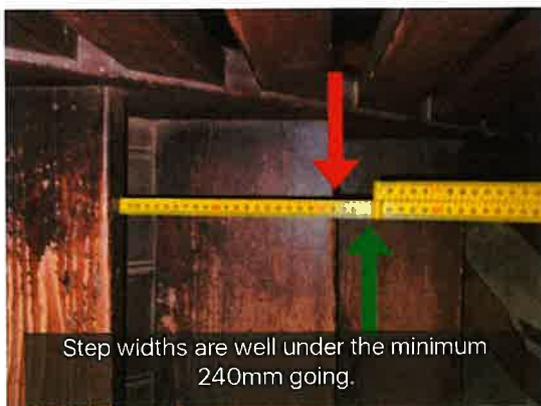
### Serious Safety Hazard 1.01

It was noted at the time of inspection that the stairs that have been installed to the dwelling have been poorly constructed, creating a potential trip hazard for users of the staircase. According to normal building practices all stairs should be measured and levelled to exact heights so to prevent tripping as well have a minimum tread/step width of 240mm and a maximum rise/height of 190mm.

Although retrospective works may not be relevant or cost efficient, replacement of the stairs advised. Consultation with a qualified carpenter as to the cost of potential solutions is recommended as soon as possible.

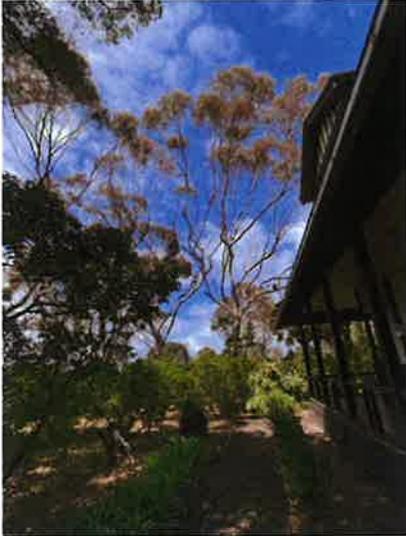
## Serious Safety Hazard 1.02

**Finding:** Trees - Falling vegetation

It was observed at the time of inspection that there is evidence where deteriorated tree branches / vegetation exist throughout the property. The vegetation will require trimming / removal. A specialist arborist should be engaged as soon as possible to rectify this issue.

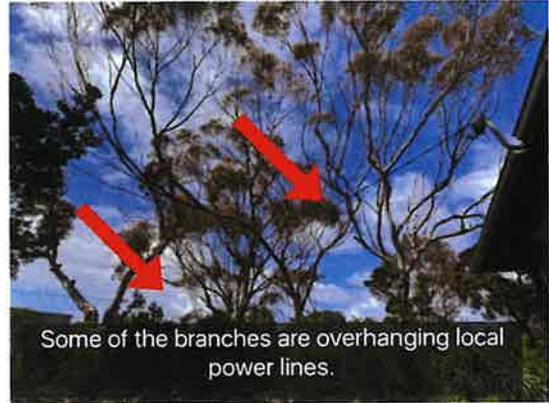
**Location:** The site

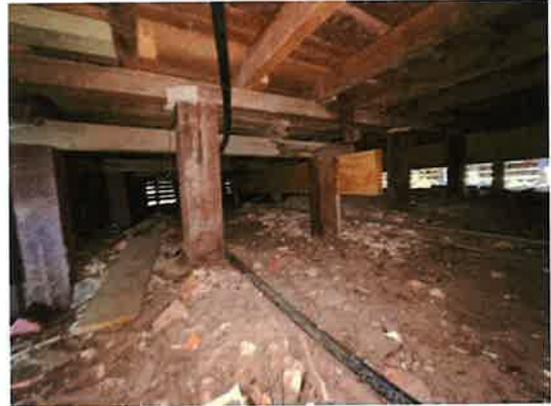
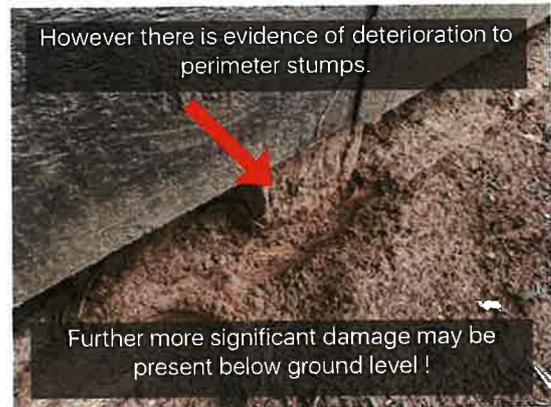
**Location:** Subfloor  
**Finding:** Timber stumps - Suspected deterioration

It was noted that the property has timber stumps. Inspection of the condition of the timber stumps - below the surface of the ground - is excluded from the scope of this report. Where timber stumps are failing replacement of stumps may be required in the short- to medium-term future. Timber stumps are no longer used in current building practices due to their susceptibility to wood rot and deterioration over time. The client should be prepared that in purchasing a property with timber stumps, that the need to either partially or fully restump the property in the short- to medium-term future is likely.

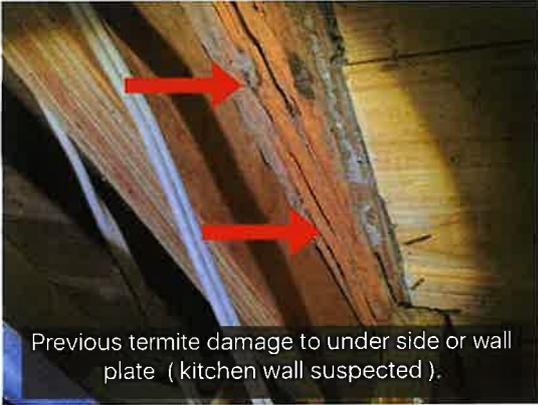
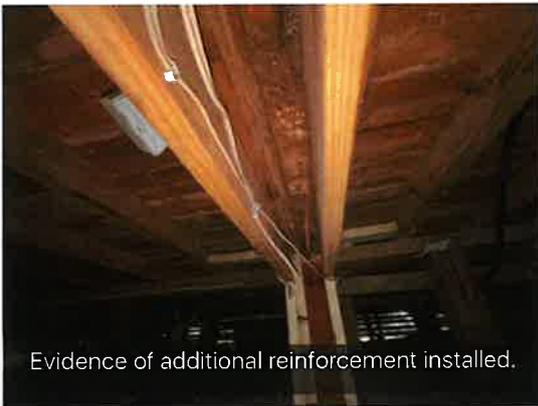
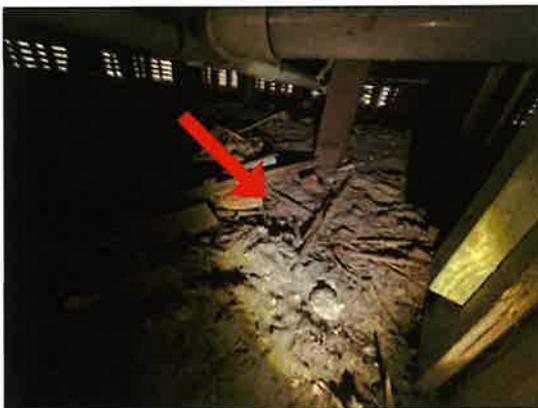
## Major Defect 2.02

**Location:** Subfloor  
**Finding:** Termite Damage/workings ( Structural )

Due to the nature of Termites it is highly likely that further damage may be present to areas that are not readily accessible. It is advised that the area be visually inspected frequently to ensure that the condition of the affected building materials does not worsen and that there is no further termite activity.

The homeowner should comply with instructions and recommendations as per the warranty provided by the pest control company and continue to monitor area's which have conditions conducive to termite activity.

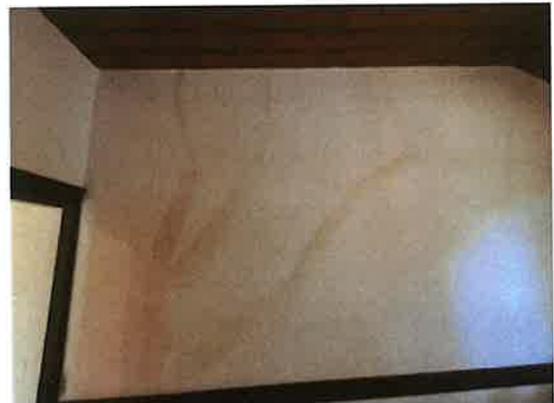
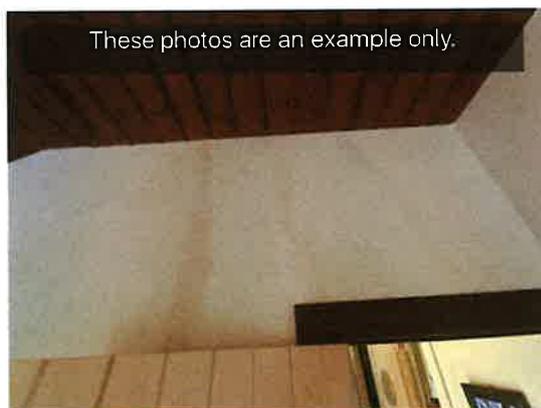
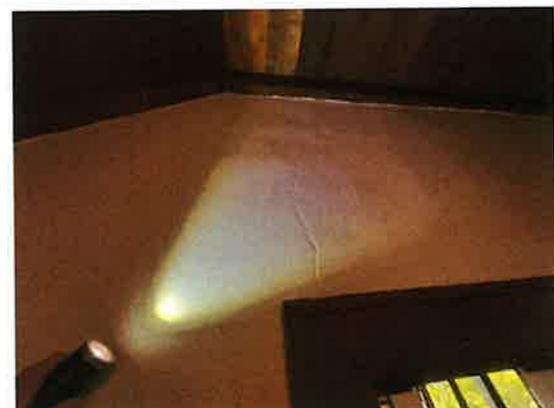
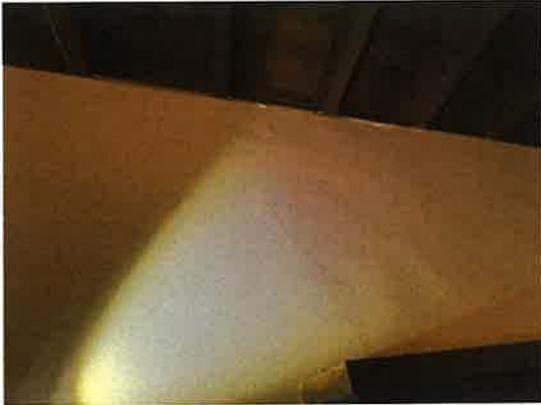
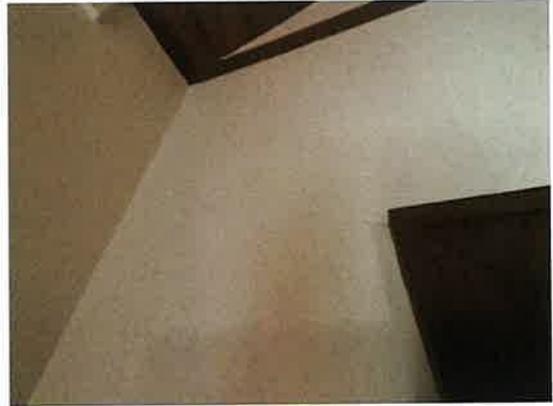
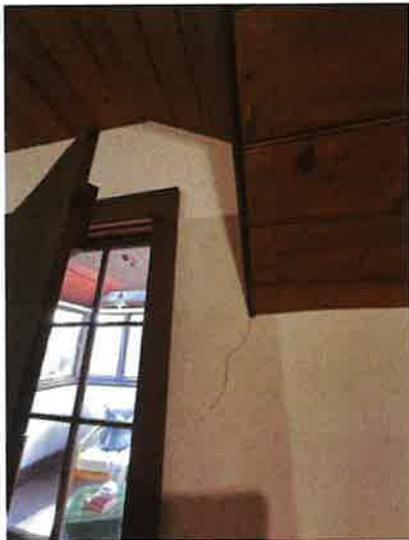
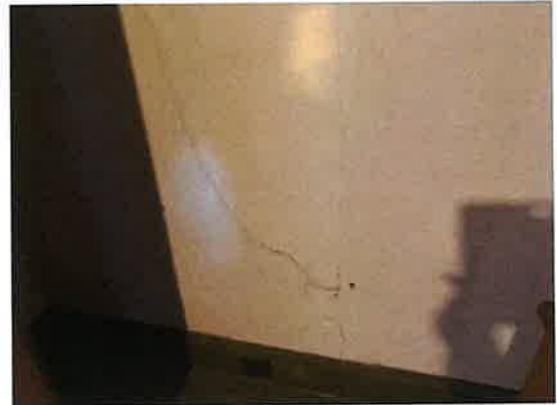
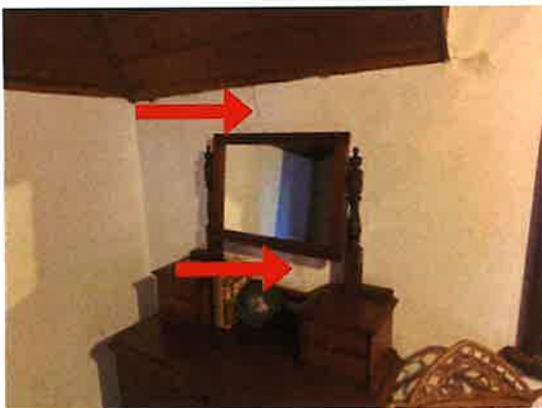
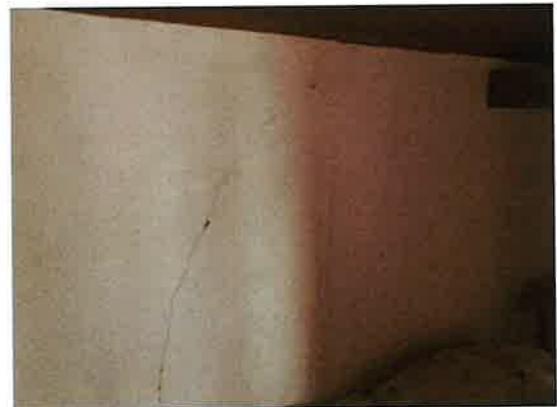
## Minor Defect 3.01

Monitoring of all cracking should be conducted frequently. Always can contact the building inspector should cracks widen lengthen or become more near but numerous. Additionally your building inspector should be contacted if associated building elements such as doors and windows become more difficult to operate overtime.

Other trades people such as carpenters, painters and plasterers should be appointed to perform remedial works as necessary !

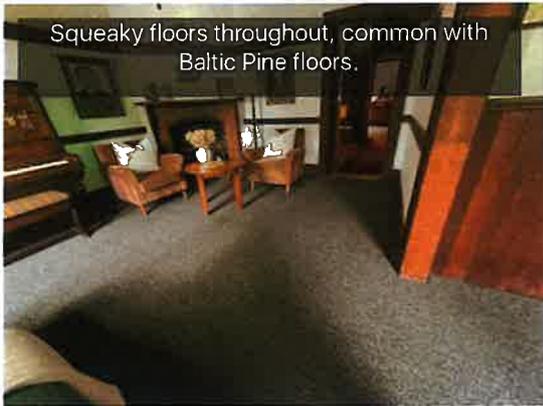
### Minor Defect 3.02

**Location:** The site  
**Finding:** Flooring - Squeaking

It was noted at the time of inspection that some of the internal floors as well the stairs are squeaky when walked across. This is quite common in older homes where there has been minor building movement as well settlement and shrinking of the timber frame and subfloor structure. Works to reduce the noise can be completed by a registered builder, at client discretion.

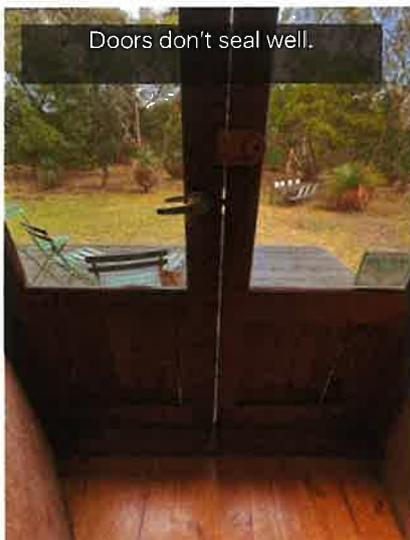
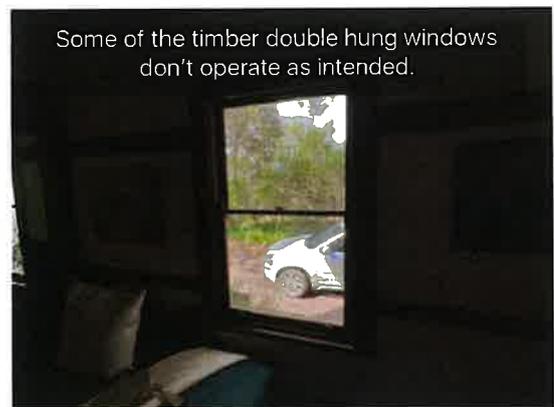
**Location:** Some Areas  
**Finding:** Door and windows – difficult to operate

A number of Doors and Windows to the dwelling were difficult to operate during standard operation. This defect inhibits the functionality of the affected building element as well as creating potential for secondary defects to associated building elements. A door that binds may have several causes, ranging from poor installation of the door or deteriorated hinges. Where door binding/jamming appears to indicate major structural issues, a registered structural engineer should be appointed to provide scope of rectification works at client discretion.

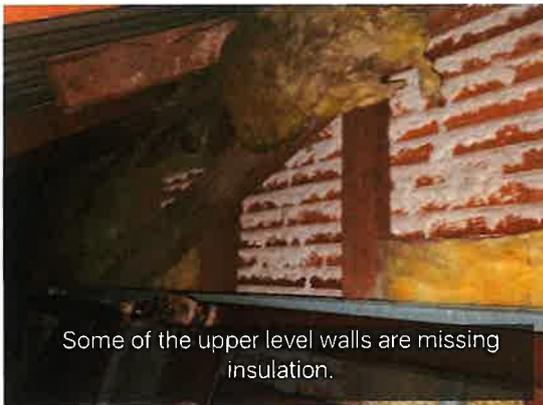
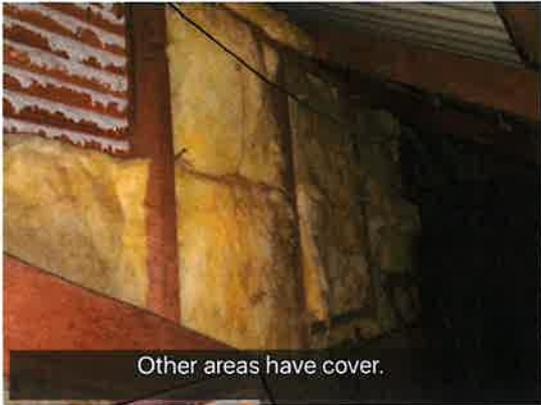
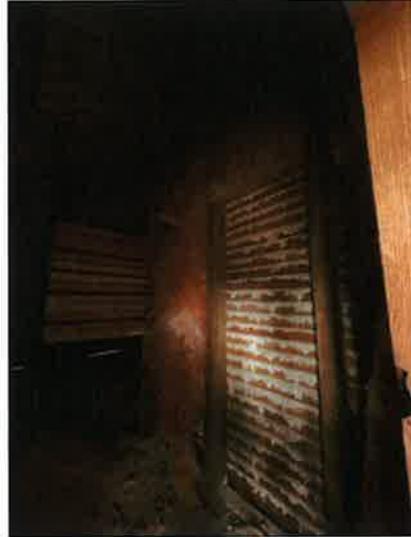
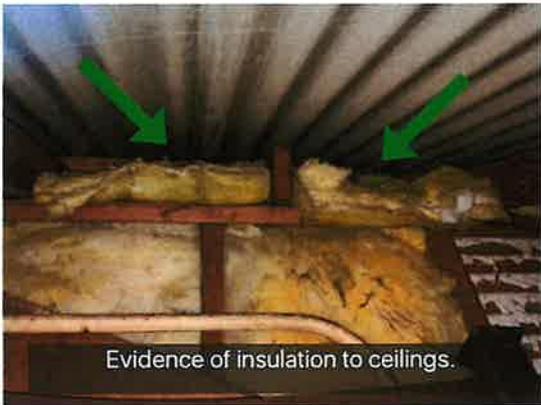
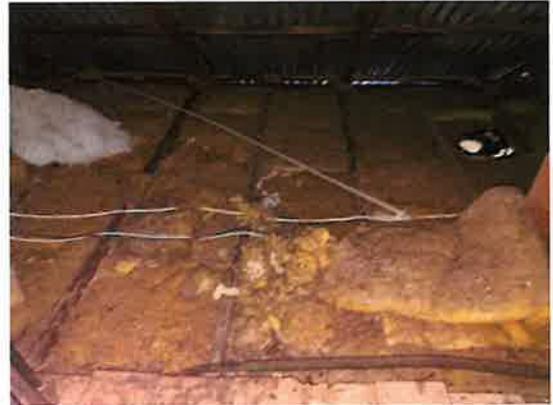
### Minor Defect 3.04

**Location:** Roofspace  
**Finding:** Insulation - Inadequate

Upon inspection of the roof void it was noted that there is a lack of adequate insulation. Insufficient insulation will result in a comparatively higher energy efficiency costs. The level of insulation in the property does not meet current Australian Standards. Installation of adequate insulation is required and should be conducted a professional contractor. Caution should be exercised when accessing the roof void, do not attempt to stand on the framework to the underside of the trusses and be aware there is a potential for electric shock if contact is made with exposed or faulty electrical wiring.

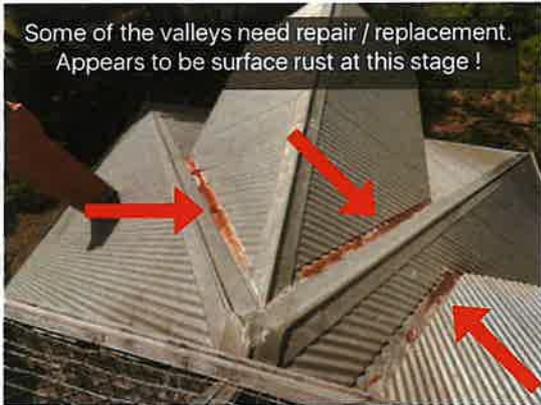
### Minor Defect 3.05

**Location:** Roof exterior  
**Finding:** Roof plumbing - Rusted or corroded

The roof plumbing has areas of rust and corrosion. It is suspected that this has been caused by blockages, resulting in pooling or standing water, that have prematurely rusted elements of the roof plumbing. Rusted roof plumbing will generally develop holes and leaks that can affect other building elements with poor drainage of storm water. A licensed plumber or specialist roof restoration company should be appointed to undertake these works. It is advised that such works be completed as soon as possible to prevent any further damage and deterioration.

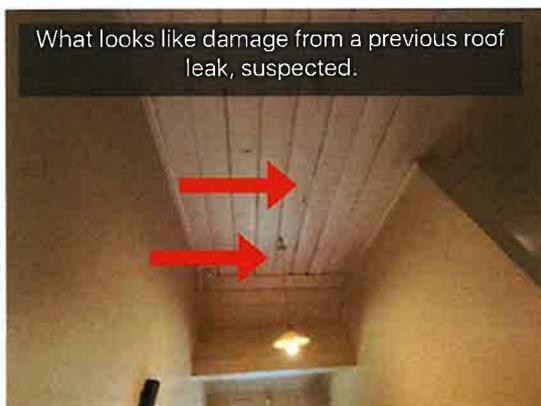
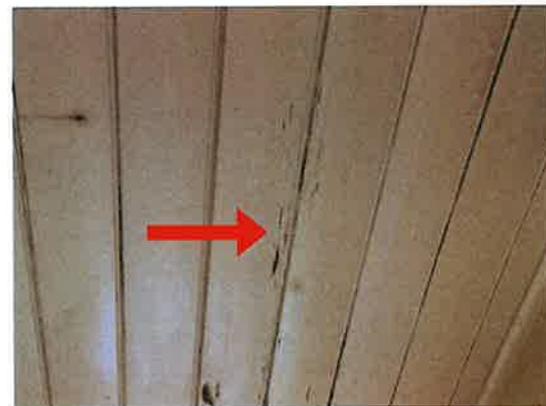
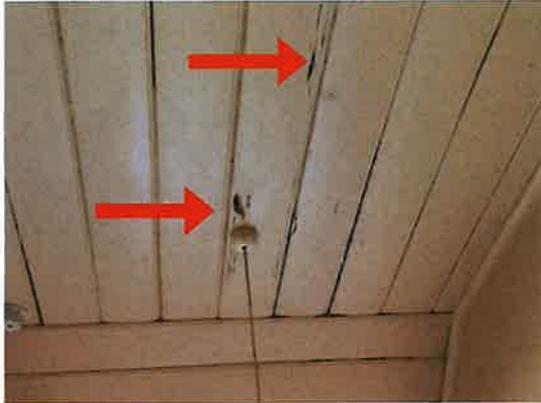
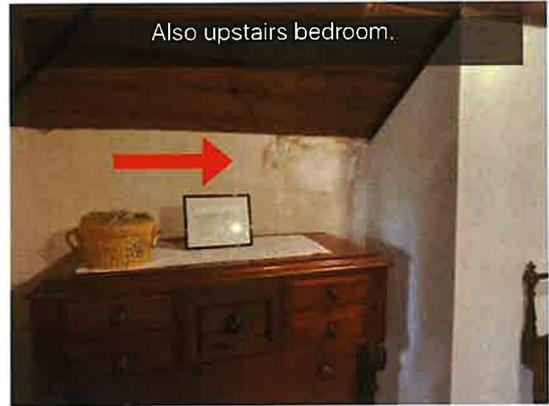
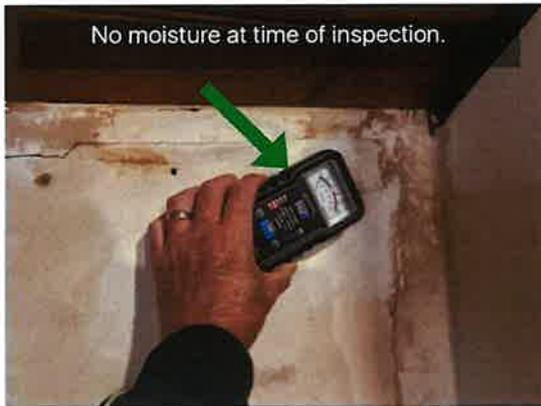
### Minor Defect 3.06

Alternatively where the property has been left vacant for a prolonged period of time we recommend a further more invasive inspection. Eg, leak testing by a Licensed Plumber and/or removal of obstructions or wall linings around the damaged area may reveal further damage which has been concealed.

A more significant or major defect may be identified at this time.

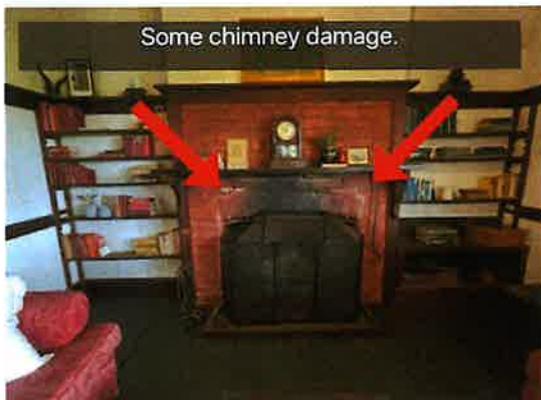
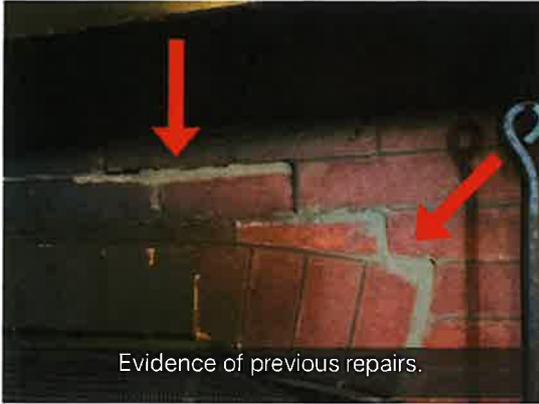
### Minor Defect 3.07

**Location:** Some Areas  
**Finding:** Damage to Masonry Walls ( Cracks )- Category 2

Damage of this category is required to be monitored for a period of 12 months, after which time a crack rated a category 3 or above is a defect requiring rectification such as minor repairs and repointing.

Always contact your building inspector should cracks widen, lengthen or grow more numerous.

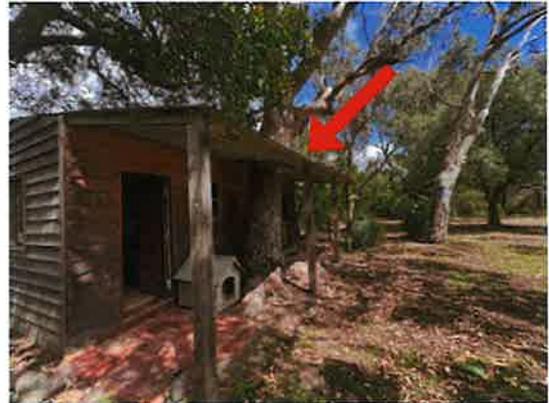
### Minor Defect 3.08

**Location:** The site  
**Finding:** Stormwater drain - Not connected

The roof plumbing is not adequately connected to stormwater drainage in this area. This disconnection negatively impacts the functional capacity of the roof plumbing. Where roof plumbing doesn't drain adequately, the area at the base perimeter can become excessively damp. It is highly recommended that a plumber be appointed to further inspect the area and to install adequate drainage equipment where necessary.

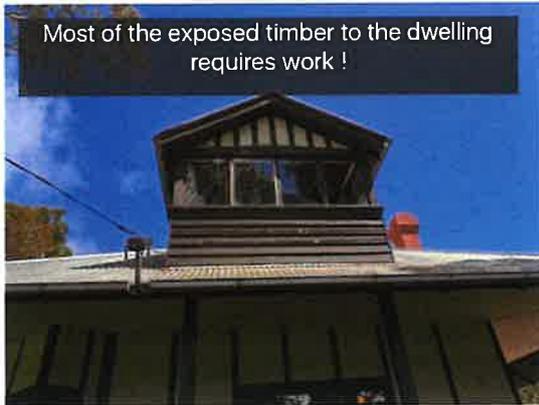
### Minor Defect 3.09

**Location:** The site  
**Finding:** Timber - exposed to weather

External timbers that are frequently exposed to harsh weather conditions require adequate protection in order to maintain their condition. Where timbers have not been painted or treated adequately, general deterioration is likely to occur at an accelerated rate. If left unattended, replacement of these timbers is likely to be necessary in the short-term future. Adequate treatment of these timbers is required as soon as possible by a painting contractor or general handyman.

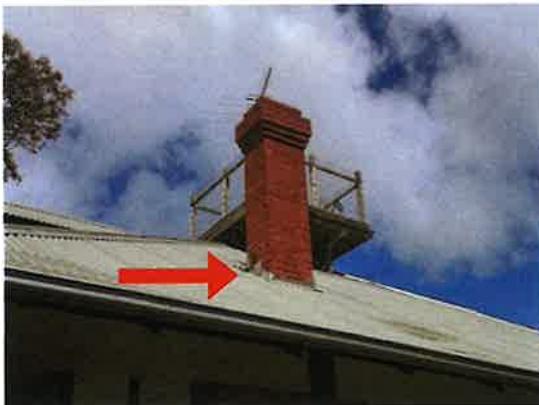
### Minor Defect 3.10

**Location:** The site  
**Finding:** Roof plumbing - Flashing inadequate

Some sections of the roof are missing or have inadequate roof flashings. Flashings are metal and other materials which are applied to seals and intersections between roof coverings and building elements. They are designed to aid in the weatherproofing of roof joins. Flashings that are not installed adequately or missing are likely to result in water penetration to the interior of the property. The roofing plumber should be appointed as soon as possible to install relevant roof plumbing materials, ensuring that no further damage is sustained.

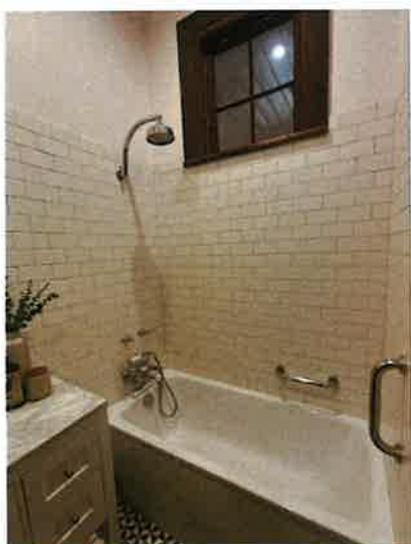
**Location:** Wet Areas  
**Finding:** Bathroom - Shower condition

At the time of inspection it was noted that the tiles grout and sealant to the shower recess are in good condition with no evidence of excessive moisture or water damage identified. Always ensure that tiles, grout and sealant are well maintained and kept in good condition at all times to prevent future moisture issues.

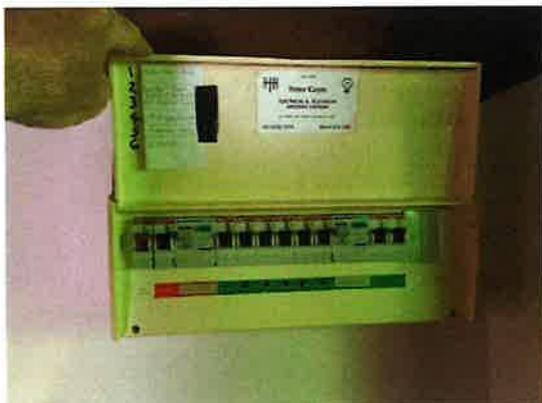
## For your information 4.02

- Location:** Electrical Switchboard
- Finding:** Electrical switchboard - Safety switch or RCD installed

Safety switches are designed to identify any faults in the electrical circuit throughout the house and switch off the power accordingly. This is a safety measure that is aimed at preventing any personal injury that may result when attempting to operate faulty switches or appliances. In addition, each State and Territory has legislation in place with different requirements that make it mandatory under certain circumstances to have a safety switch installed.

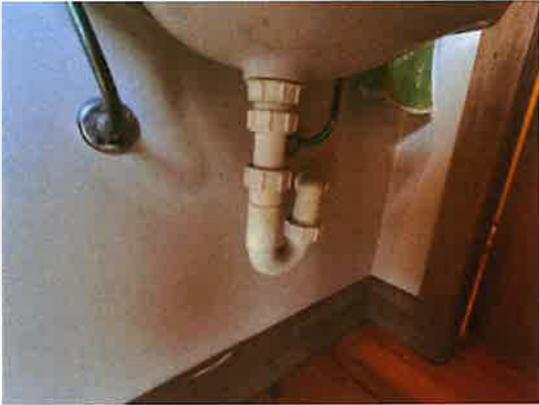
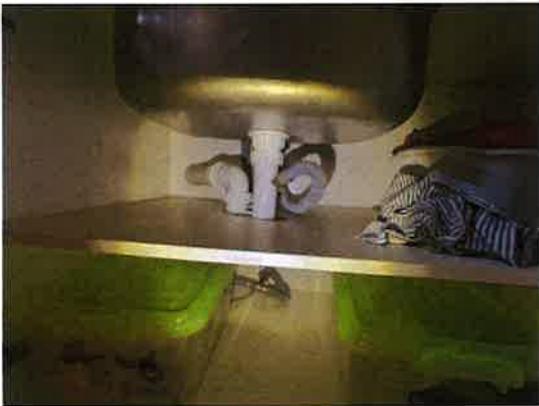
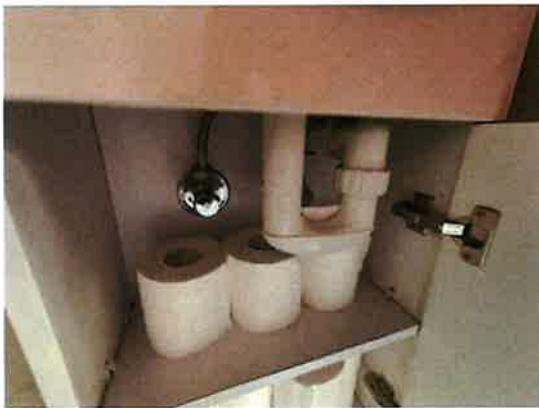
### For your information 4.03

**Location:** Wet Areas  
**Finding:** Inspection of plumbing wastes

It must be noted inspection of all plumbing waste to the dwelling showed no evidence of leaks or damp identified to all areas.

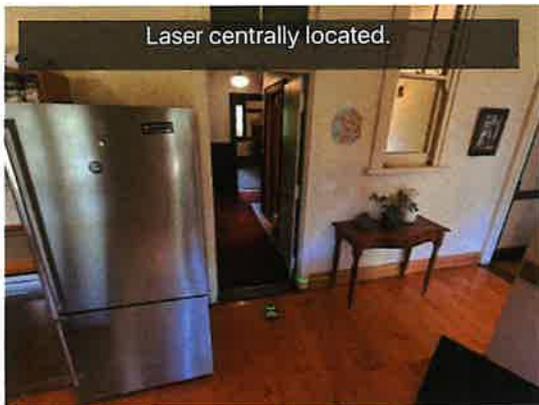
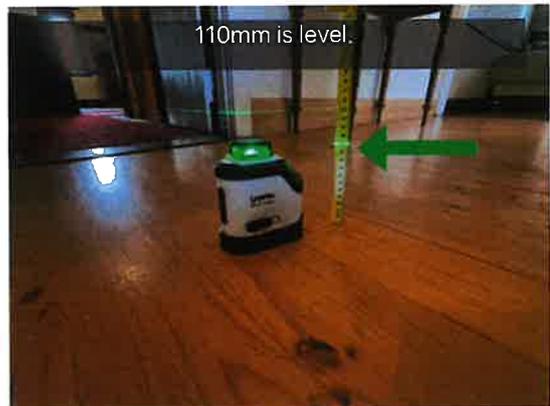
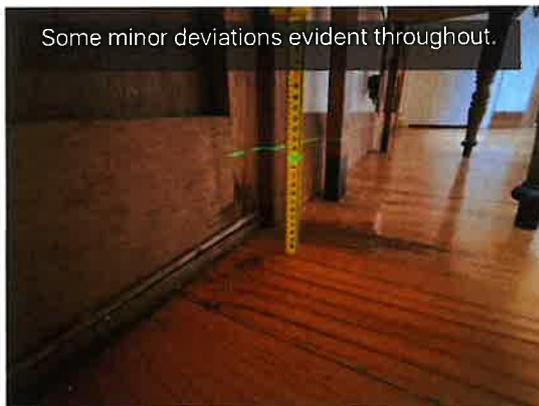
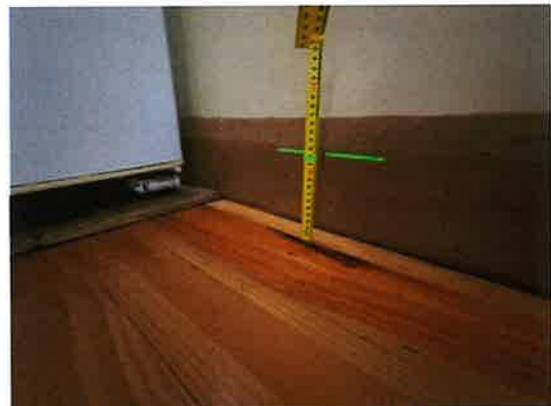
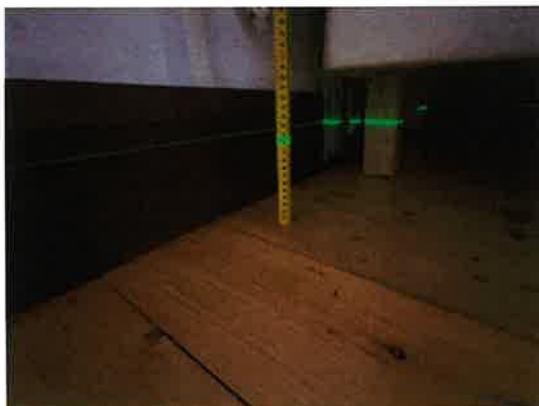
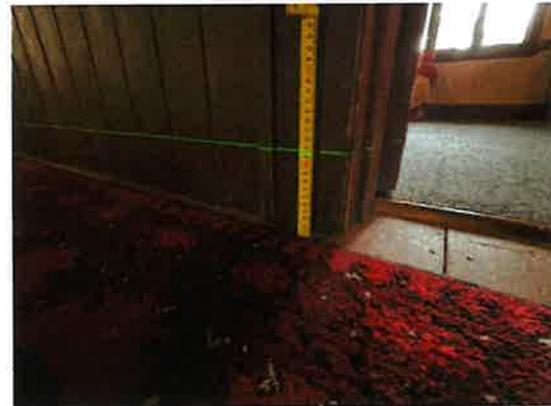
## For your information 4.04

**Location:** All Internal Areas

**Finding:** Floor Levels - Timber & Concrete Stumps.

At the time of inspection a series of levels were taken throughout the dwelling with all areas being either level or within an acceptable deviation.  
Please note a Lasertec instrument is used to assess floor levels ( at the time of inspection ) and is limited to line of sight. Eg, the laser doesn't bend around corners.  
It gives a broad assessment of the footing levels of the dwelling only !

Also more recently installed concrete stumps to some areas.

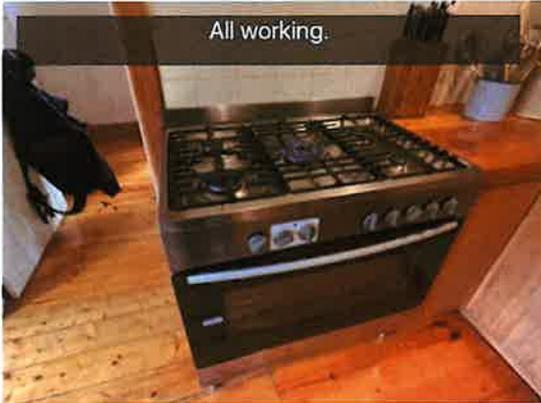
All working.

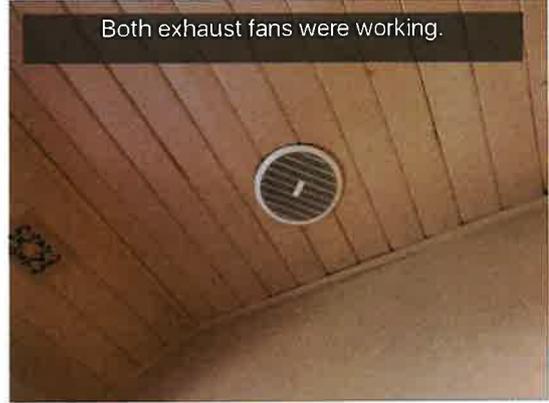
Both exhaust fans were working.

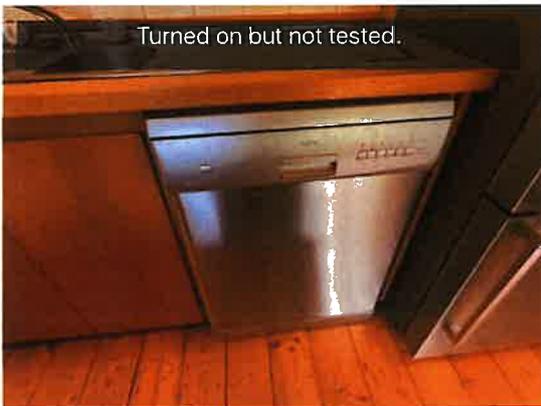
Turned on but not tested.

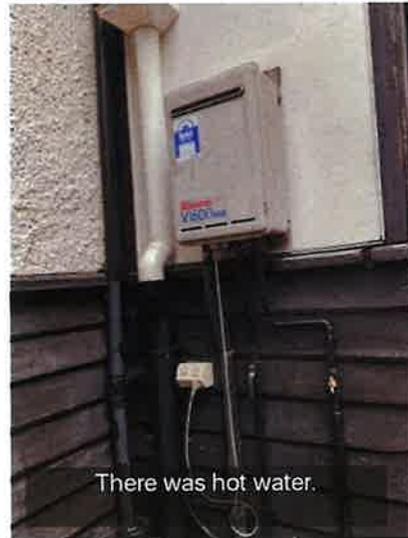
There was hot water.

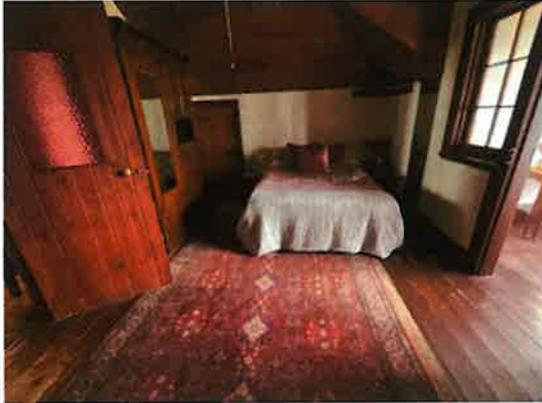
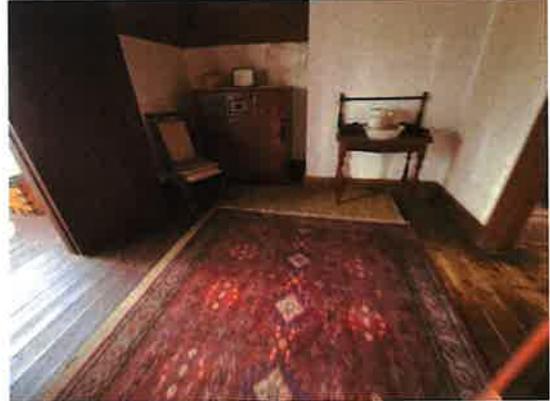
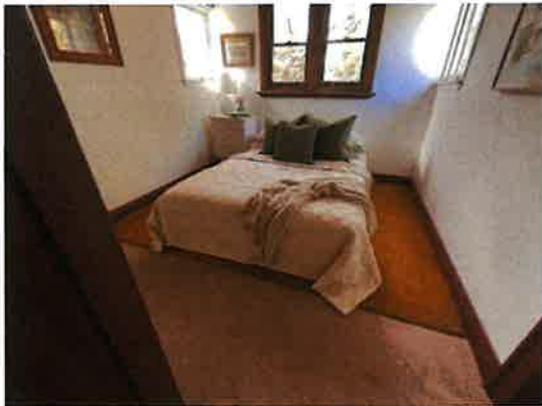
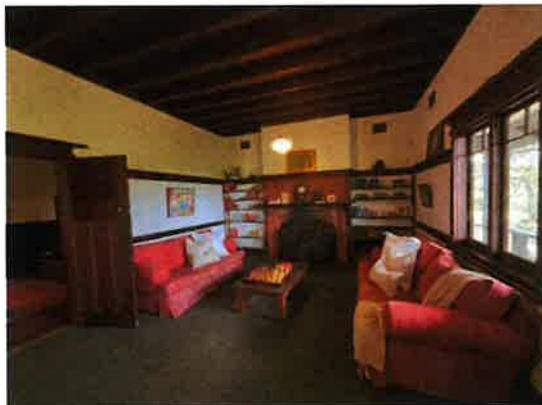
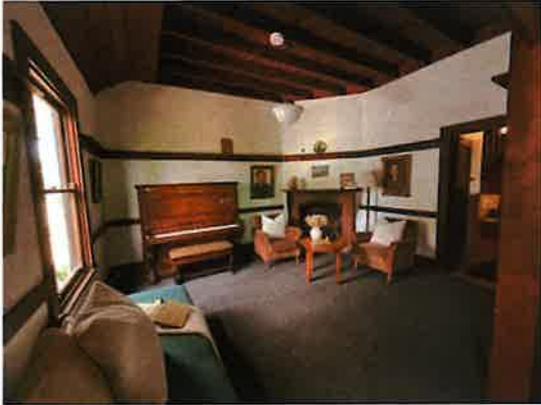
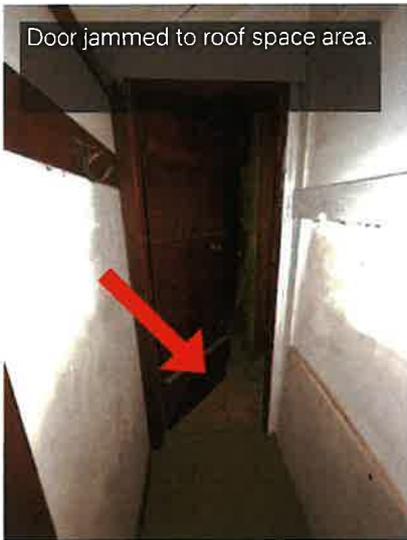
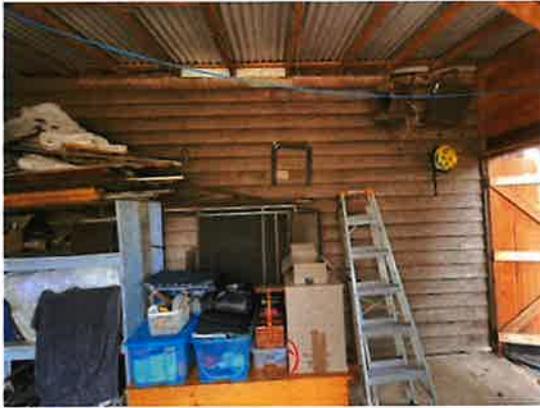
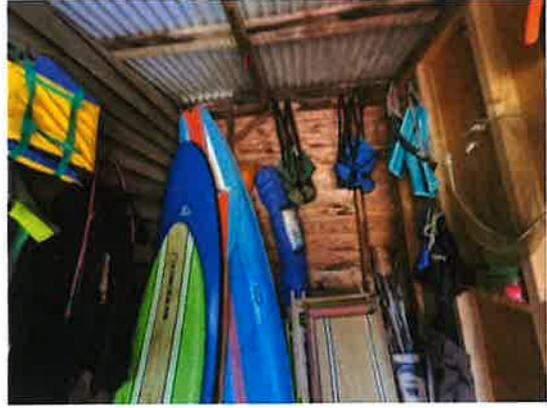
## For your information 4.10

**Location:** The site

These photos are an indication of the obstructions and limitations which impeded full inspection of the property at the time of inspection. These obstructions can hide an array of defects and should be removed where possible to allow for further inspection to be carried out.

A reinspection is highly recommended once the areas are made accessible.

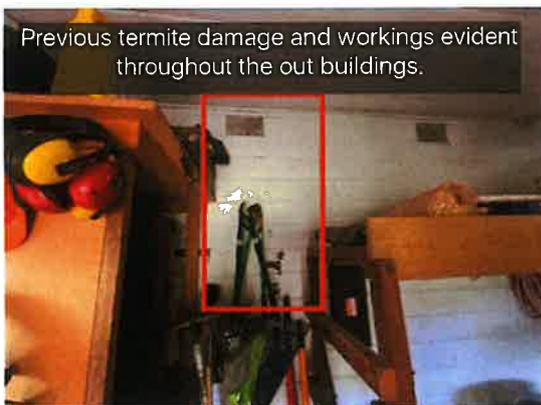
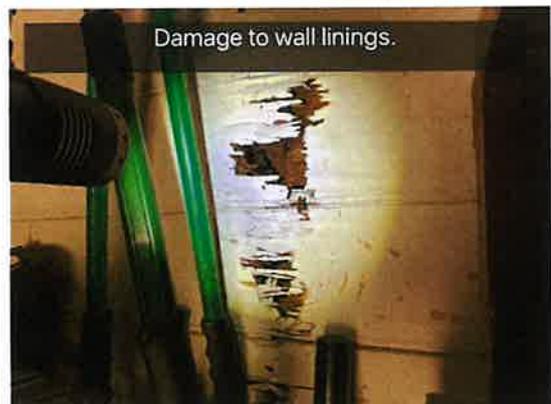
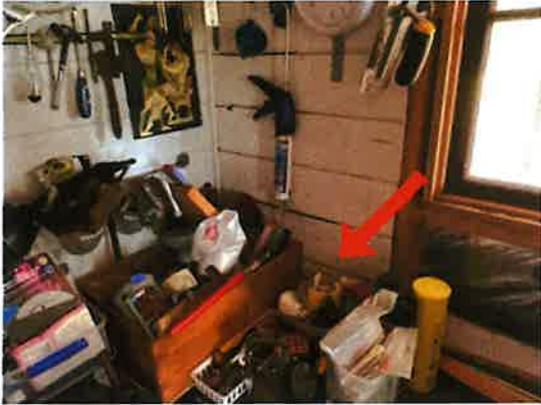
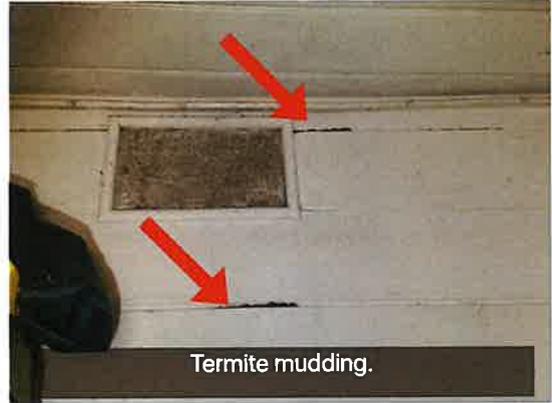
Evidence of termite damage - minor ( non structural )

Despite no live termite or timber pest activity being indicated, previous termite damage was found to have affected this area. This damage is considered to be inactive and is minor in nature. However where previous termite activity has been detected it is highly likely that there could be more significant damage to areas that are otherwise not accessible during a routine ( visual ) inspection, Eg wall and ceiling cavity's, inaccessible roof space and subfloor areas !

Termite mudding.

It is also advised that the area be visually inspected frequently to ensure that the condition of the affected building materials does not worsen. At the time of inspection the damage is not structural and is only considered to be superficial.

A building contractor may be appointed to provide a further more invasive inspection at client discretion.

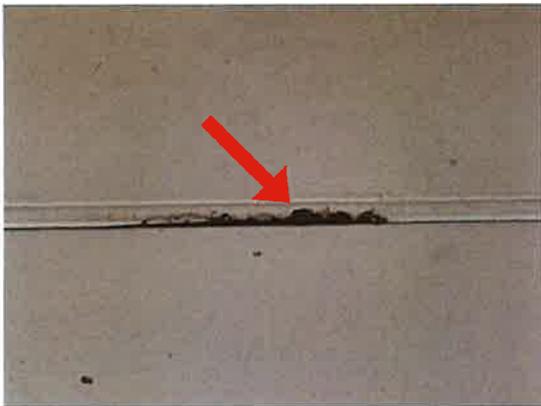
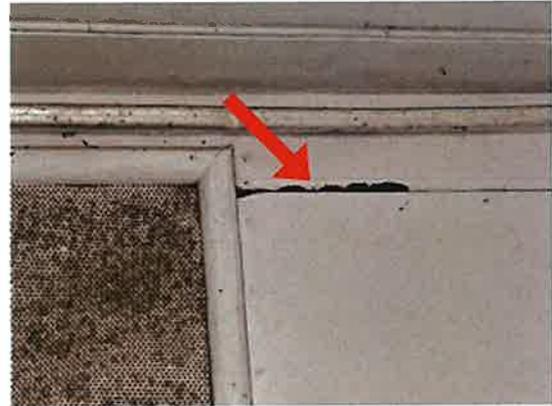
Termite mudding to walls.

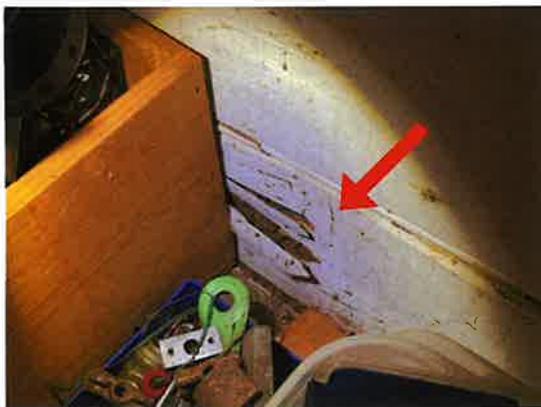
Termite damage near leaking down pipe.

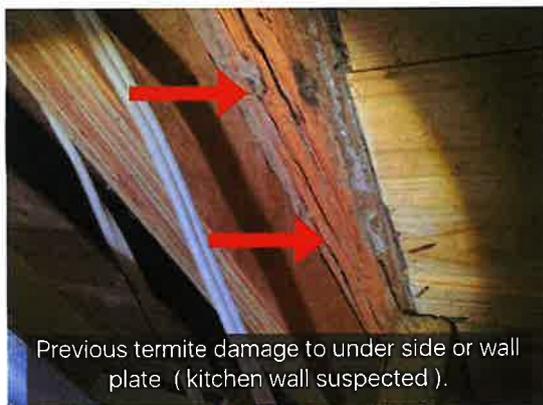
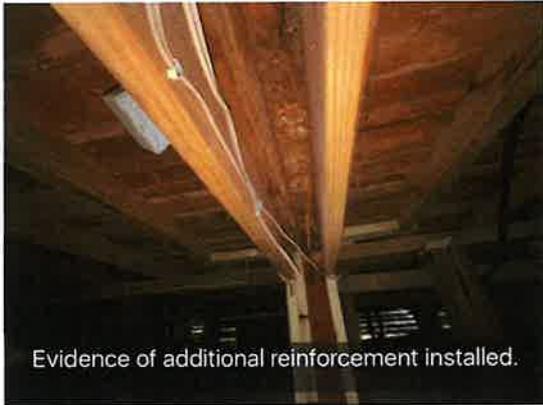
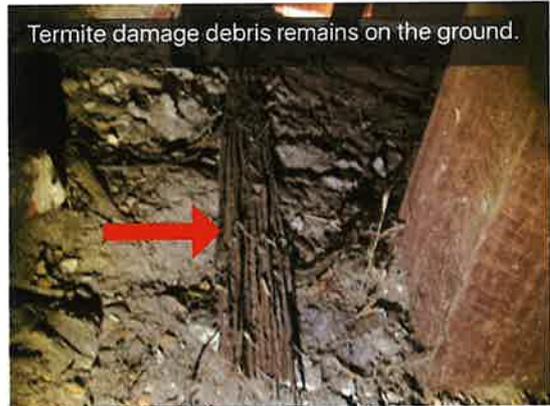
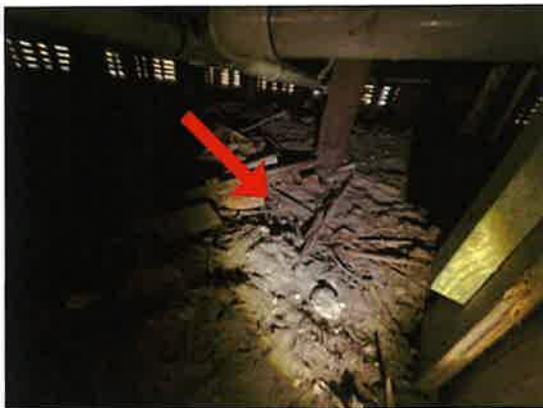
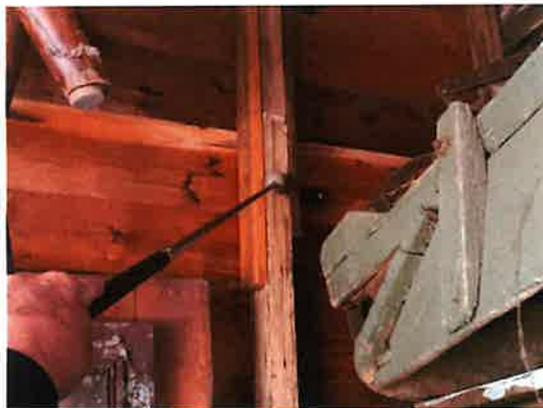
## Timber pest attack 5.02

**Location:** Subfloor  
**Finding:** Termite Damage/workings ( Structural )

Despite no live termite or timber pest activity been identified, previous termite damage was found in this area. This damage is considered to be inactive but structural in nature. It was however noted that damaged sections of the structure have been either replaced or reinforced with new timbers.

It is highly recommended that advise from the home owner be given with regard to the reparative works that have been completed and any permits or certificates that may have been issued by the builder to complete such works.

Due to the nature of Termites it is highly likely that further damage may be present to areas that are not readily accessible. It is advised that the area be visually inspected frequently to ensure that the condition of the affected building materials does not worsen and that there is no further termite activity.

The homeowner should comply with instructions and recommendations as per the warranty provided by the pest control company and continue to monitor area's which have conditions conducive to termite activity.

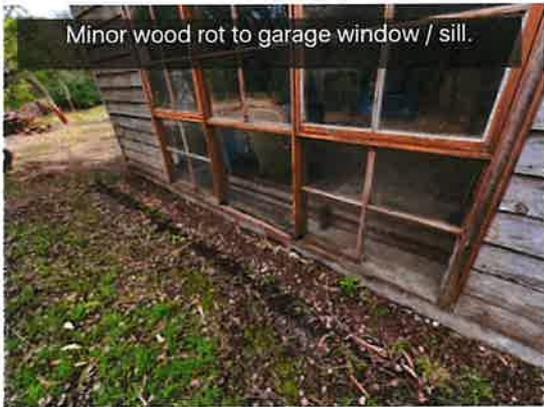
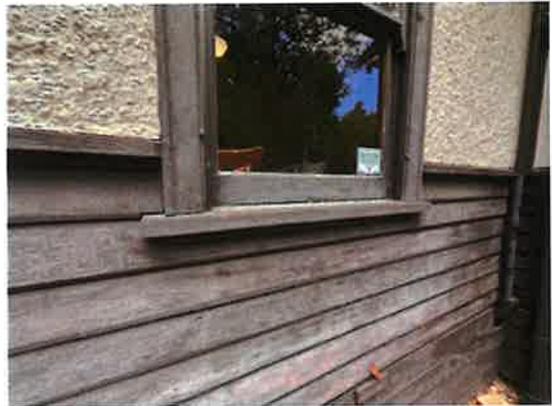
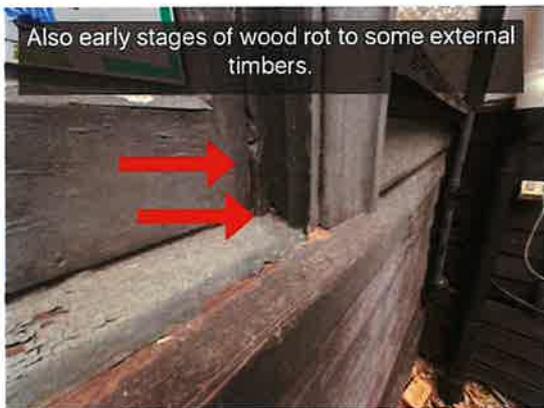
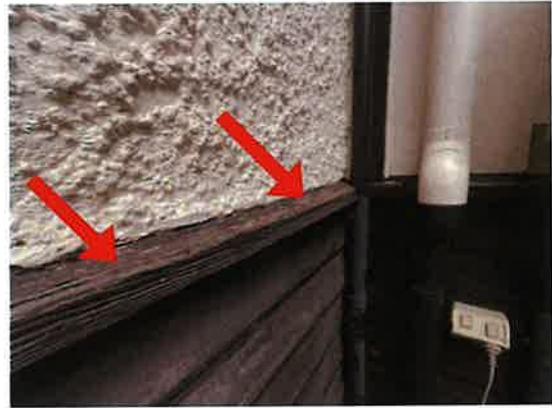
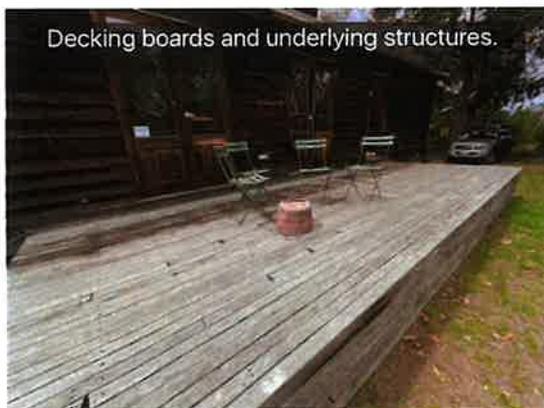
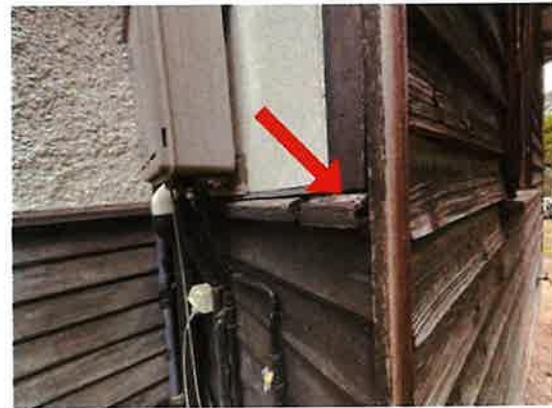
**Finding:** Wood rot

Wood rot which also known as Fungal Decay, occurs when timbers and other cellulose type building materials are exposed to damp conditions on a continual basis. Replacement of affected timbers may then be a necessary step in protecting surrounding building elements from such deterioration. Where wood rot is present to any structural timber, the replacement of the affected timber is required immediately. A qualified carpenter or registered builder may also be required to replace affected building materials. Consultation with a structural engineer is highly advised as soon as possible.

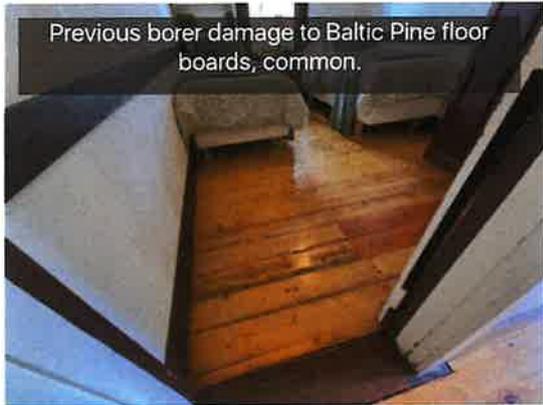
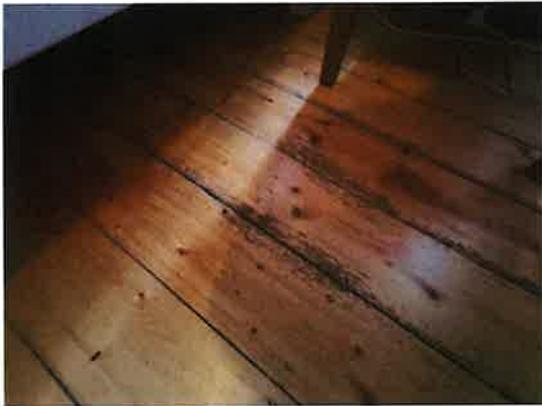
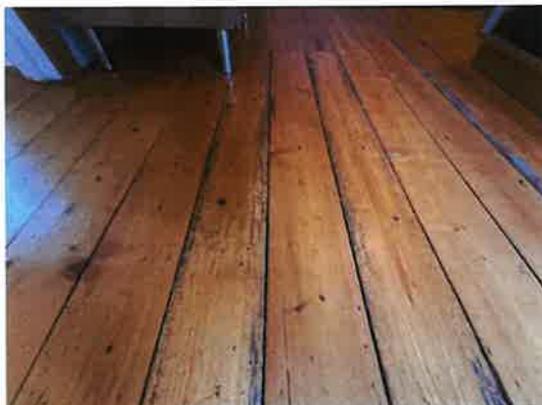
### Timber pest attack 5.04

Evidence of wood Borer damage identified

Wood borer, small Beetles that colonise an exposed timber elements are a common timber pest that are regularly mistaken for termites. Although wood borer activity is generally not detrimental to the affected timber they may lead to serious damage and necessitate replacement of certain building elements if left unattended.

As no live wood Borer activity was identified treatment is not required at this time. Replacement of affected timbers maybe considered by the client for superficial reasons.

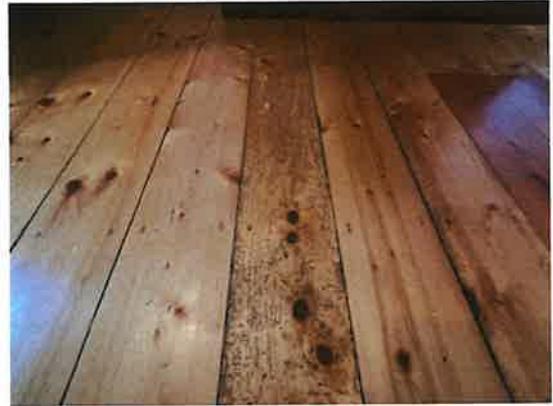
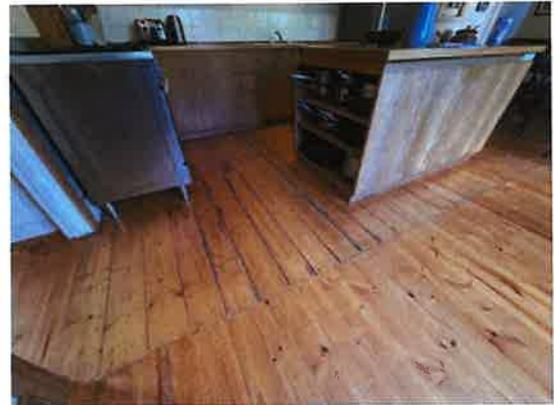
The other commonly known borer, the Anobium borer is more likely to attack floor boards and may cause severe structural damage to flooring areas.
