# CONTRACT OF SALE

**Property:** "Ballara" 57-73 Glaneuse Road, Point Lonsdale 3225

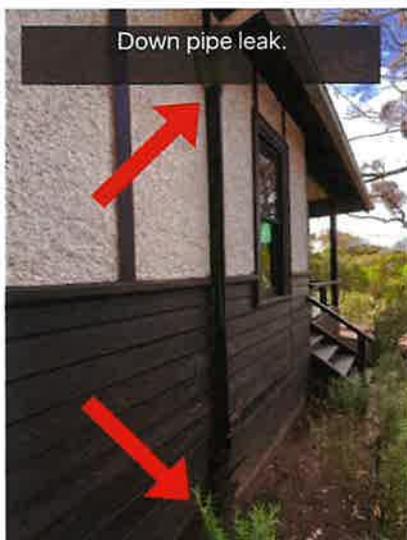
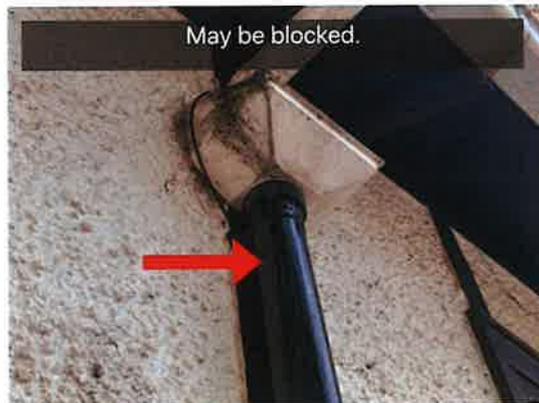
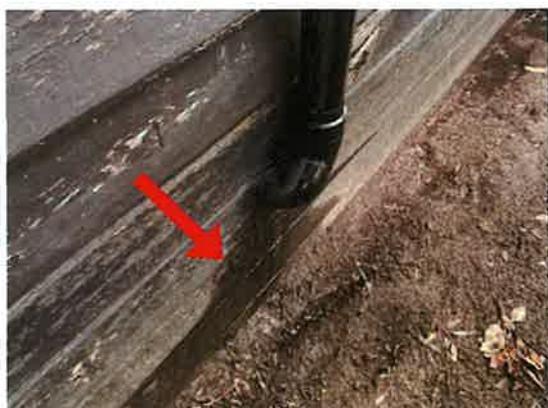
## Conditions conducive to timber pest attack 5.05

**Location:** Some Areas  
**Finding:** Damp or wet-leak

Damp or wet conditions are generally a direct result of poor drainage, an active leak, or poor ventilation (or a combination of the three). Dry conditions should be maintained to prevent secondary building defects from developing.

If left unmanaged damp or wet conditions may have many consequences including the development of fungal decay and/or wood rot as well as providing an environment that may be conducive to termite and timber pest attack.

A qualified plumber should be appointed to identify the cause of the excessive moisture in order to prevent further damage. The water leak should be resolved prior to any repairs of the damaged area which may require localised replacement of building materials and re-finishing.

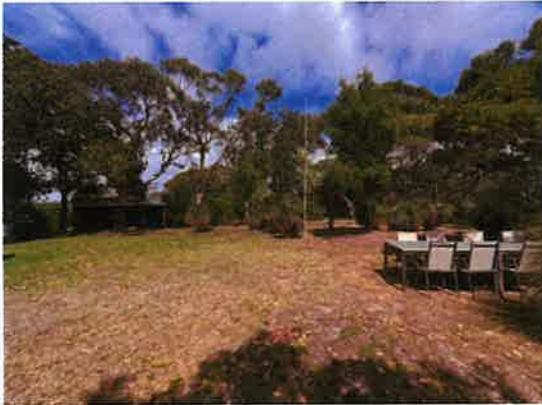
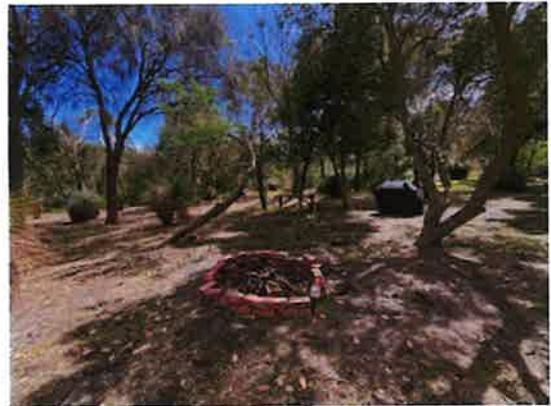
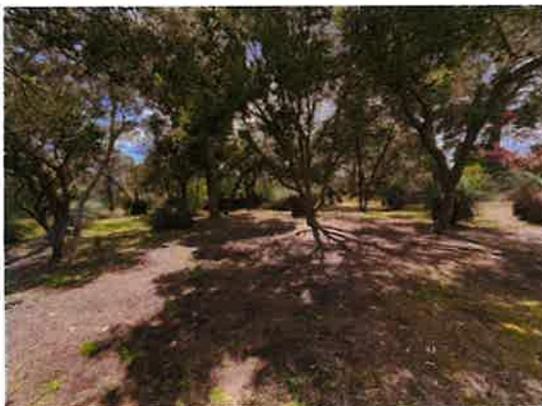
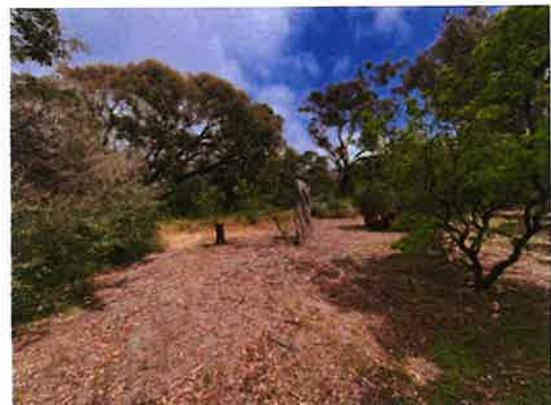
### Conditions conducive to timber pest attack 5.06

Garden Beds and especially mulched areas and non durable timbers in direct contact with the ground provide opportunities for concealed Termite activity and/or entry and are likely to be subject to premature rot and decay as the soil retains moisture or damp conditions against the timbers.

Remove all untreated timber that is in direct contact with external grounds. Consider replacement with more durable materials i.e. treated timber or non-timber elements. Frequent pest inspections are advised to readily identify any termite activity in these areas.

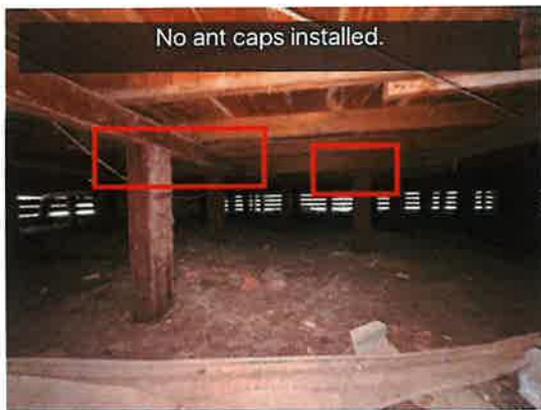
## Conditions conducive to timber pest attack 5.07

**Location:** Subfloor  
**Finding:** Ant caps - Not Installed

Where Ant caps have not been installed, frequent monitoring of these areas should be carried out in order to identify signs of termite or timber pest workings.

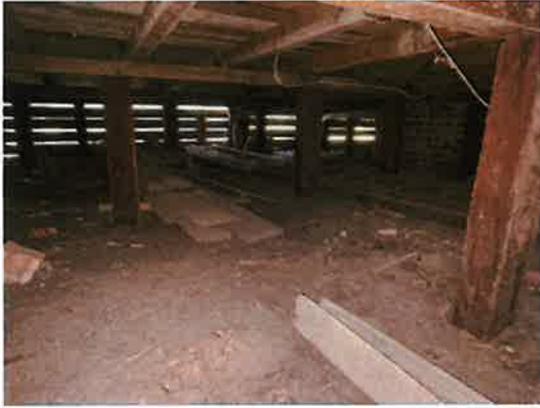
## Conditions conducive to timber pest attack 5.08

An array of debris was found in the subfloor area at the time of inspection. Debris in this area restricts subfloor ventilation and creates potential for concealed pest entry. Stored timbers and other materials may also make the area susceptible to termite activity and would rot.

A clear and empty subfloor will be better ventilated and easier to maintain in a dry condition. The removal of any timber debris is vital in minimising the risk of termite or Wood Borer activity.

Debris in the subfloor should be removed as soon as possible. Depending on the location and amount of debris and stored items the homeowner may elect to undertake this task. Alternatively there are a large number of rubbish removal subcontractors that could undertake these works.

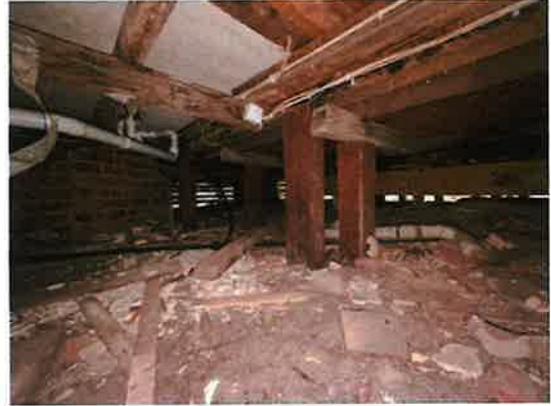
**Location:** Subfloor  
**Finding:** Subfloor -Debris

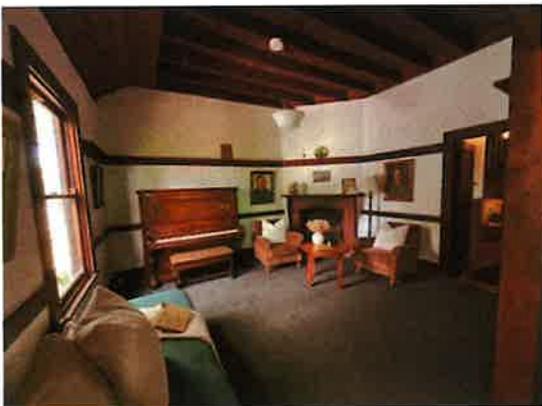
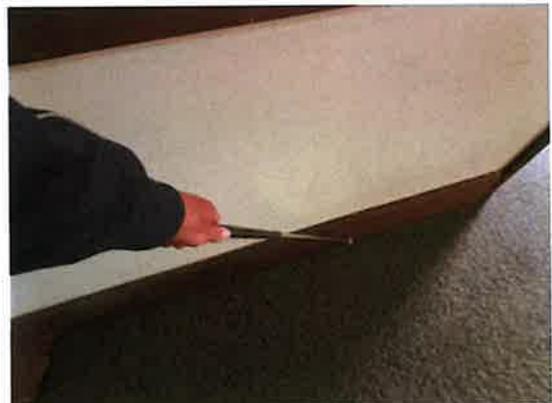
**Finding:** Termite Inspection

A thorough inspection of all internal and external " accessible " timbers was performed throughout the property. All areas of the dwelling are checked with particular attention paid to wet areas which were closely check for excessive levels of moisture anomalies. In an attempt to identify the presence of hidden timber pest activity a variety of techniques are adopted to identify irregularities including a moisture meter to help identify conducive areas around the building, sounding of all accessible timber elements using a sounding device along with close visual assessment of materials affected by moisture or signs of deformity. Also close examination of external areas looking for timbers that are in direct contact with the ground where termite activity is highly likely. Any damp or rotting timbers, trails and bridging constructed by termites and trees fencing and external structures are examine closely for timber pest damage. Generally the moisture content variation at the time of inspection was quite low with the range between 7% and 18% which is considered acceptable.

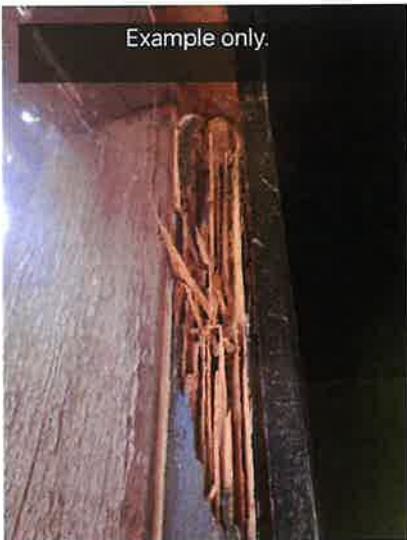
### For your information 5.11

**Location:** The site  
**Finding:** Termite damage

Damage caused by termites that occurs in areas not designated by the relevant council as a termite risk area is the responsibility of the owner.  
Damage caused by termites in buildings within designated termite risk areas is defective if the termite management system has not been installed in accordance with the Building Code of Australia.  
Damage caused by termites in buildings within designated termite risk areas is not defective if the termite management system has not been regularly maintained by the owner, made non-compliant by the owner after handover, or not maintained in accordance with the manufacturer's instructions and AS 3660.2.

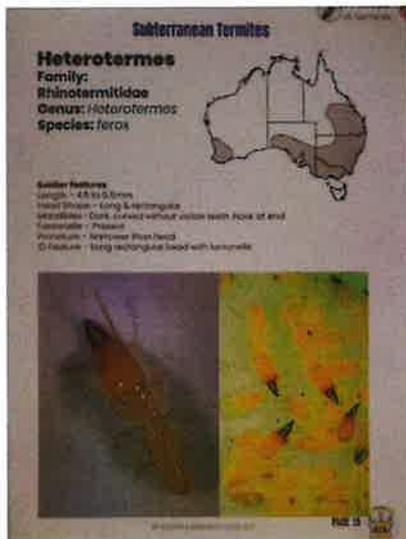
## For your information 5.12

**Location:** The site

Termites can circumvent properly executed termite protection measures, such as building tunnels around barriers. Tunnels can be identified through regular inspections and, if found, the termite nest should be located and destroyed by a suitably qualified pest controller.

Termite management systems are intended to reduce the risk of damage to the structural members of buildings by deterring concealed entry of termites into a building. Termite management systems cannot prevent the entry of termites into the building. In Victoria, a termite management system is only required to be installed where the primary building elements are susceptible to termite attack, as defined in the Building Code of Australia.
